Subject: Notice of Violation and Order (NOVO)
Docket No. 2017-CW-EO-08
Hawaii Water Pollution Rules and Regulations
Big Island Dairy
O'okala, Island of Hawaii, Hawaii

DEPARTMENT OF HEALTH
NOTICE OF VIOLATION AND ORDER

Concentrated Animal Feeding Operation
NPDES Inspection Report
Facility Name: Big Island Dairy
Photograph Log

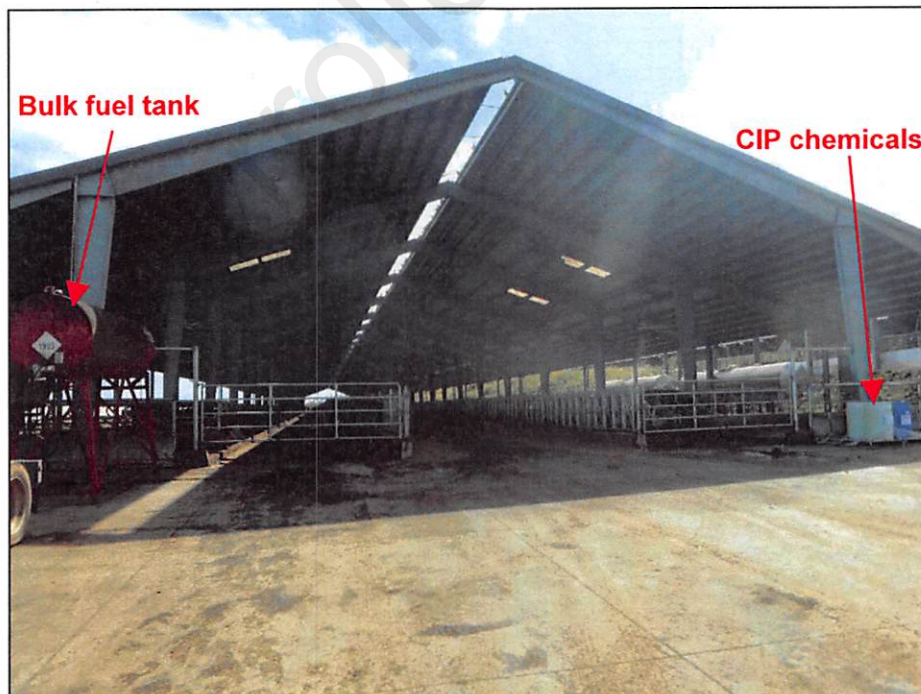
5. During the inspection, I observed 4 bulk gasoline and diesel aboveground fuel storage tanks: 2 at the lower freestall barn and 2 at the maintenance building (refer to Photograph 4). Based on the approximate size of the aboveground storage tanks, it appeared that the Facility had the potential to store greater than 1,320 gallons of fuel onsite, and as such, may be subject to spill prevention control and countermeasure rule specified in 40 CFR Part 112.12. The Facility should ensure that the bulk fuel aboveground storage tanks are either a double-walled tank, or stored within secondary containment to minimize the possibility of a leak or spill.

Photograph 4. View of the Facility's newly constructed lower 1,000-cow freestall barn. Note the bulk fuel tank and CIP chemicals. Photo by A. D'Angelo; 12/14/16.

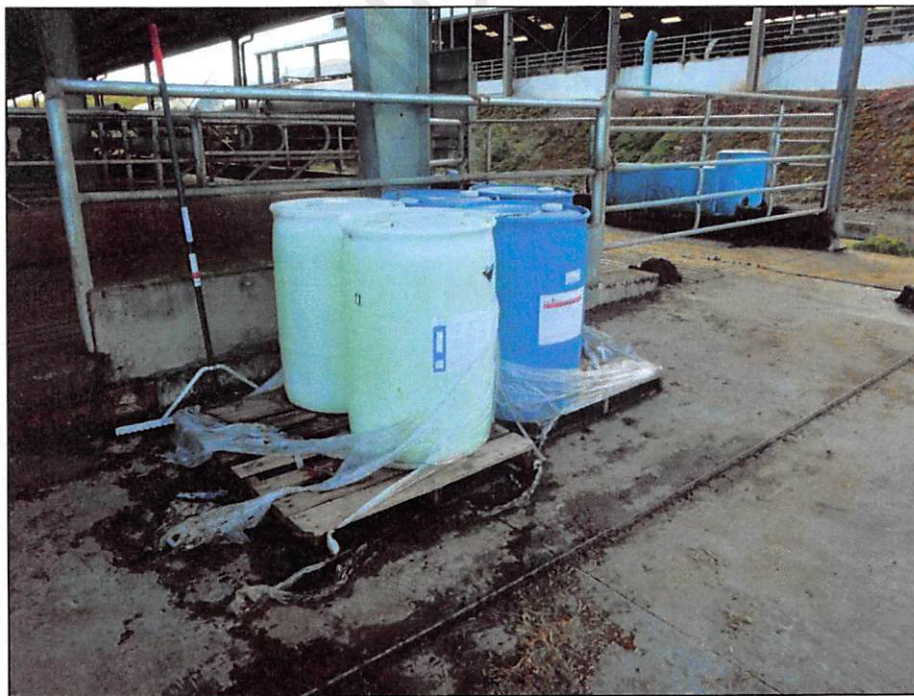
tour, I observed multiple 55-gallon drums of caustic detergent and acid (incompatible chemicals) stored together on a pallet, outdoors without secondary containment (refer to Photographs 4 and 10). Milking cows are directed through a copper sulfate hoof bath when entering and exiting the milking barn to prevent spread of disease and bacteria in an area of high cow traffic (refer to Photograph 11). Milk product is stored in two 20,000-gallon milk silos. Well water used for general dairy operations is stored in a 17,000-gallon aboveground tank located adjacent to the milk silos.

4. During the inspection, I observed chemical storage practices that may present hazardous conditions for Facility employees and livestock. Specifically, I observed multiple 55-gallon drums of caustic detergent and acid stored together on pallets, outdoors without secondary containment (refer to Photographs 4 and 10). After the inspection, I reviewed the Safety Data Sheets (SDSs) for the two CIP chemicals and verified that the chemicals were incompatible based on their pH: Solution® chlorinated alkaline detergent 11.5 standard pH units; CIP Acid Cleaner 2.4 standard pH units. Mr. Duff stated that due to a lack of storage space, surplus CIP chemicals are stored on wooden pallets outside each of the freestall barns. Due to the incompatibility of acids and bases, uncontained drums of the two CIP chemicals stored adjacent to each other can create environmental and health hazards in the event of a spill or leak. This concern is elevated due to the truck/tractor traffic at the freestall barns associated with feed and bedding operations.

Photograph 10. View of two 55-gallon drums of acid and two 55-gallon drums of caustic detergent used in the milking barn CIP system. The drums were stored outside, without overhead coverage or containment, and in close proximity to each other. Photo by A. D'Angelo; 12/14/16.

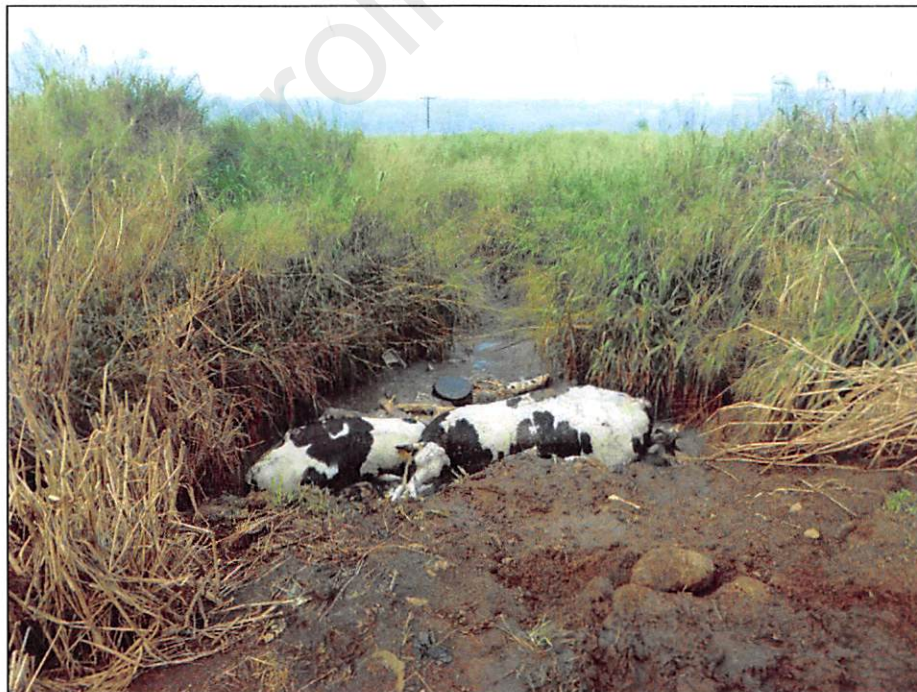
Photograph 14. View, facing northeast, of the Facility's active mortality burial pit, which was located near the manure separation cells, in an existing gulch that drains into the lower lagoon. Photo by A. D'Angelo; 12/14/16.

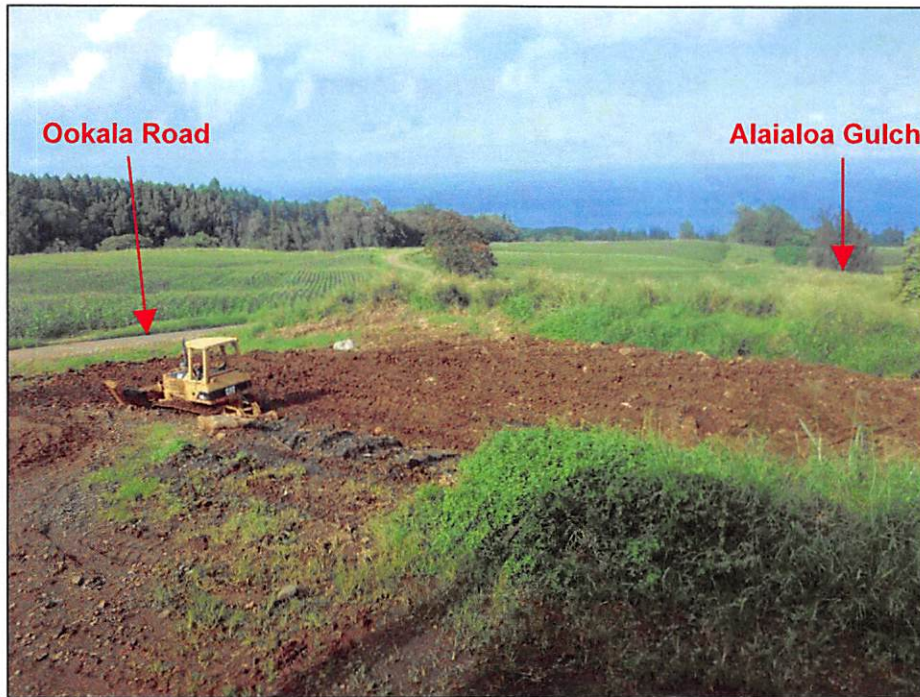
- Steep topography of the BID property, and
 - High annual rainfall amount.
3. During the inspection, I observed a potential for pollutants from the Facility's manure composting operations to contaminate storm water runoff. The manure composting building is located near the origin of Alaiialoa Gulch (refer to Figure 3). Storm water runoff from the manure composting building, and uncovered concrete cow bedding loading area appears to most likely flow into the upgradient reach of Alaiialoa Gulch. As previously stated, during the visit to the manure composting building, I observed a tractor actively loading a trailer with cow bedding (refer to Photographs 15 through 19, and 21).

Photograph 21. View, facing north, of a disturbed area near Ookala Road. This area will be paved to store the honeywagon shown in Photographs 15 and 20. I observed a vegetated buffer between the disturbance and Alaiialoa Gulch. Photo by A. D'Angelo; 12/14/16.

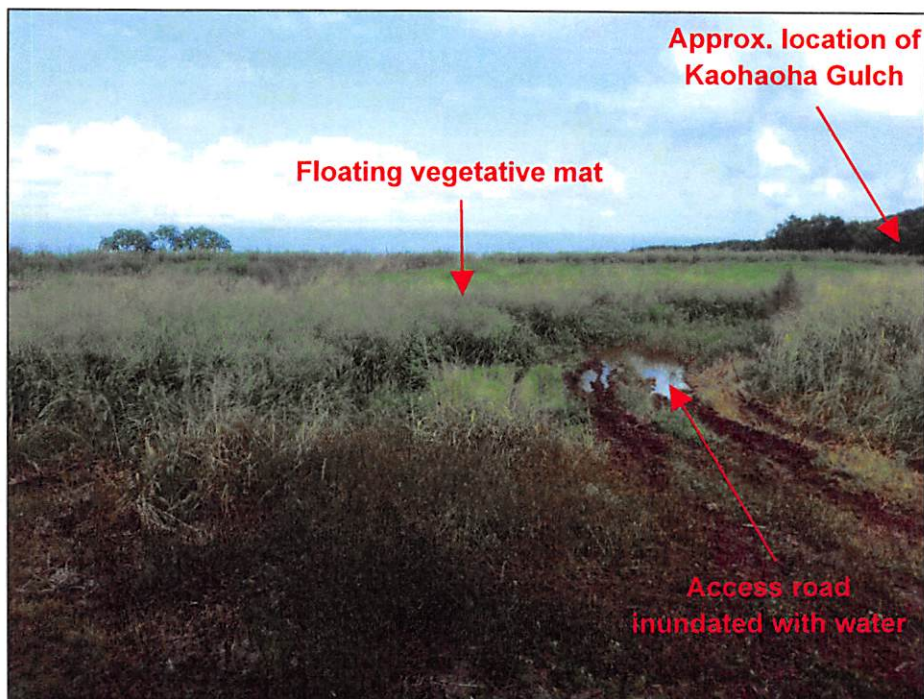
At the time of the inspection, Mr. Kurano and I observed the large vegetative mat on the surface of the upper lagoon (refer to Photograph 25). Mr. Duff stated that the vegetative mat has been present since the property was purchased in 2012, and that it has prevented Facility personnel from accessing the lagoon or identifying the depth of accumulated solids. As such, Mr. Duff stated that the upper lagoon had not been cleaned since at least 2012, and that he was unaware of the depth of solids in the lagoon or the exact date of the last cleaning event. Mr. Kurano and I observed that the upper lagoon was not equipped with a depth marker at the time of the inspection.

Photograph 25. View, facing east, of the upper lagoon which contained a floating vegetative mat. An access road along the south side of the lower lagoon was inundated with water. Photo by A. D'Angelo; 12/14/16.

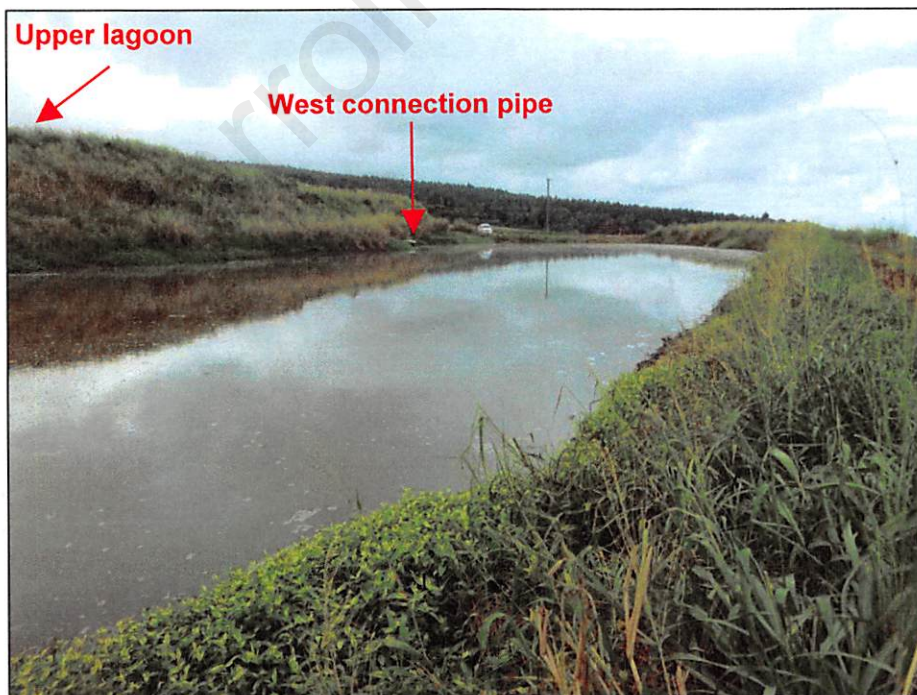
Photograph 26. View, facing west, of the lower lagoon. The lagoon was near capacity at the time of the inspection and was not equipped with a depth marker. Photo by A. D'Angelo; 12/14/16.

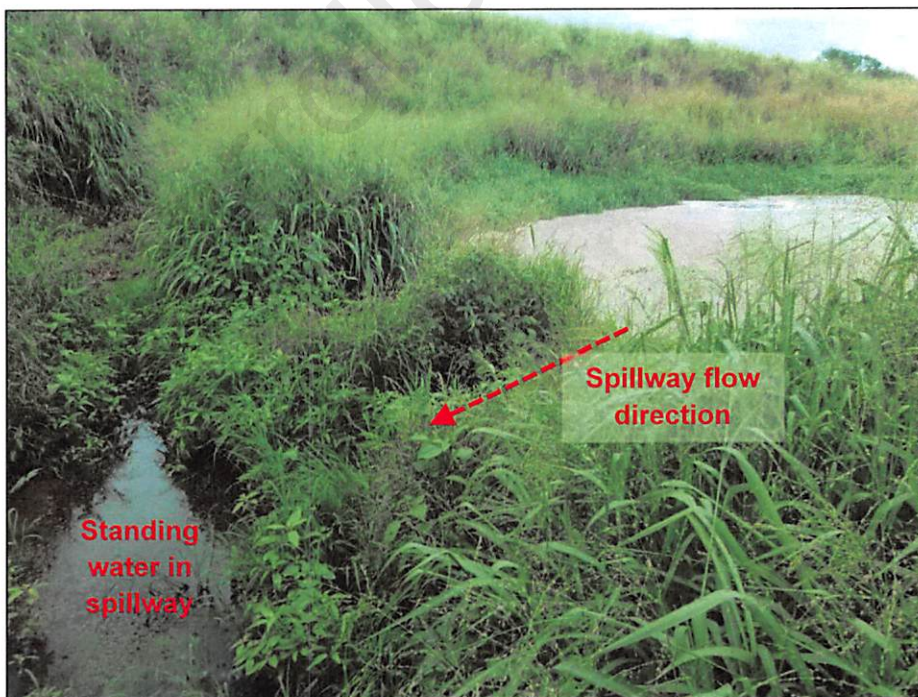
During the inspection, I observed algae growth and standing water in the lower lagoon's overflow spillway (refer to Photographs 32, 33, and 35). Mr. Duff stated that he did not believe that the standing water present in the lower lagoon overflow spillway was from the lagoon, but from storm water runoff from upgradient land caused by recent heavy rainfall. This was inconsistent with a statement made by the BID Representatives during the opening conference, when they stated that the lagoons do not receive storm water runoff. The upper lagoon is located directly upgradient from the lower lagoon and overflow spillway (refer to Photograph 27). As previously stated, Mr. Duff informed Mr. Kurano and I that a large floating vegetative mat on the surface of the upper lagoon prevented Facility employees from accessing the lagoon for cleaning, and as such, the upper lagoon had not been cleaned since the current owners purchased the Facility in 2012. At the time of the inspection, the upper lagoon was not equipped with a depth marker. Additionally, Mr. Duff stated that the majority of flow from the upper lagoon is transferred to the lower lagoon via the east connection pipe. At the time of the inspection, an access road that runs along the south side of the upper lagoon was inundated with water; therefore, the perimeter of the upper lagoon, including the east side of the lagoon that abuts Kaohaoha Gulch was inaccessible (refer to Photograph 25).

Photograph 32. View, facing southwest, of the lower lagoon overflow spillway. Note the presence of algae growth and standing water in the overflow spillway. Photo by A. D'Angelo; 12/14/16.

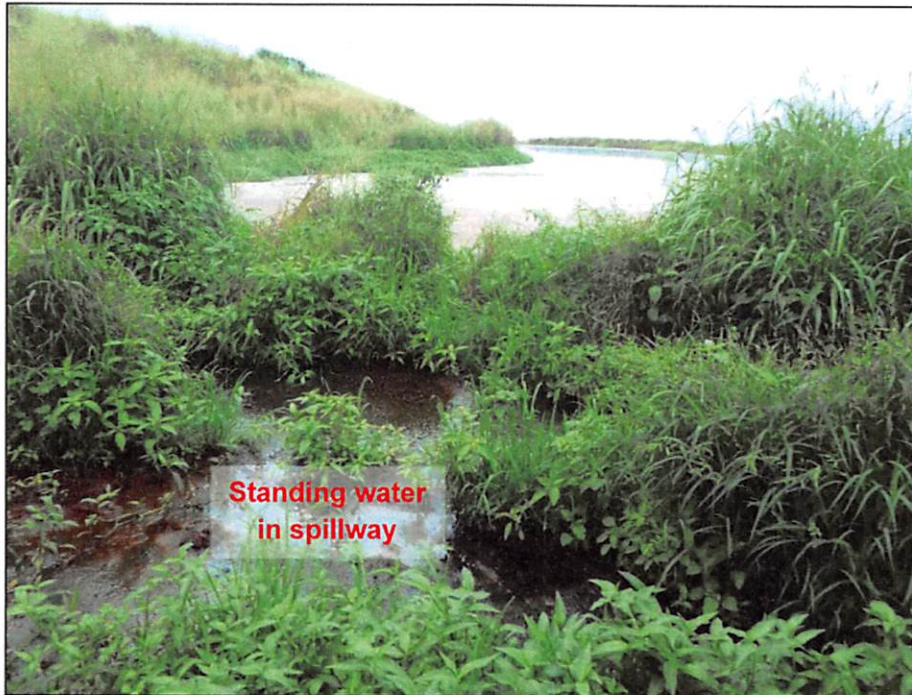
Photograph 33. View of algae growth and standing water in the lower lagoon overflow spillway. Photo by A. D'Angelo; 12/14/16.

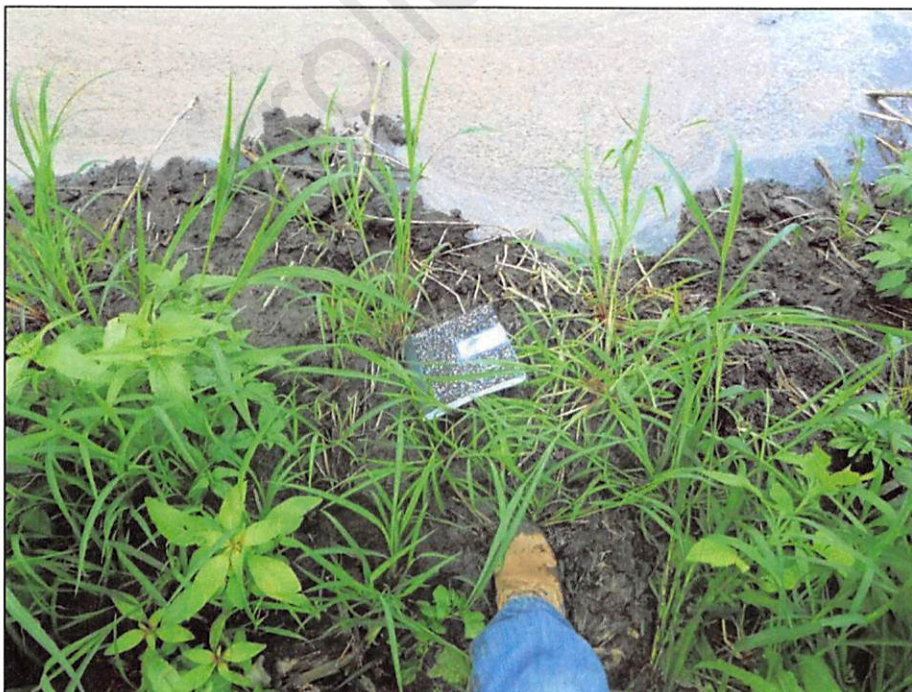
Photograph 34. Standing on the lower lagoon overflow spillway, I estimated the freeboard of the lagoon at approximately twelve inches (note the notebook for reference). Photo by A. D'Angelo; 12/14/16.

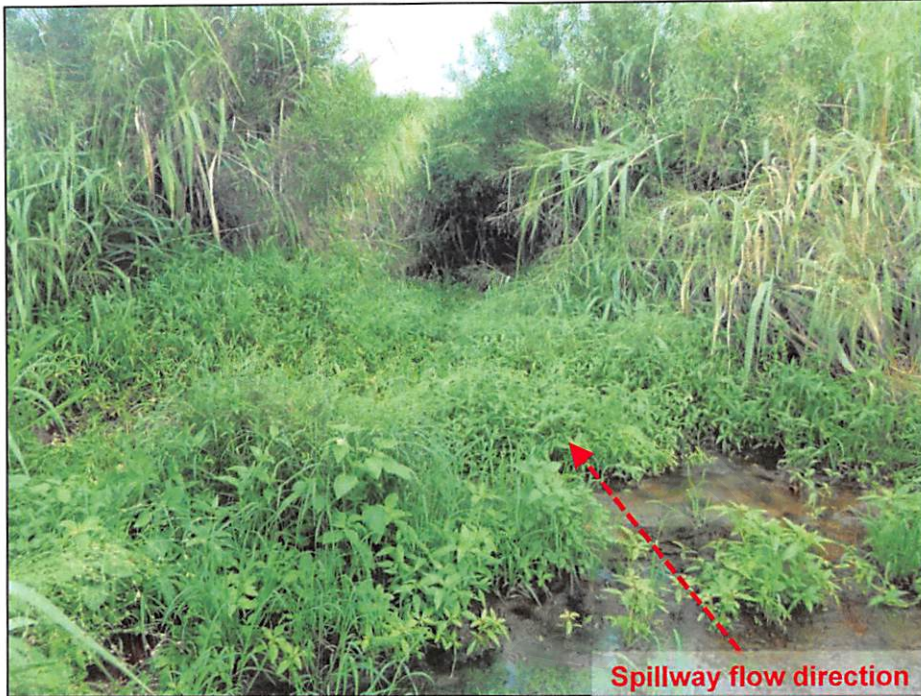
Photograph 35. View, facing southeast from the lower lagoon overflow spillway, down the vegetated channel that connects the lagoon to Kaohaoha Gulch. Photo by A. D'Angelo; 12/14/16.

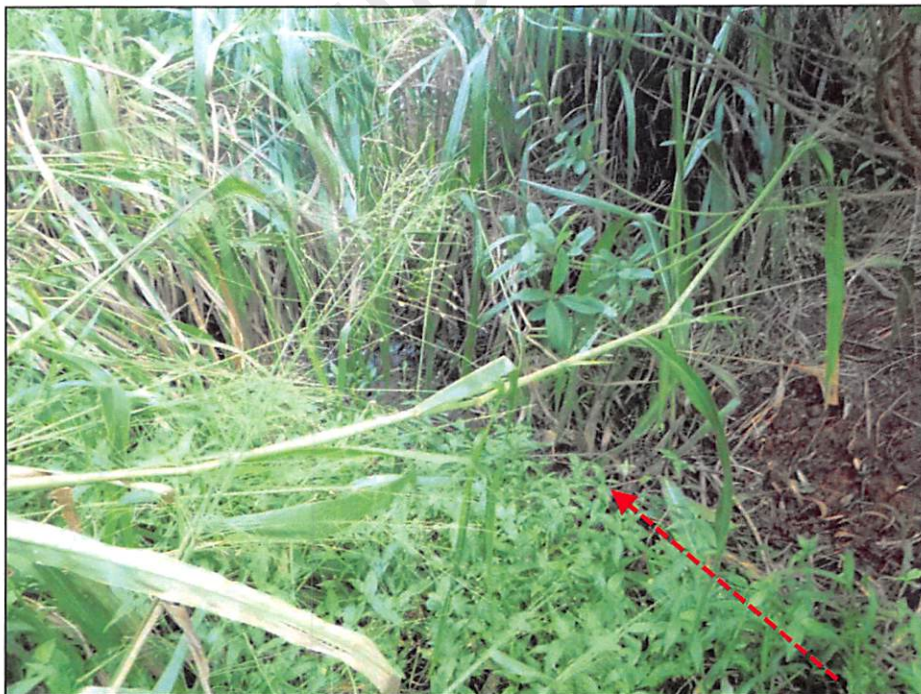
During the opening conference, I asked the BID Representatives if the newly constructed lower lagoon was lined and if it was equipped with an overflow spillway. The BID Representatives did not believe the lower lagoon contained a liner and were initially unaware if the lower lagoon contained a spillway. It should be noted that historical aerial imagery from August 2014 potentially shows a liner on the bottom of the lower lagoon; however, the presence of this liner was not confirmed during the inspection. Before visiting the lagoons, Mr. Duff informed Mr. Kurano and I that a dairy employee went down to the lower lagoon and confirmed that the southeast side of the lower lagoon contained an overflow spillway. We visited the overflow spillway of the lower lagoon and observed algae growth and standing water in the spillway (refer to Photographs 28, and 31 through 33). While standing on the overflow spillway, which was saturated and coated in unstable muck, I estimated the freeboard underneath the lagoon's overflow spillway at approximately twelve inches (refer to Photograph 34). Facing southeast from the overflow spillway, I observed a clear flow pathway down a heavily vegetated conveyance channel that flowed to the southeast (refer to Photographs 35 and 36). Based on aerial imagery, this conveyance channels flows directly into Kaohaoha Gulch, approximately 100 feet southeast of the lower lagoon overflow spillway (refer to Figures 1 through 3). I was unable to hike down the conveyance channel due to unstable mucky conditions and thick vegetation (refer to Photograph 36).

Photograph 36. The channel downgradient of the lower lagoon overflow spillway was heavily vegetated; however, I observed clear channelization and a flow pathway toward Kaohaoha Gulch. Photo by A. D'Angelo; 12/14/16.

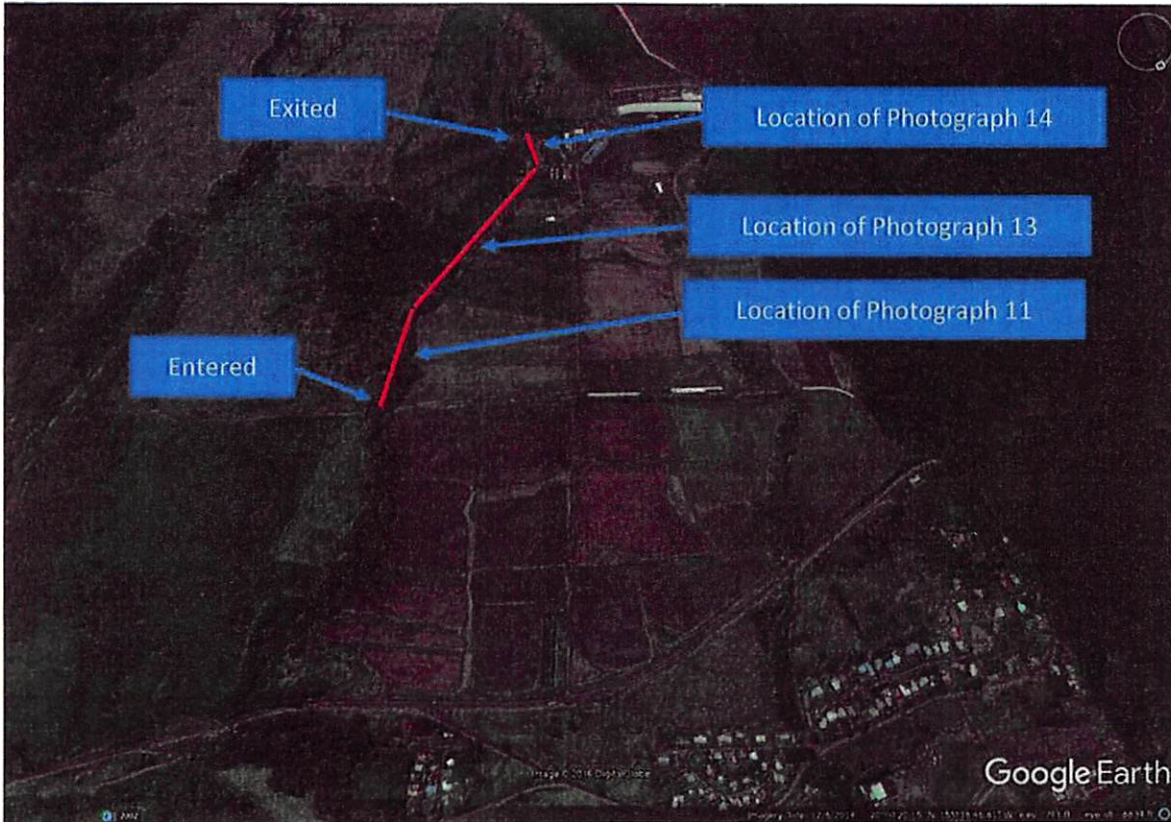
Figure 4: View of the segment of Kaohaoha Gulch inspected on March 29, 2017

Description: The red line is the path upon which N. Mukai, B. Duff and I followed in the inspection of Kaohaoha Gulch. Photograph 11 is the location where a discharge of wastewater from fertilization of the fields was observed. Photograph 13 is the location where evidence of discharge from the wastewater lagoons was observed. Photograph 14 is the location where the dry streambed was observed.
