Investigation Report

Department of Health

Clean Water Branch

Facility: City and County of Honolulu

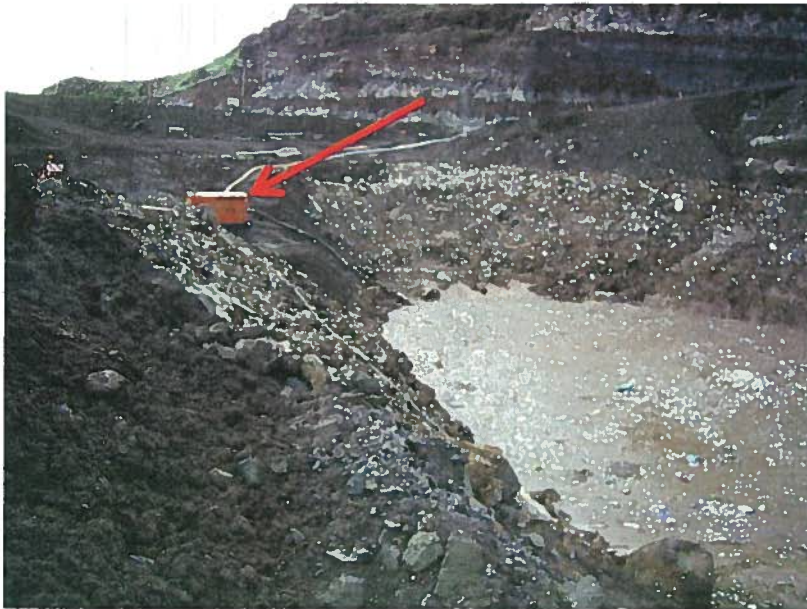
Photograph # 3

14) Statements by J. Lottig as well as the hoses and pumping apparatus observed in the E6 cell was clear evidence that leachate was purposefully discharged into the Landfill's storm water drainage system. The Landfill's storm water drainage system discharges into State waters at a shoreline outfall in the Pacific Ocean West of the Landfill. The Landfill is not authorized to discharge leachate to State waters. Since the subsurface drainage pipe that is designed to divert storm water from the upper watershed was cleared prior to the initiation of pumping activities, it appears that the unauthorized discharges were preventable. J. Lottig stated that the DOH was not contacted prior to the Landfill's initiation of pumping activities which resulted in the discharge of leachate to State waters. It is a violation of Hawaii Revised Statute 342D-50 to discharge a water pollutant to State waters without authorization.

Description: View of the E6 cell facing South. Solid waste was observed throughout the downstream side of the E6 cell. Pumping apparatus (Red Arrow) and hoses were observed connecting the E6 cell to the storm drainage system.
