DEPARTMENT OF HEALTH
NOTICE OF VIOLATION AND ORDER

TO: Big Island Dairy, LLC 695 N 700 E Rupert, Idaho 83350 Respondent Attn: Steve Whitesides Manager	NOVO No. 2017-CW-EO-08 <i>Please write this NOVO number on all correspondence</i> Re: Unauthorized Discharge of Pollutants from Big Island Dairy, Concentrated Animal Feeding Operation to State waters Property/Facility: Big Island Dairy, Near Mile Marker 30, O'okala, HI
--	--

Concentrated Animal Feeding Operation
NPDES Inspection Report
Facility Name: Big Island Dairy
Photograph Log

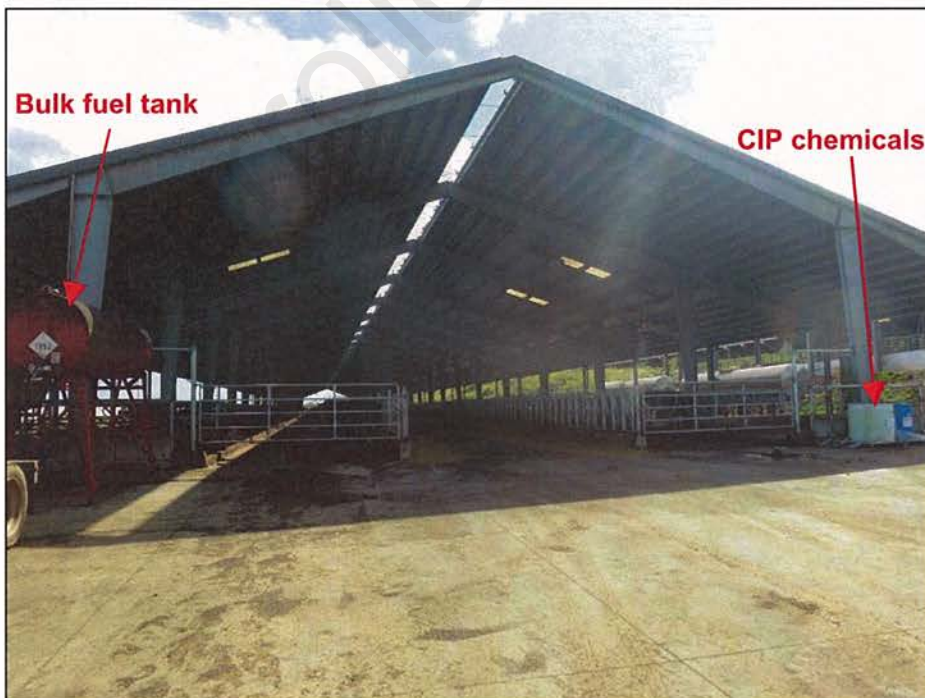
5. During the inspection, I observed 4 bulk gasoline and diesel aboveground fuel storage tanks: 2 at the lower freestall barn and 2 at the maintenance building (refer to Photograph 4). Based on the approximate size of the aboveground storage tanks, it appeared that the Facility had the potential to store greater than 1,320 gallons of fuel onsite, and as such, may be subject to spill prevention control and countermeasure rule specified in 40 CFR Part 112.12. The Facility should ensure that the bulk fuel aboveground storage tanks are either a double-walled tank, or stored within secondary containment to minimize the possibility of a leak or spill.

Photograph 4. View of the Facility's newly constructed lower 1,000-cow freestall barn. Note the bulk fuel tank and CIP chemicals. Photo by A. D'Angelo; 12/14/16.

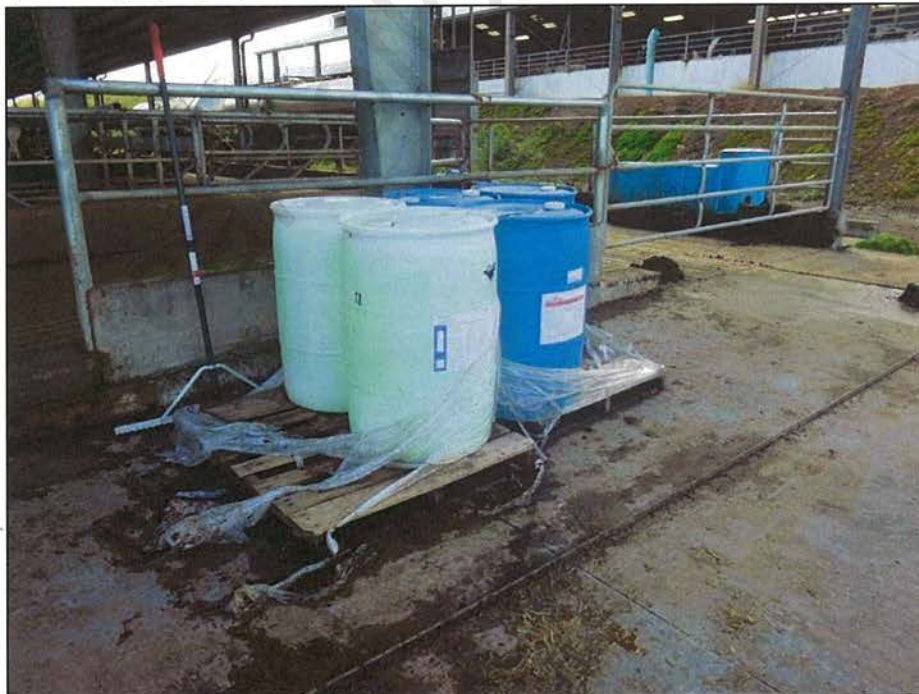
tour, I observed multiple 55-gallon drums of caustic detergent and acid (incompatible chemicals) stored together on a pallet, outdoors without secondary containment (refer to Photographs 4 and 10). Milking cows are directed through a copper sulfate hoof bath when entering and exiting the milking barn to prevent spread of disease and bacteria in an area of high cow traffic (refer to Photograph 11). Milk product is stored in two 20,000-gallon milk silos. Well water used for general dairy operations is stored in a 17,000-gallon aboveground tank located adjacent to the milk silos.

4. During the inspection, I observed chemical storage practices that may present hazardous conditions for Facility employees and livestock. Specifically, I observed multiple 55-gallon drums of caustic detergent and acid stored together on pallets, outdoors without secondary containment (refer to Photographs 4 and 10). After the inspection, I reviewed the Safety Data Sheets (SDSs) for the two CIP chemicals and verified that the chemicals were incompatible based on their pH: Solution® chlorinated alkaline detergent 11.5 standard pH units; CIP Acid Cleaner 2.4 standard pH units. Mr. Duff stated that due to a lack of storage space, surplus CIP chemicals are stored on wooden pallets outside each of the freestall barns. Due to the incompatibility of acids and bases, uncontained drums of the two CIP chemicals stored adjacent to each other can create environmental and health hazards in the event of a spill or leak. This concern is elevated due to the truck/tractor traffic at the freestall barns associated with feed and bedding operations.

Photograph 10. View of two 55-gallon drums of acid and two 55-gallon drums of caustic detergent used in the milking barn CIP system. The drums were stored outside, without overhead coverage or containment, and in close proximity to each other. Photo by A. D'Angelo; 12/14/16.

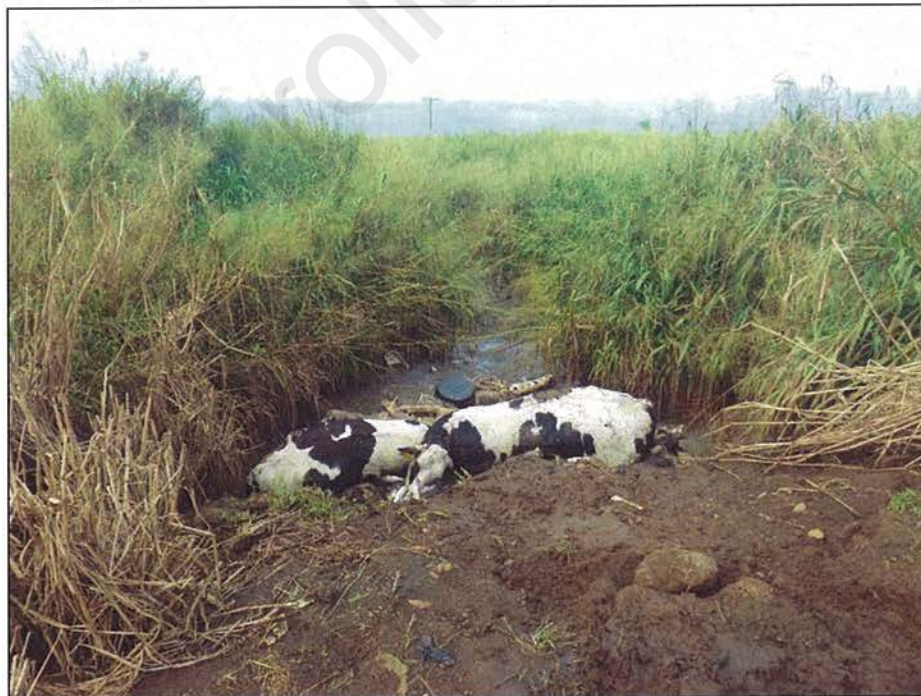
Photograph 14. View, facing northeast, of the Facility's active mortality burial pit, which was located near the manure separation cells, in an existing gulch that drains into the lower lagoon. Photo by A. D'Angelo; 12/14/16.

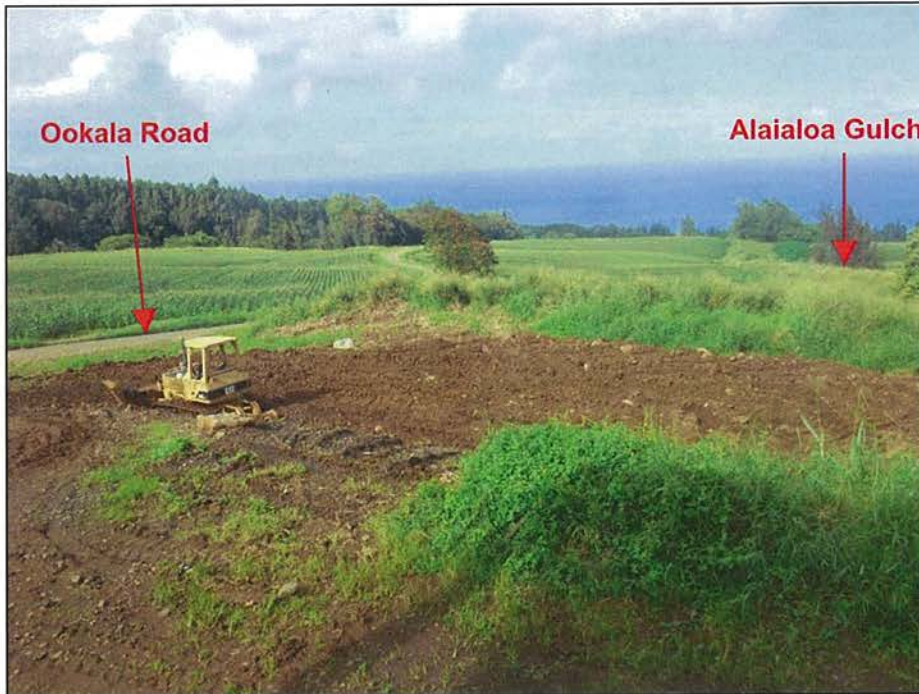
Photograph 21. View, facing north, of a disturbed area near Ookala Road. This area will be paved to store the honeywagon shown in Photographs 15 and 20. I observed a vegetated buffer between the disturbance and Alaiialoa Gulch. Photo by A. D'Angelo; 12/14/16.

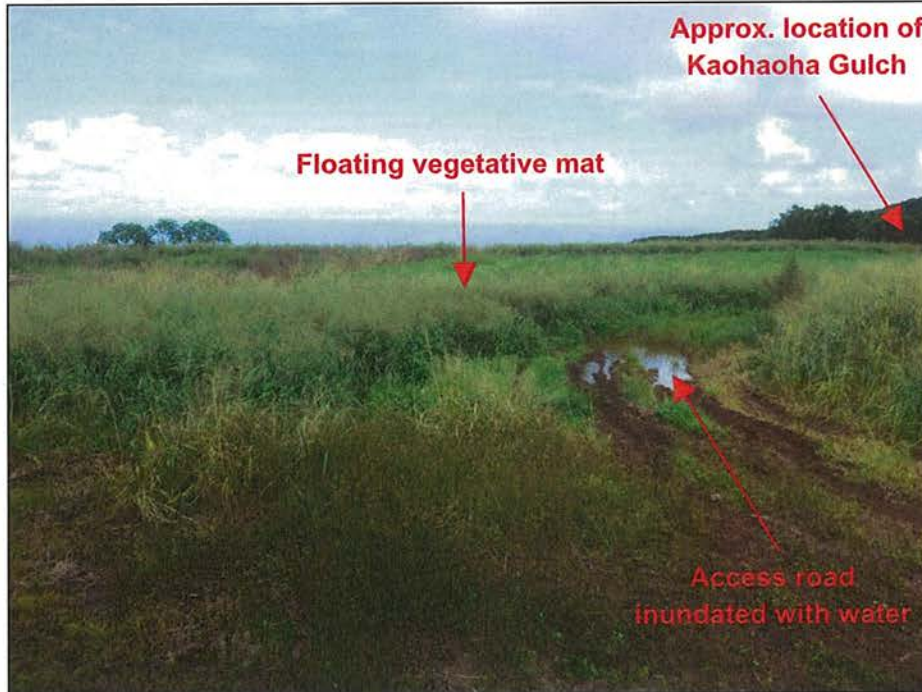
At the time of the inspection, Mr. Kurano and I observed the large vegetative mat on the surface of the upper lagoon (refer to Photograph 25). Mr. Duff stated that the vegetative mat has been present since the property was purchased in 2012, and that it has prevented Facility personnel from accessing the lagoon or identifying the depth of accumulated solids. As such, Mr. Duff stated that the upper lagoon had not been cleaned since at least 2012, and that he was unaware of the depth of solids in the lagoon or the exact date of the last cleaning event. Mr. Kurano and I observed that the upper lagoon was not equipped with a depth marker at the time of the inspection.

Photograph 25. View, facing east, of the upper lagoon which contained a floating vegetative mat. An access road along the south side of the lower lagoon was inundated with water. Photo by A. D'Angelo; 12/14/16.

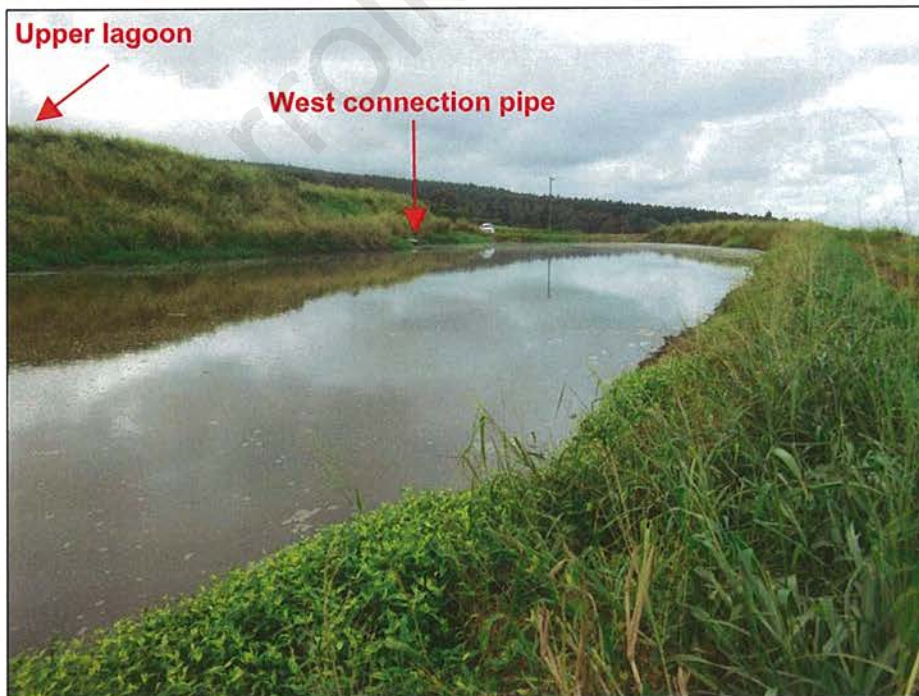
Photograph 26. View, facing west, of the lower lagoon. The lagoon was near capacity at the time of the inspection and was not equipped with a depth marker. Photo by A. D'Angelo; 12/14/16.

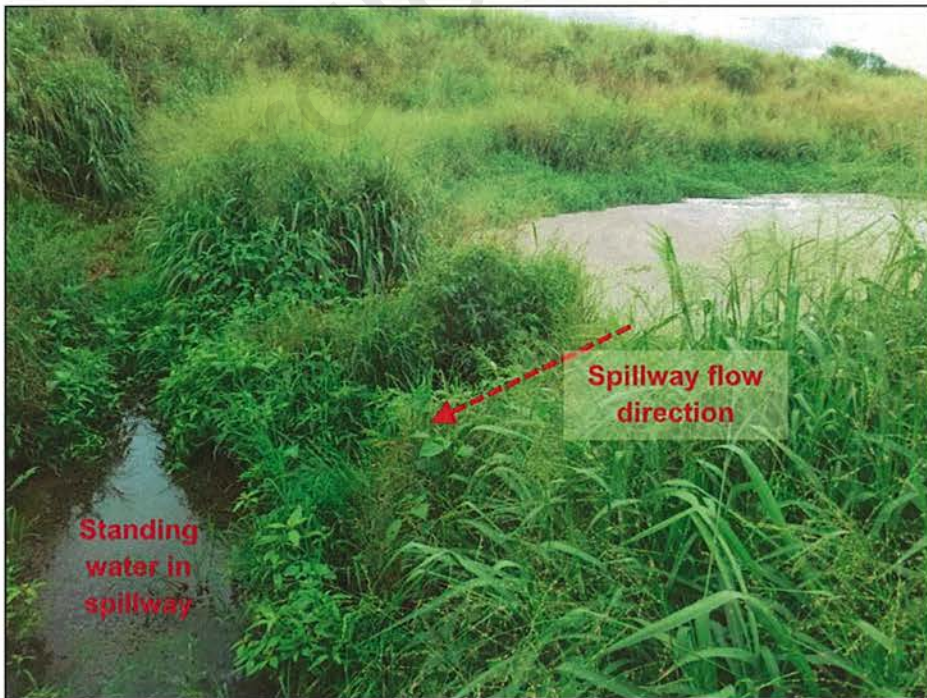
During the inspection, I observed algae growth and standing water in the lower lagoon's overflow spillway (refer to Photographs 32, 33, and 35). Mr. Duff stated that he did not believe that the standing water present in the lower lagoon overflow spillway was from the lagoon, but from storm water runoff from upgradient land caused by recent heavy rainfall. This was inconsistent with a statement made by the BID Representatives during the opening conference, when they stated that the lagoons do not receive storm water runoff. The upper lagoon is located directly upgradient from the lower lagoon and overflow spillway (refer to Photograph 27). As previously stated, Mr. Duff informed Mr. Kurano and I that a large floating vegetative mat on the surface of the upper lagoon prevented Facility employees from accessing the lagoon for cleaning, and as such, the upper lagoon had not been cleaned since the current owners purchased the Facility in 2012. At the time of the inspection, the upper lagoon was not equipped with a depth marker. Additionally, Mr. Duff stated that the majority of flow from the upper lagoon is transferred to the lower lagoon via the east connection pipe. At the time of the inspection, an access road that runs along the south side of the upper lagoon was inundated with water; therefore, the perimeter of the upper lagoon, including the east side of the lagoon that abuts Kaohaoha Gulch was inaccessible (refer to Photograph 25).

Photograph 32. View, facing southwest, of the lower lagoon overflow spillway. Note the presence of algae growth and standing water in the overflow spillway. Photo by A. D'Angelo; 12/14/16.

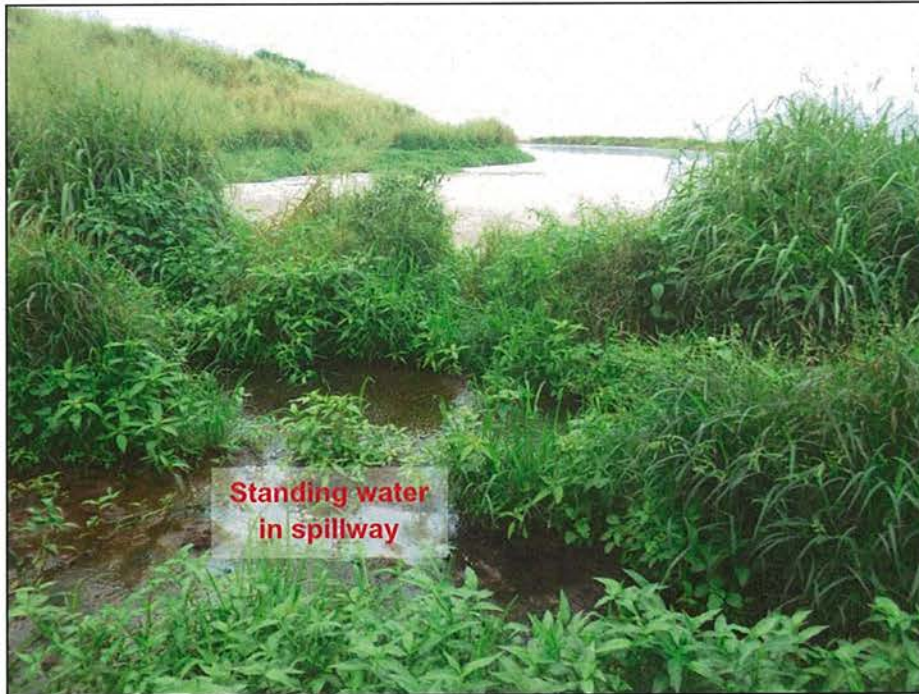
Photograph 33. View of algae growth and standing water in the lower lagoon overflow spillway. Photo by A. D'Angelo; 12/14/16.

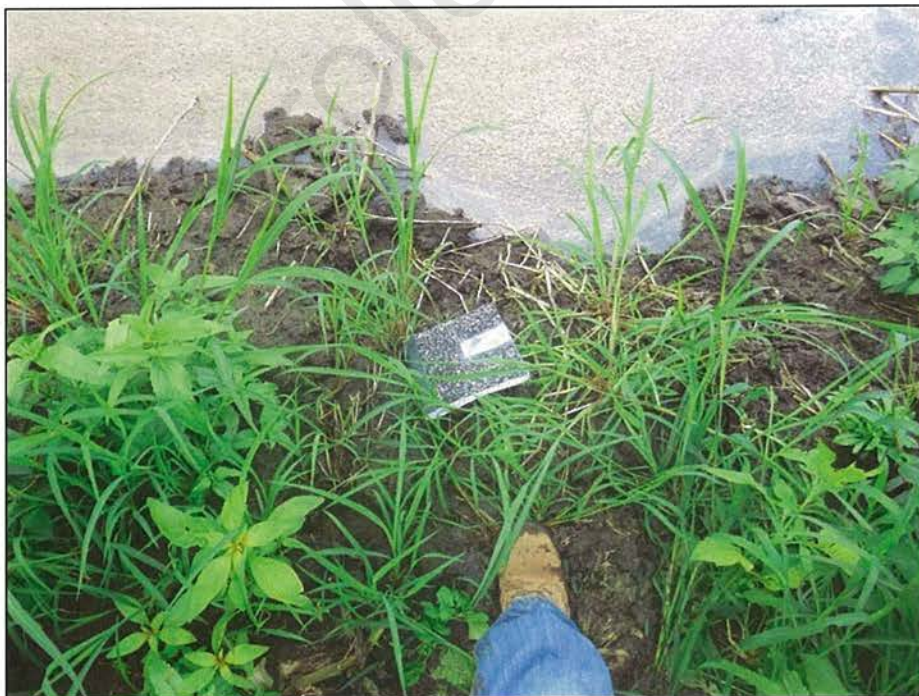
Photograph 34. Standing on the lower lagoon overflow spillway, I estimated the freeboard of the lagoon at approximately twelve inches (note the notebook for reference). Photo by A. D'Angelo; 12/14/16.

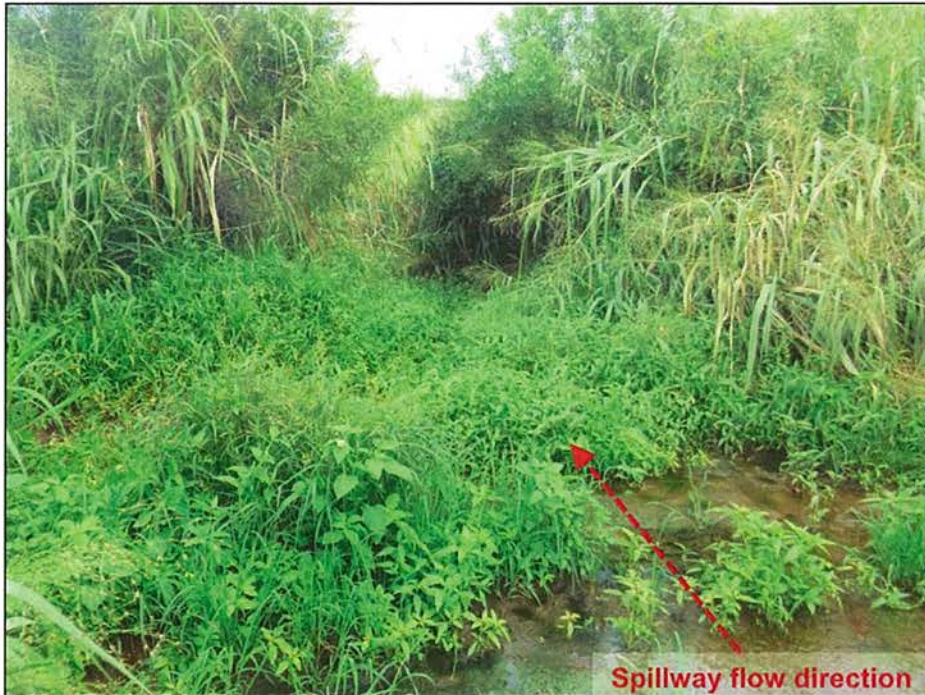
Photograph 35. View, facing southeast from the lower lagoon overflow spillway, down the vegetated channel that connects the lagoon to Kaohaoha Gulch. Photo by A. D'Angelo; 12/14/16.

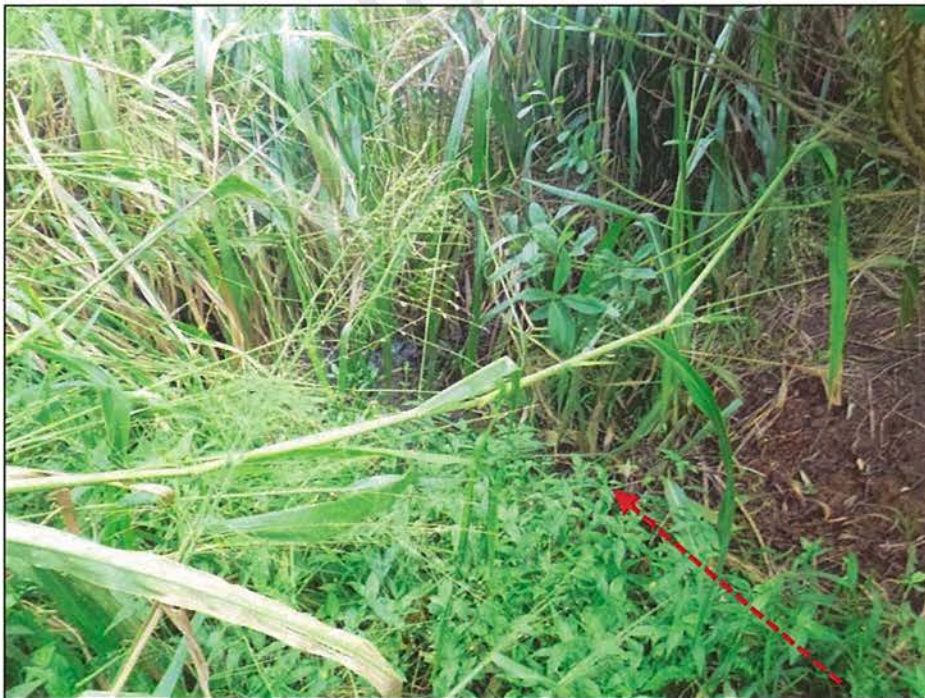
During the opening conference, I asked the BID Representatives if the newly constructed lower lagoon was lined and if it was equipped with an overflow spillway. The BID Representatives did not believe the lower lagoon contained a liner and were initially unaware if the lower lagoon contained a spillway. It should be noted that historical aerial imagery from August 2014 potentially shows a liner on the bottom of the lower lagoon; however, the presence of this liner was not confirmed during the inspection. Before visiting the lagoons, Mr. Duff informed Mr. Kurano and I that a dairy employee went down to the lower lagoon and confirmed that the southeast side of the lower lagoon contained an overflow spillway. We visited the overflow spillway of the lower lagoon and observed algae growth and standing water in the spillway (refer to Photographs 28, and 31 through 33). While standing on the overflow spillway, which was saturated and coated in unstable muck, I estimated the freeboard underneath the lagoon's overflow spillway at approximately twelve inches (refer to Photograph 34). Facing southeast from the overflow spillway, I observed a clear flow pathway down a heavily vegetated conveyance channel that flowed to the southeast (refer to Photographs 35 and 36). Based on aerial imagery, this conveyance channels flows directly into Kaohaoha Gulch, approximately 100 feet southeast of the lower lagoon overflow spillway (refer to Figures 1 through 3). I was unable to hike down the conveyance channel due to unstable mucky conditions and thick vegetation (refer to Photograph 36).

Photograph 36. The channel downgradient of the lower lagoon overflow spillway was heavily vegetated; however, I observed clear channelization and a flow pathway toward Kaohaoha Gulch. Photo by A. D'Angelo; 12/14/16.

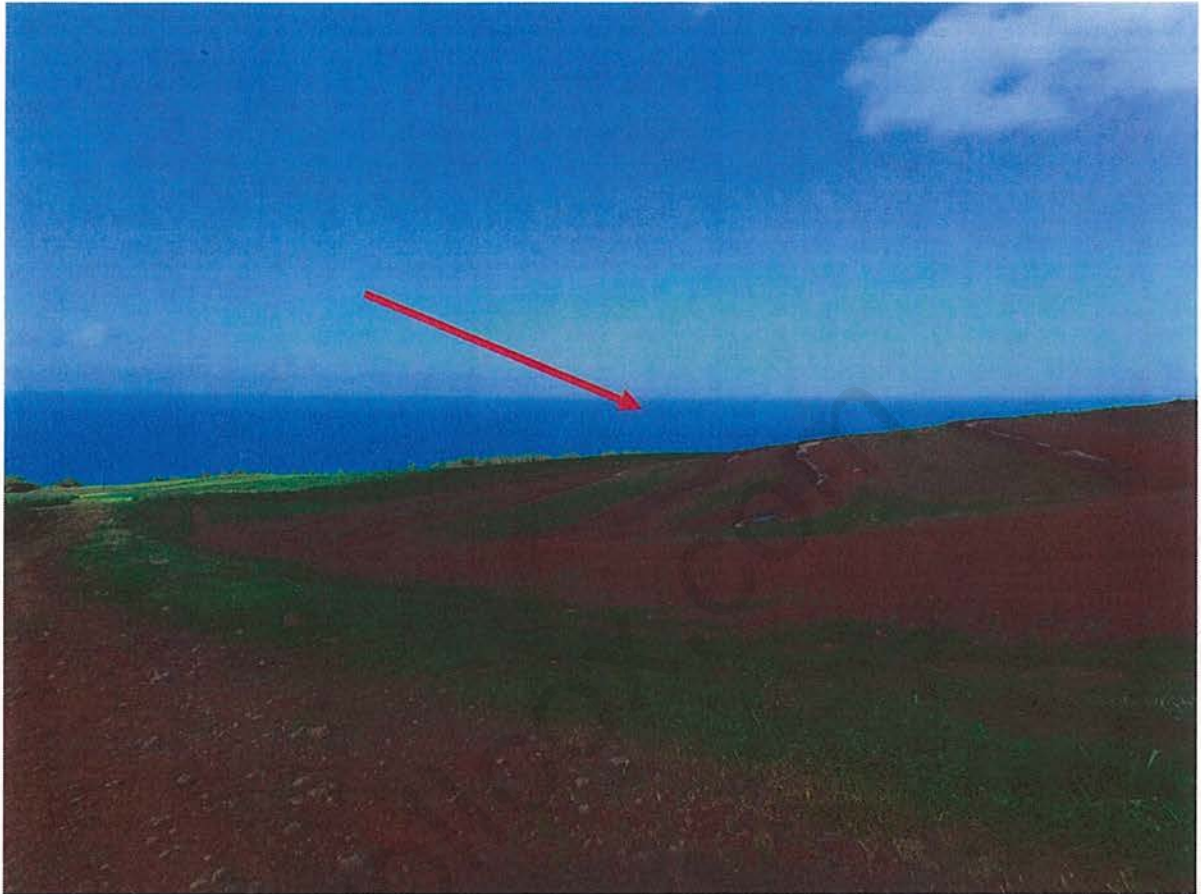
- 1) The crop fields, immediately North (makai) of the "airstrip" appeared to be recently graded (Photograph 3). I observed corn growing in the fields in rows perpendicular to the slope of the property. What appeared to be small trenches were cut perpendicular to the slope of the property such that any excess irrigation water would stay onsite. Further, the fields sloped up towards Alailoa Gulch such that there was a low potential for storm water or irrigation water to discharge from the fields. Of note, the grading and terrace-like features was not ubiquitous throughout the Dairy's fields. The field pictured in Photograph 3 depicts one (1) of the fields B. Duff stated was modified following the DOH inspection in December 2016.

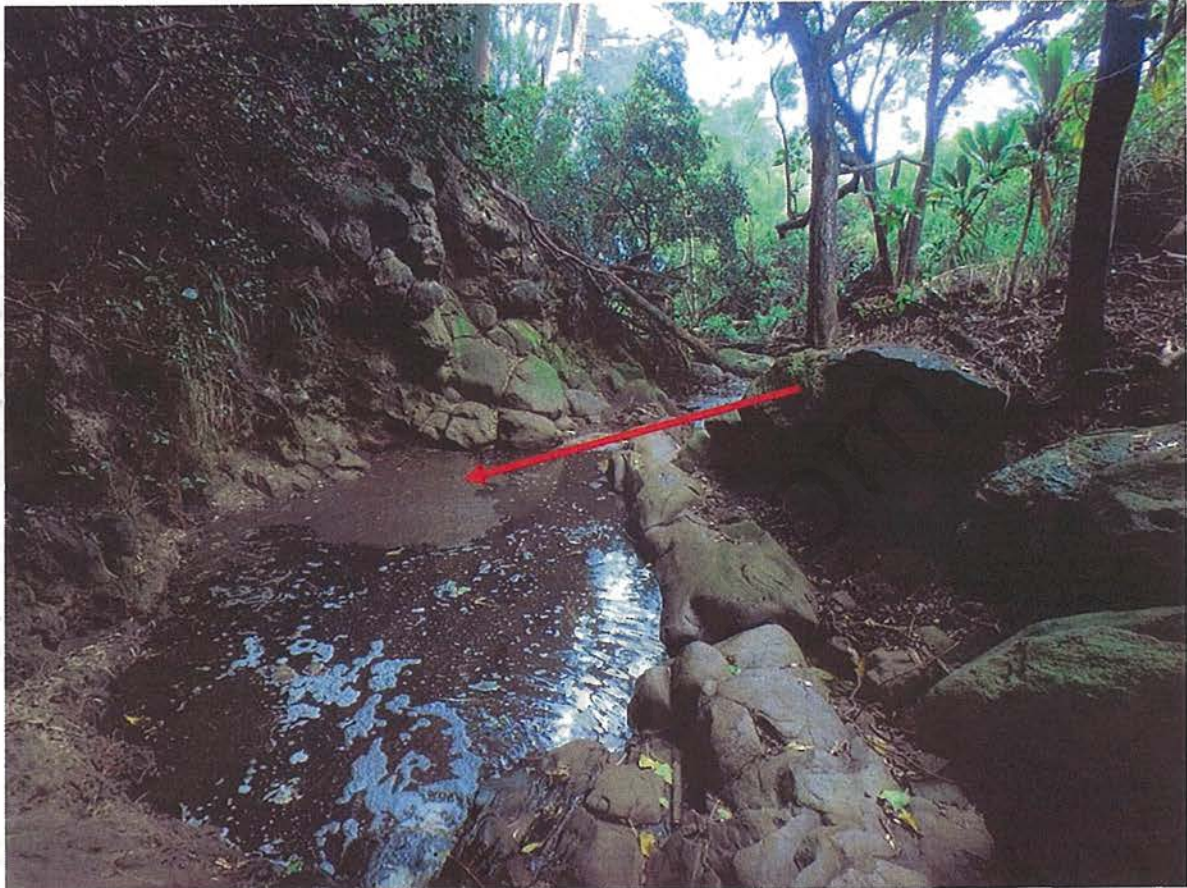
Photograph 6

- 3) Upon descent into Kaohaoha Gulch, pools of what appeared to be polluted water (Photograph 6) was observed. The water appeared to have a scum layer with accumulated floatable sludge. The sludge appeared to be organic material. Ordinary water marks on the sides of the stream were easily viewed due to a brown stain.

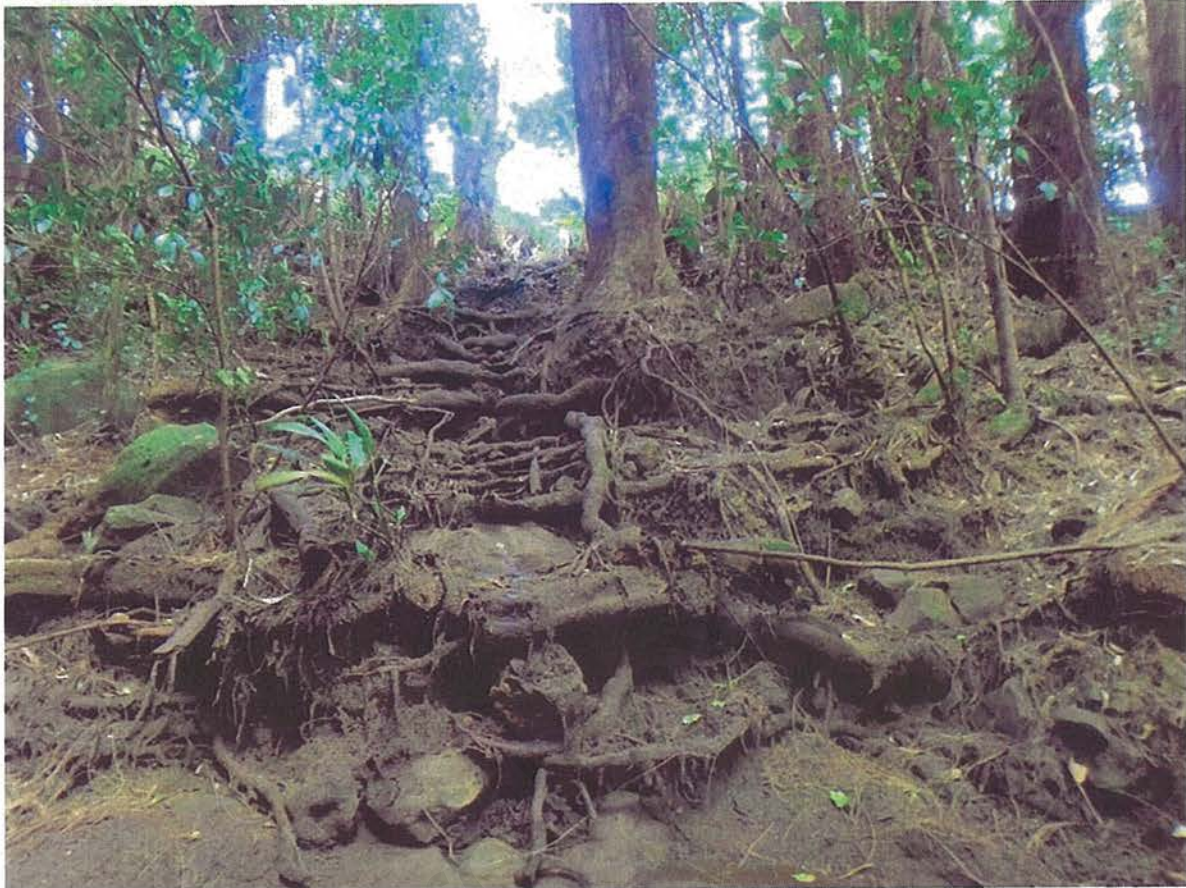
Photograph 8

- 5) On the east bank of Kaohaoha Gulch, I observed clear evidence of erosion due to a concentrated flow (Photograph 8). The flow path was covered by a layer of what appeared to be a sludge-like cake. Within the layer of sludge, I observed residual fibrous material that looked like short segments of straw, similar to the compost I observed at the Dairy's composting facility.

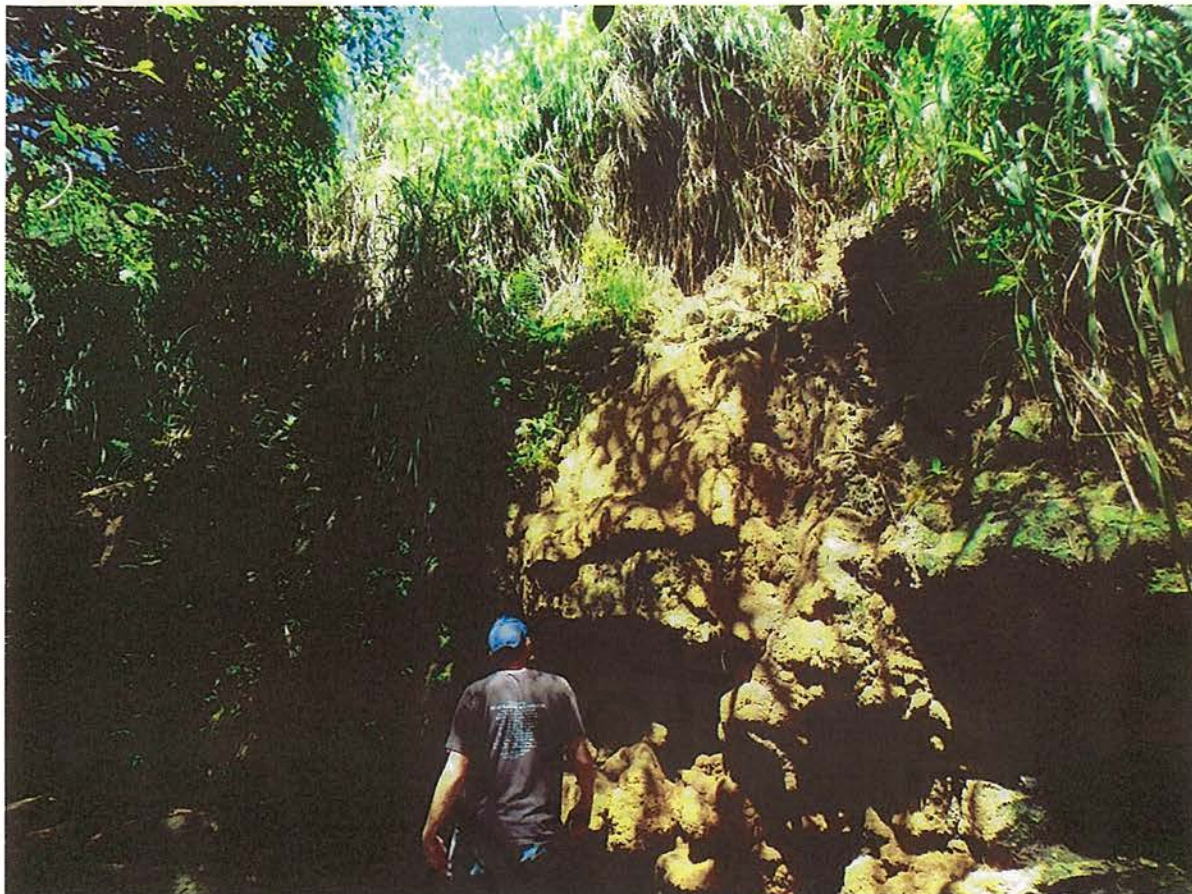
Photograph 13

- 9) At the location where the Dairy's wastewater lagoon's spillway connects to Kaohaoha Gulch, I observed clear evidence of previous discharges. A cascade (Photograph 13) of
