**Hawaii Department of Health
 Clean Water Branch
 Enforcement Oversight Inspection Report**

Inspection Date: May 17, 2018

Inspection Report Number: HA0296

Site Name: Big Island Dairy

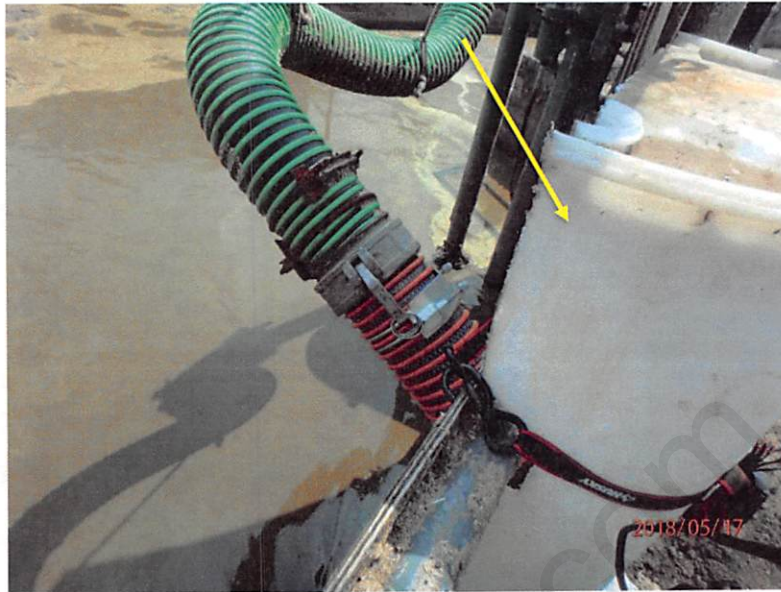
Photograph 1.

- a. Within the wastewater sump, I observed a recently installed new portion of orange piping. J. Mecham stated that the new piece of pipe was a replacement for where the original pipe had broken. The Dairy also installed a temporary splash guard as a BMP that would insure future releases would not discharge to ground in the event of another pipe failure (refer to, Photograph 1).

- b. Based on the statements made by Dairy representatives, it is unclear as to the total volume of wastewater discharged from the wastewater sump. While a 30-minute spill time was estimated by the Dairy, it could not be verified. The Dairy reported a volume of 10,000 gallons was spilled from the Wastewater Sump on May 6, 2018.

Description: View₇ inside of the Wastewater Sump Pit. The break occurred where the orange and green hose pieces now meet. Yellow arrow points to temporary splash guard installed to prevent further discharge in the event of a future hose failure.

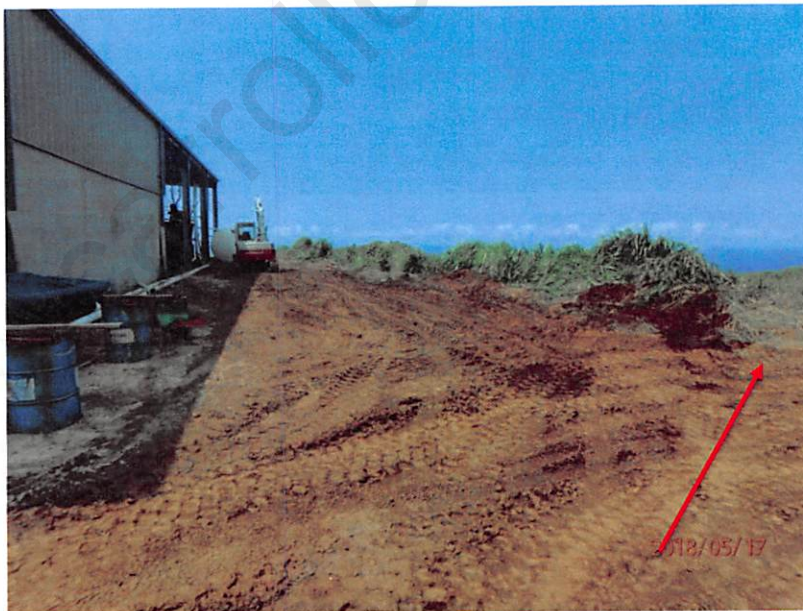
Photograph 2.

1. The Inspection Team and J. Mecham departed the office and drove to the Wastewater Sump Pit. Upon arriving, I could see the top layer of vegetation and soil had been removed adjacent and north of the wastewater sump (refer to, Photograph 2). J. Mecham explained this was a result of clean-up efforts and in preparation of a survey team coming to begin construction of a berm around the wastewater sump to provide a measure of secondary containment. I did not observe any wastewater outside of the wastewater sump pit.

Description: View, facing north, standing at the Wastewater Sump Pit of the area affected by the discharge on May 6, 2018. Affected soils had been removed. Red arrows points in direction of flow path to Alaialoa Gulch.

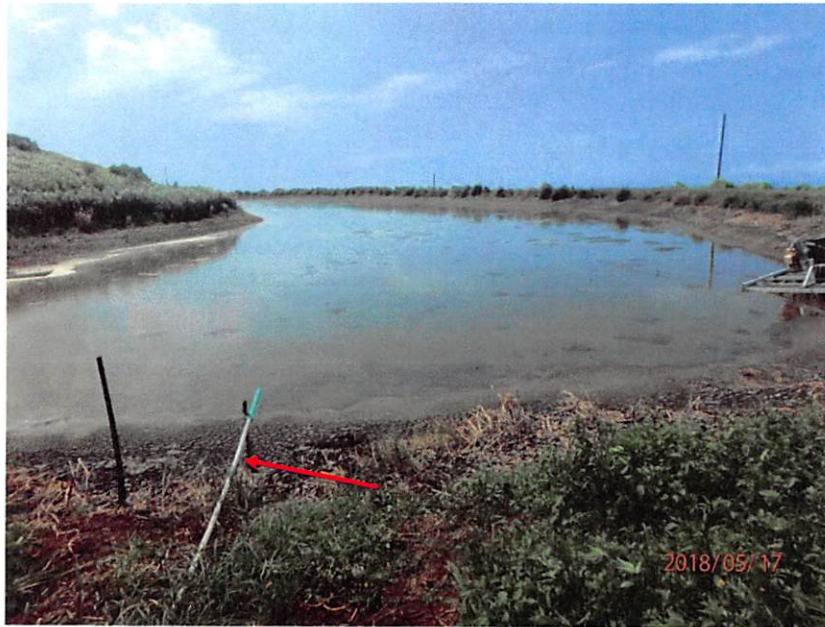
Photograph 3.

2. The inspection then continued at the spillway for Wastewater Lagoon #2. Wastewater Lagoon #2 had approximately five (5) feet of freeboard (refer to, Photograph 3 & 4). I did not observe evidence of a discharge or ground disturbance on or near the spillway (refer to, Photograph 5 & 6). J. Mecham stated that wastewater was not discharged over the spillway.

Description: View, facing northwest, of Wastewater Lagoon #2 from the spillway. Approximately five (5) feet of freeboard existed at the time of inspection. Red arrow points to height marker of spillway.

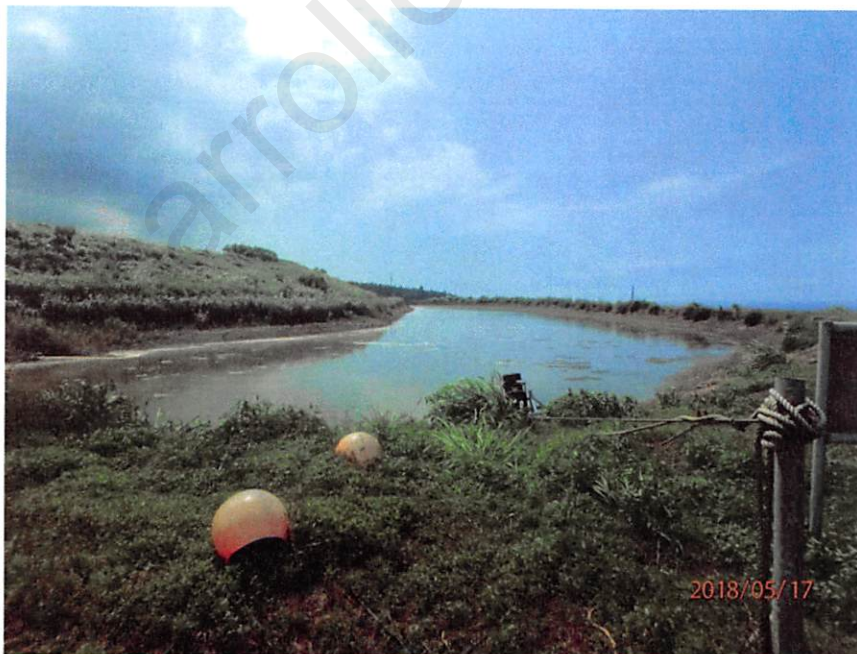
Photograph 4.

Description: View facing west of Wastewater Lagoon #2. Approximately five (5) feet of freeboard existed at the time of inspection. Exposed banks are visible on the left and right side of lagoon.

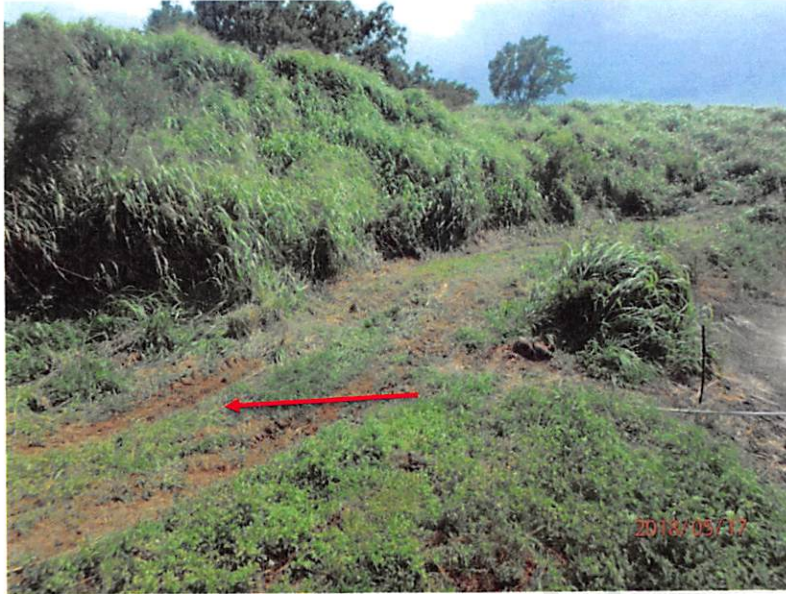
Photograph 5.

Description: View facing south of the spillway for Wastewater Lagoon #2. Red arrow shows potential flow path for spillway. No evidence a recent discharge was observed and no active discharge was occurring.

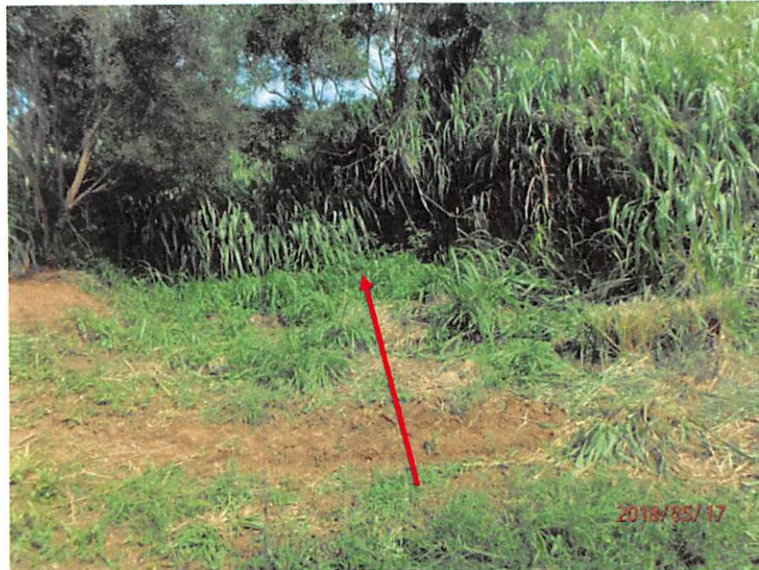
Photograph 6.

Description: View facing east of the spillway for Wastewater Lagoon #2. Red arrow shows direction of potential flow path. No evidence of a recent discharge was present and no active discharges were occurring.

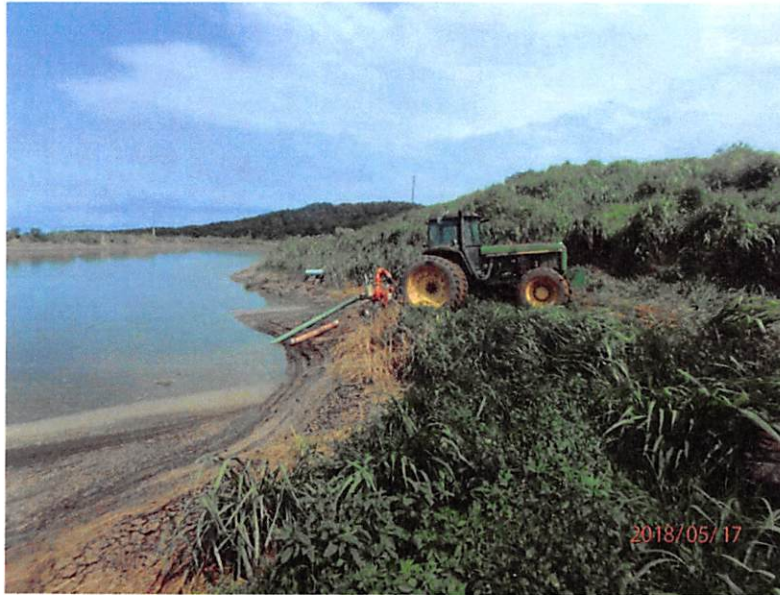
Photograph 7.

Description: View facing east of the pumping unit used for incorporation. This tractor/pump was used during Discharge #2 to pump wastewater onto Field 33. This pump has a designed pumping capacity of 700 gallons per minute.

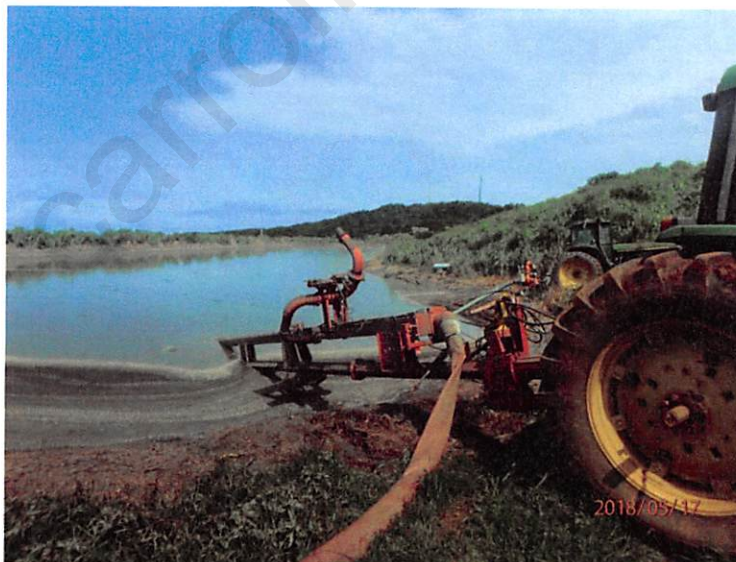
Photograph 8.

Description: View, facing east, of the agitator pump used to pump wastewater to Field 33 during Discharge #2. The agitator pump is also used to mix Wastewater Lagoon #2 during incorporation activities.

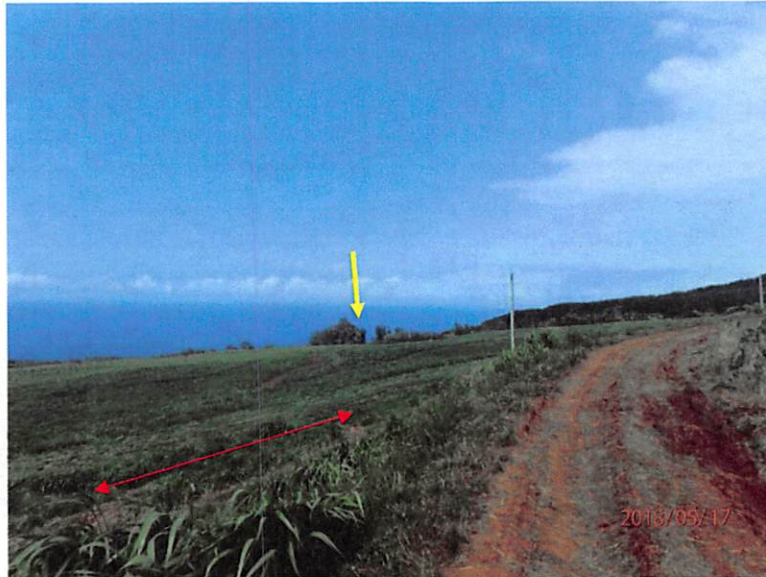
Photograph 9.

- b. The Inspection Team and J. Mecham proceeded to the north side of Wastewater Lagoon #2. J. Mecham stated that wastewater was discharged from the top of the field and flowed via sheet flow to Kaohaoha Gulch (refer to, Photograph 9). At the time of the inspection I did not observe evidence of wastewater in Field 33 and did not observe any ongoing discharges.

Description: View, facing northeast, of Field 33 where wastewater was pumped from Wastewater Lagoon #2 and subsequently flowed to Kaohaoha Gulch. Yellow arrow points to Kaohaoha Gulch location. Red arrow indicates approximate location of where wastewater was released.

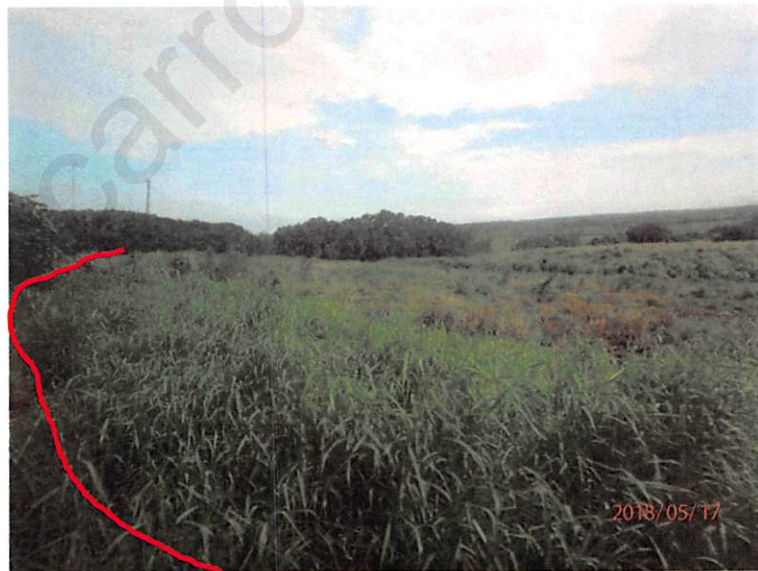
Photograph 10.

4. The Inspection then continued by driving around the perimeter of Wastewater Lagoon #1. I could not see a clear demarcation between the banks and the lagoon due to a thick vegetation layer on the top of the lagoon (refer to, Photograph 10). J. Mecham explained that the lagoon was "full" and that wastewater passed through Wastewater Lagoon #1 to Wastewater Lagoon #2 via an overflow pipe. I asked when the last time maintenance had been completed on the lagoon. J. Mecham was not sure but stated it had been many years.

Description: View, facing southeast, of Wastewater Lagoon #1, red line shows approximate location of lagoon banks along the north side of the pond.

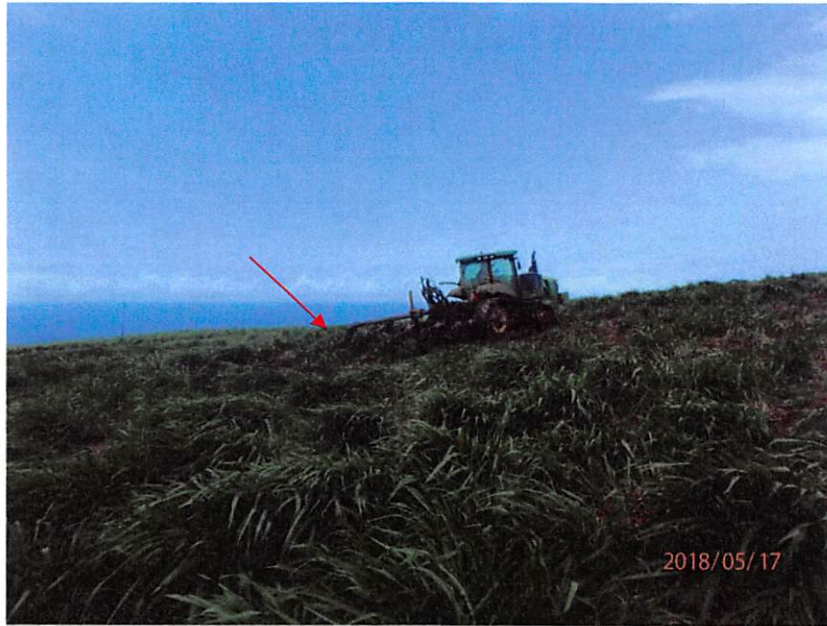
Photograph 11.

Description: View, facing northeast, of incorporator in the Lower Agricultural Fields in operation. Notice tines (red arrows) are submerged in the soil and no wastewater is surface applied.

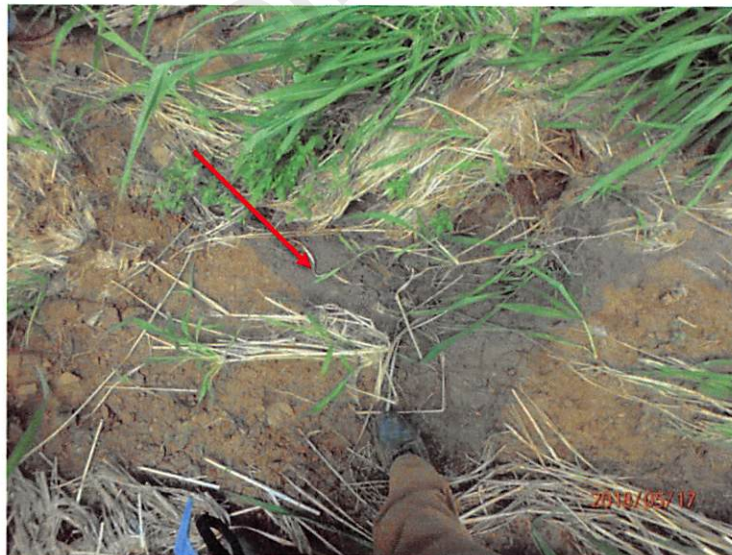
Photograph 12.

Description: View of wastewater that surfaced after incorporation. Minimal amounts of wastewater appear to surface flow as a result of incorporation.

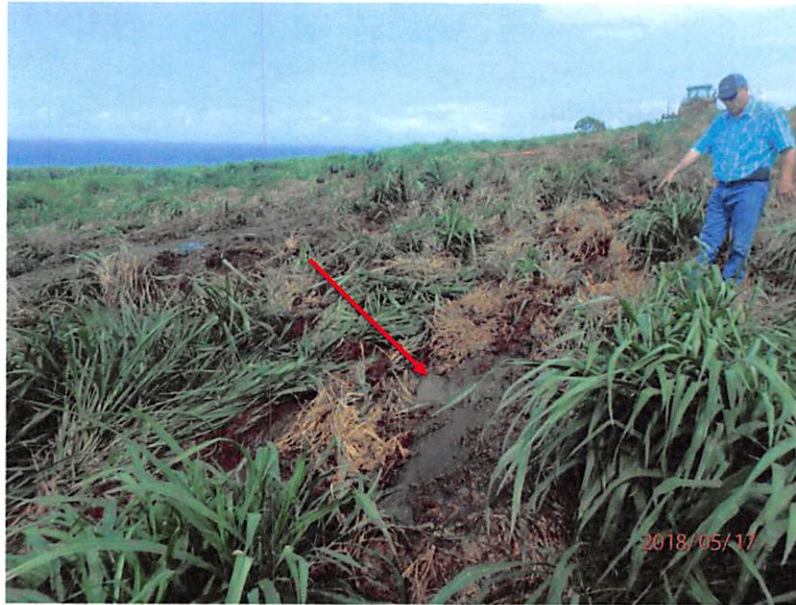
Photograph 13.

5. The Inspection Team and J. Mecham continued to the Lower Agricultural Fields to meet S. Manning and observe the incorporator in operation (refer to, Photograph 11). The Inspection Team was positioned at the most down gradient spot of the agricultural field. I did not observe runoff or wastewater discharge while the incorporator was in operation. Although there was no observed runoff from the field while the Incorporator was in operation, I did observe wastewater surfacing immediately after the incorporator had passed. However, I observed the surfacing wastewater to be absorbed immediately into the ground and not mobilize a significant distance from where it was incorporated (refer to, Photograph 12 & 13). I observed an appreciable disturbance to vegetation produced by the incorporator (refer to, Photograph 13).

Description: View, facing northeast, of the Lower Agricultural Fields immediately after the incorporator had passed by. Significant vegetation disturbance can be seen. The red arrow points to wastewater that is surfacing after incorporation but no surface flow of water was noted.
