An Archaeological Inventory Survey
of the Former Voice of America Site,
Mā‘ili, Lualualei Ahupua‘a, Wai‘anae District, O‘ahu
TMK:(1) 8-7-010:007

AUGUST 2009

TMK:(1) 8-7-010:007

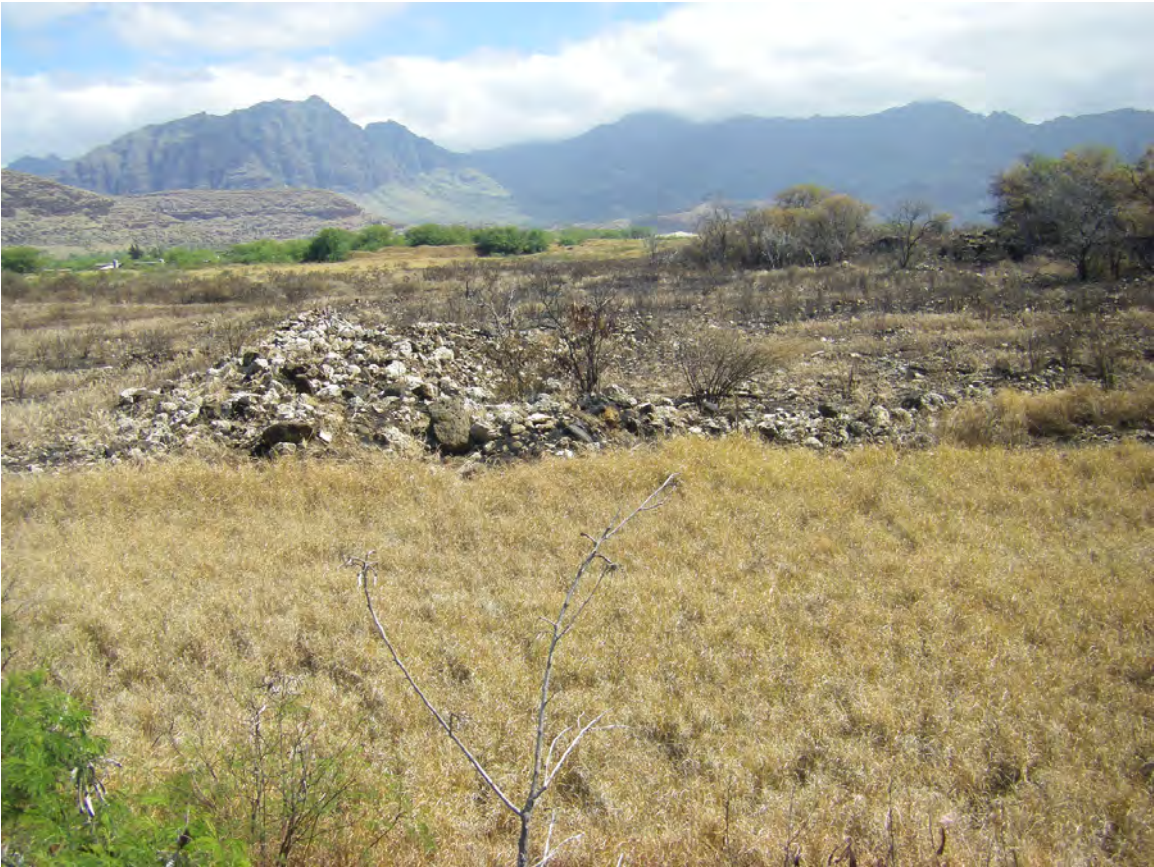
Earth-moving and construction activities associated with the antenna station have significantly modified the terrain within the former VOA parcel. Soil/sediment and stone berms created during previous bulldozing are numerous across the area, often extending for over 10.0 m in length and greater than 1.0 m in height (Photo 1).

Photo 1. A representative view of the berms present in the project area, indicating the degree to which the terrain had been modified by construction activities. View north.

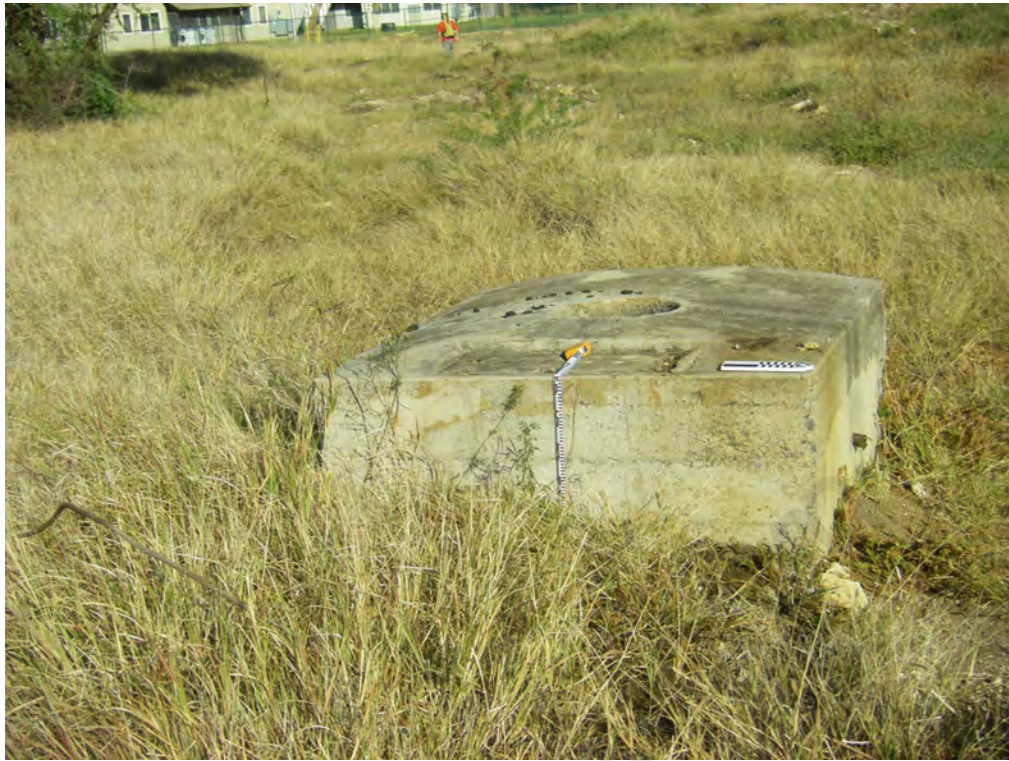
Feature 1 is a concrete pedestal foundation measuring 1.52 m in length, 1.52 m in width, and 0.82 m in height (Photo 4). The upper surface of the pedestal is convex and a central posthole is present measuring 0.4 m in diameter. The posthole is filled with a mixture of tar/creosote and gravel. Along the east side of the upper surface is a rectangular impression measuring 0.72 m in length and 0.26 m in width. Bolt attachments along the edges of the impression would have secured a metal support structure presumably to stabilize the creosoted pole in the posthole. A small-diameter metal pipe that projects from the north side of the pedestal possibly functioned as conduit for electrical wire. The foundation is in good condition.

Photo 4. Feature 1, concrete pedestal foundation. View west.

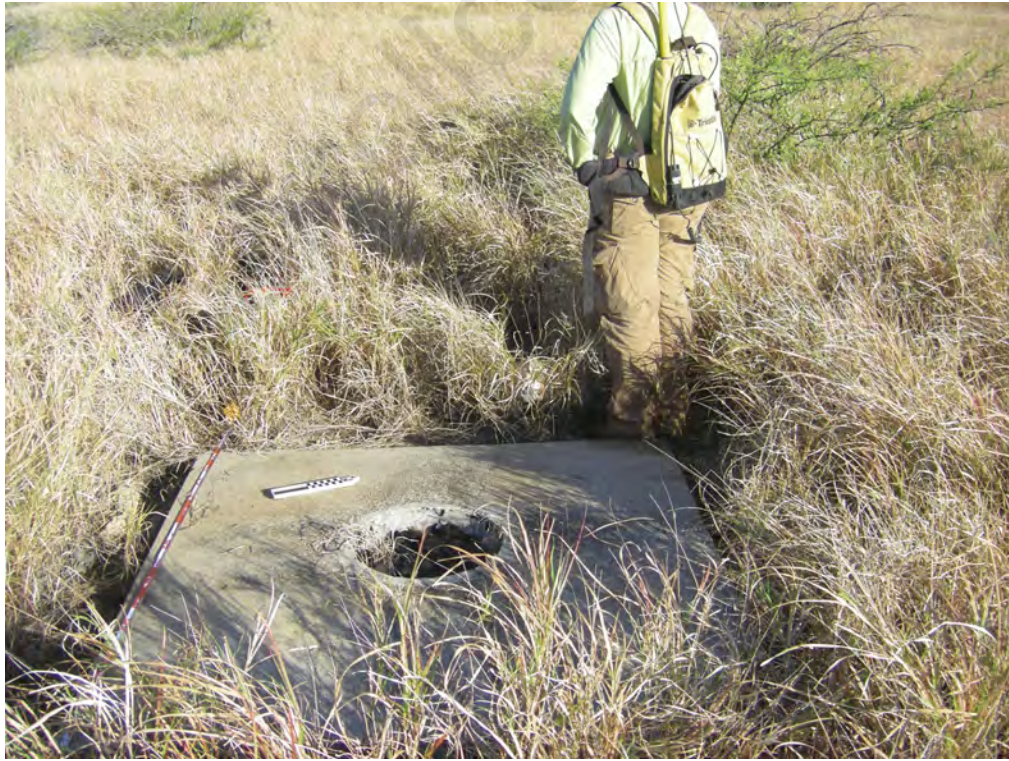
Feature 2 is a concrete pedestal foundation measuring 1.52 m in length, 1.52 m in width, and approximately 0.1 m in height (Photo 5). The posthole measures approximately 0.4 m in diameter and is filled with a mixture of tar/creosote and gravel. No additional components are present. The foundation is in good condition.

Photo 5. Feature 2, concrete pedestal foundation. View west.

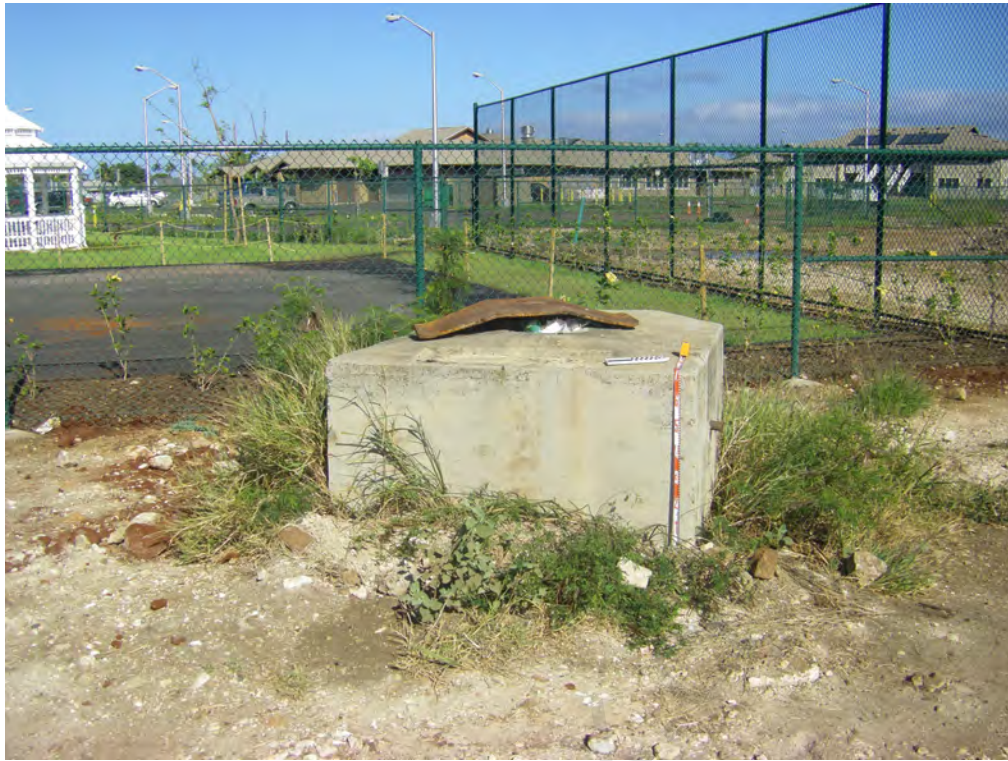
Feature 3 is a concrete pedestal foundation measuring 1.52 m in length, 1.52 m in width, and 0.68 m in height (Photo 6). The posthole measures 0.4 m in diameter and is filled with a mixture of tar/creosote and gravel. Along the east side of the upper surface is a rectangular impression identical to that at Feature 1. Bolt attachments along the edges of the impression would have secured a metal support structure presumably to stabilize the creosoted pole located in the posthole. A small-diameter metal pipe projecting from the north side of the pedestal possibly functioned as conduit for electrical wire. The foundation is in good condition.

Photo 6. Feature 3, concrete pedestal foundation. View west-northwest.

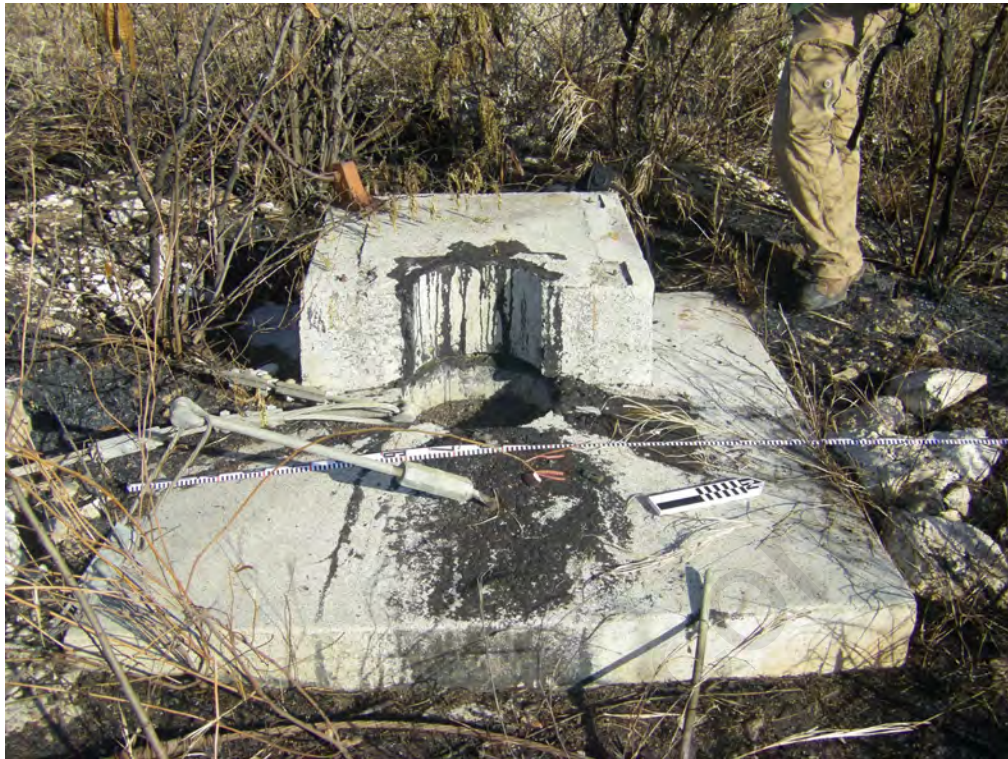
Feature 4 is a concrete pedestal foundation measuring 1.52 m in length, 1.52 m in width, and approximately 0.1 m in height (Photo 7). The posthole measures approximately 0.4 m in diameter and is filled with a mixture of tar/creosote and gravel. A second, smaller concrete block measuring 0.8 m in length, 0.7 m in width, and 0.25 m in height is positioned adjacent to the posthole to provide additional support for the pole. A metal stanchion for the pole guide wires is cemented into the upper surface of the pedestal. The pole and associated cables are present east of the feature. No additional components are present. The foundation is in good condition.

Photo 7. Feature 4, concrete pedestal foundation. View west.

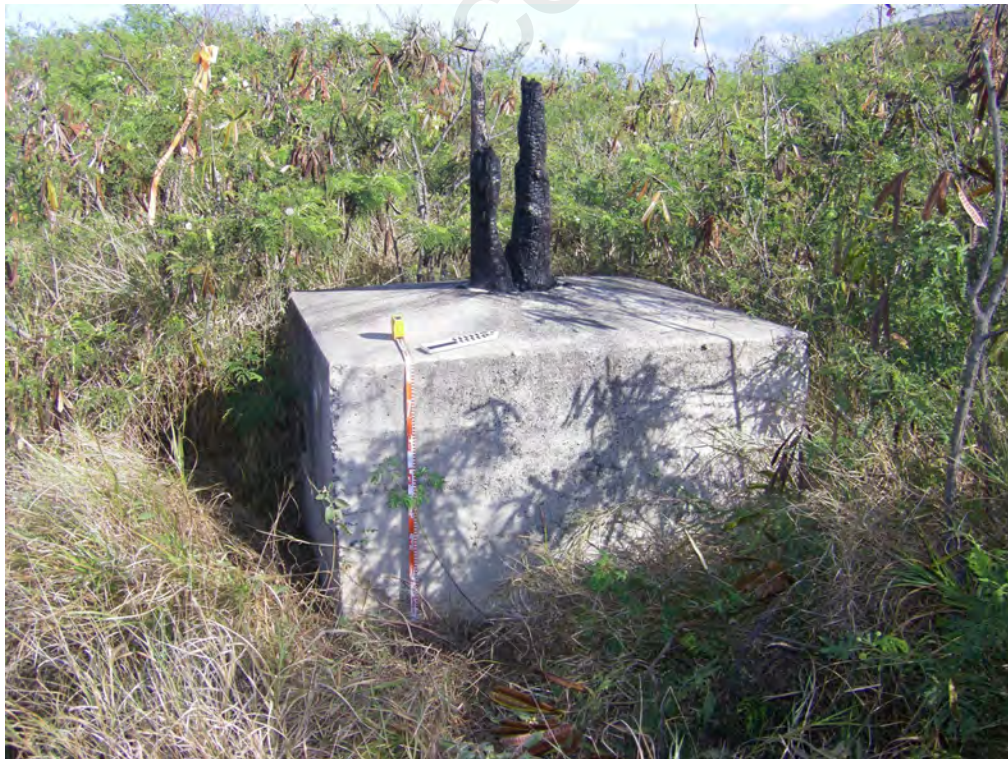
Feature 5 is a concrete pedestal foundation measuring 1.52 m in length, 1.52 m in width, and 0.84 m in height (Photo 8). The posthole, which retains the base of the creosoted pole, measures approximately 0.4 m in diameter. A small-diameter metal pipe projecting from the north side of the pedestal may have functioned as conduit for electrical wire. No additional components are present. The foundation is in good condition.

Photo 8. Feature 5, concrete pedestal foundation. View west.

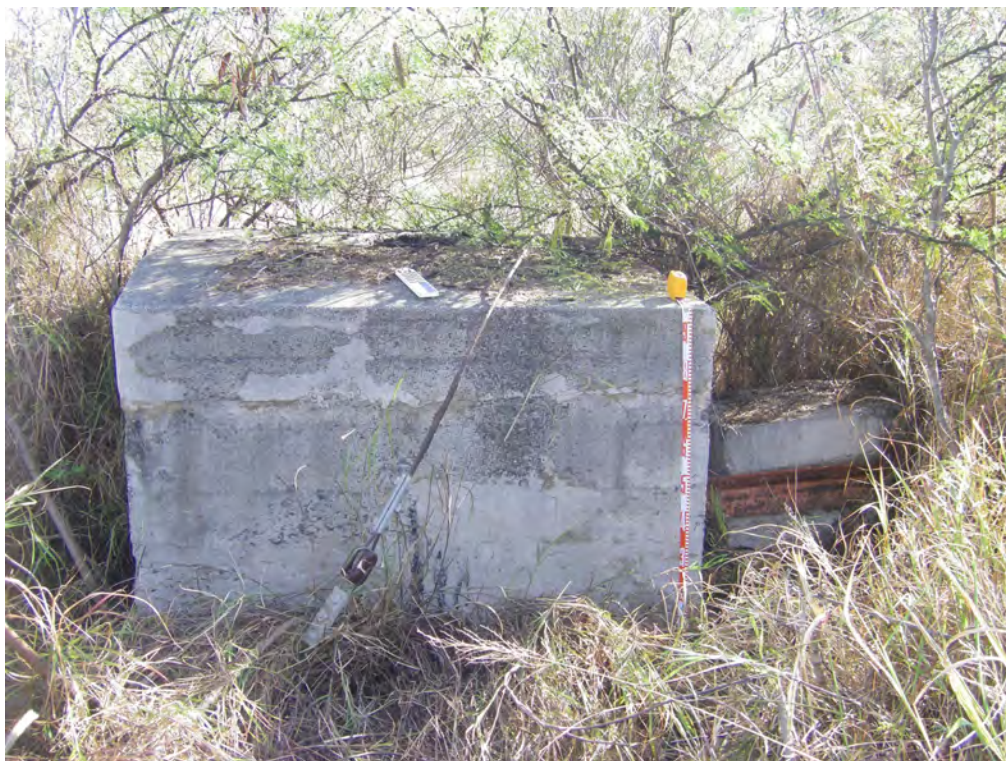
Feature 6 is a concrete pedestal foundation measuring 1.52 m in length, 1.52 m in width, and 0.95 m in height (Photo 9). The posthole measures 0.3 m in diameter and is filled with a mixture of tar/creosote and gravel. Along the east side of the upper surface is a rectangular impression measuring 0.72 m in length and 0.26 m in width. The metal support structure that was attached to the pedestal at this point has fallen along the east side of the feature. The support consists of a steel plate approximately 0.7 m in length and 0.3 m in width with two parallel steel bars projecting from either end, each approximately 2.0 m in height. A concrete block measuring 0.63 m in length, 0.47 m in width, and 0.46 m in thickness is constrained by the two rails towards the base of the support, acting as a counterweight to stabilize the support structure. The foundation is in good condition.

Photo 9. Feature 6, concrete pedestal foundation. View north-northeast.

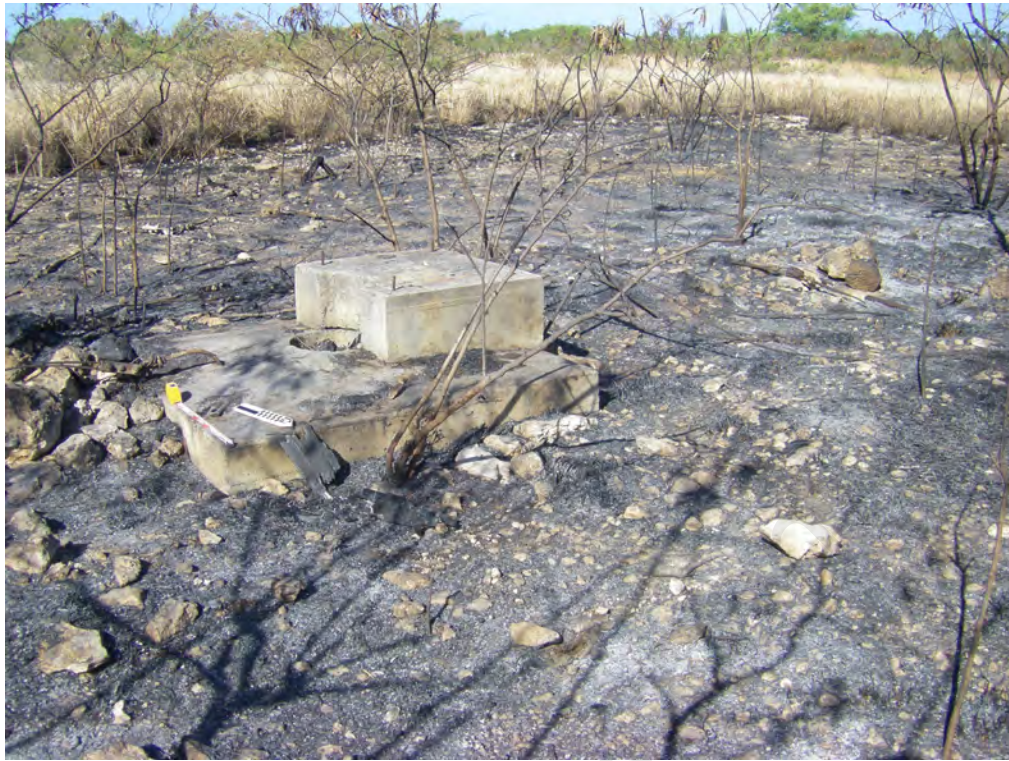
Feature 8 is a concrete pedestal foundation measuring 1.52 m in length, 1.52 m in width, and approximately 0.1 m in height (Photo 10). The posthole measures approximately 0.4 m in diameter and is filled with a mixture of tar/creosote and gravel. A second, smaller concrete block measuring 0.8 m in length, 0.7 m in width, and 0.25 m in height is adjacent to the posthole to provide additional support for the pole. The pole and associated cables are present to the east of the feature. No additional components are present. The foundation is in good condition. At least two welded steel jackets for creosoted poles were noted in the surrounding area.

Photo 10. Feature 8, concrete pedestal foundation. View southwest.

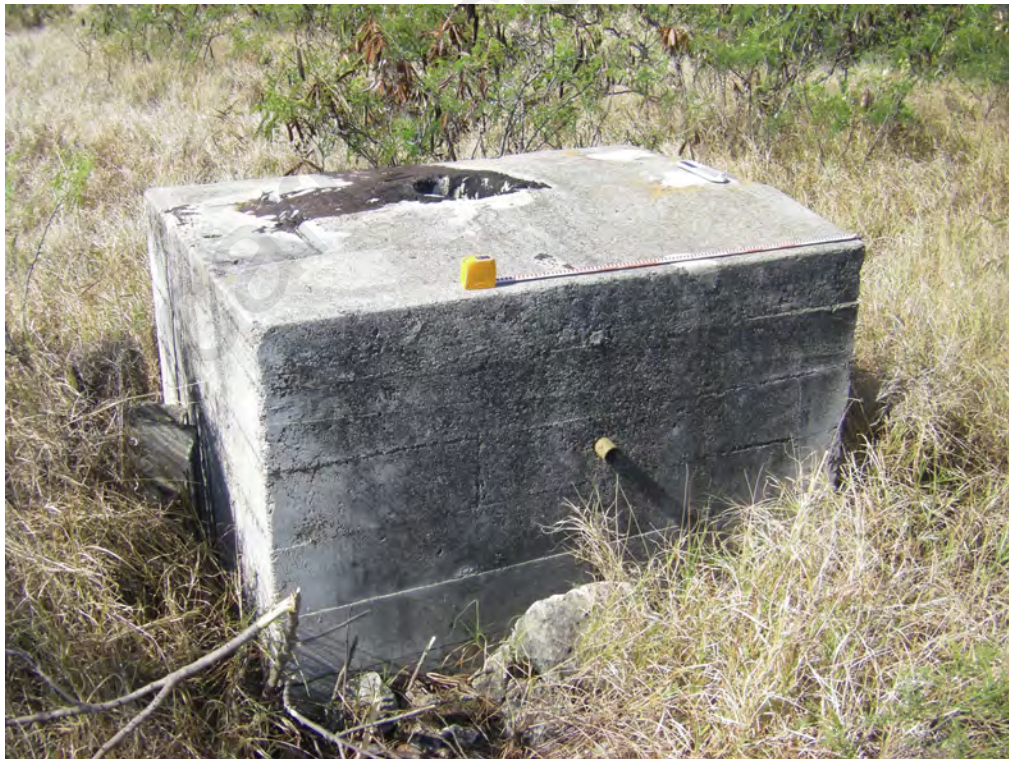
Feature 9 is a concrete pedestal foundation measuring 1.52 m in length, 1.52 m in width, and 0.9 m in height (Photo 11). The posthole measures 0.28 m in diameter and is filled with a mixture of tar/creosote and gravel. Along the east side of the upper surface is a rectangular impression measuring 0.72 m in length and 0.26 m in width. Bolt attachments along the edges of the impression would have secured a metal support structure presumably to stabilize the creosoted pole located in the central posthole. A small-diameter metal pipe projects from the north side of the pedestal that possibly functioned as conduit for electrical wire. The foundation is in good condition.

Photo 11. Feature 9, concrete pedestal foundation. View southwest.

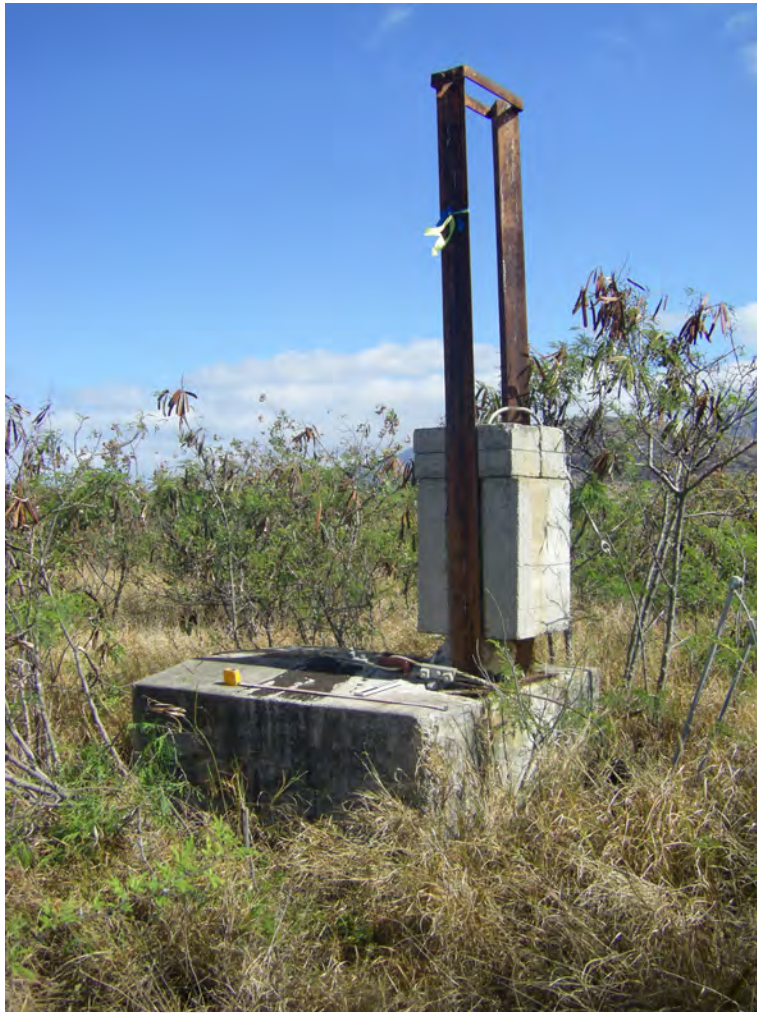
Feature 11 is a concrete pedestal foundation measuring 1.52 m in length, 1.52 m in width, and 0.95 m in height (Photo 12). The posthole measures 0.3 m in diameter and is filled with a mixture of tar/creosote and gravel. Along the east side of the upper surface is an intact, upright metal support structure, which is identical to the structure documented at Feature 6. The support consists of a steel plate measuring approximately 0.7 m in length and 0.3 m in width with two parallel steel bars projecting from either end approximately 2.0 m in height. A concrete block measuring 0.63 m in length, 0.47 m in width, and 0.46 m in thickness is secured between the two rails towards the base of the support, acting as a counterweight to stabilize the support structure. The foundation is in good condition.

Photo 12. Feature 11, concrete pedestal foundation. View northwest.

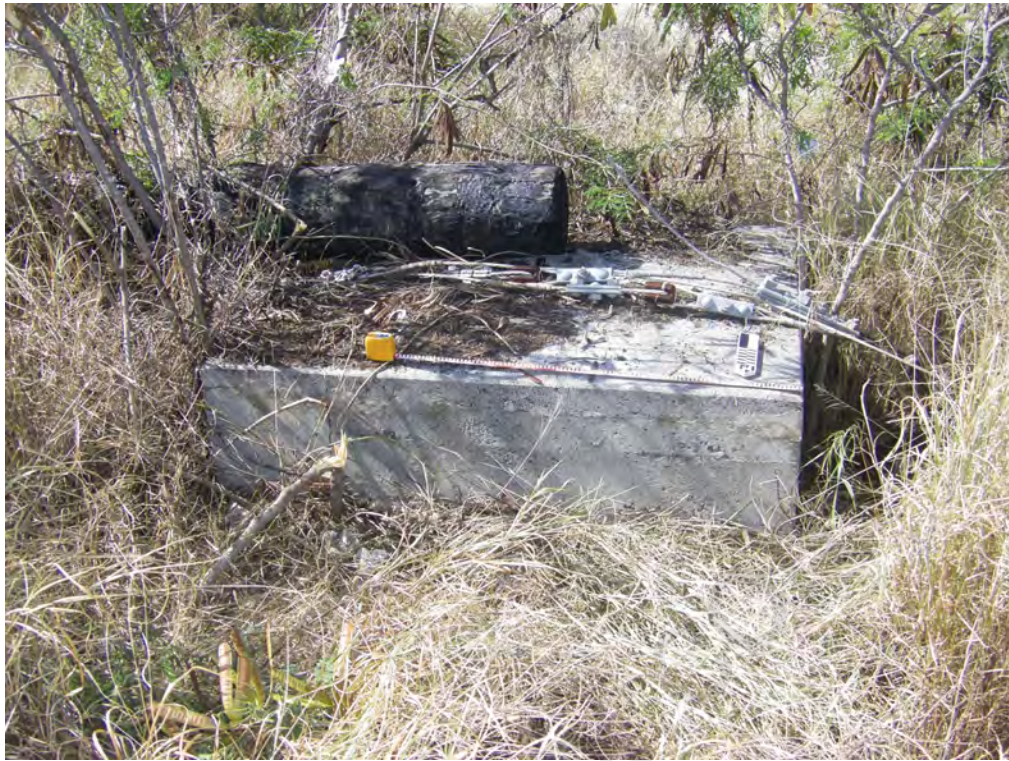
Feature 12 is a concrete pedestal foundation measuring 1.52 m in length, 1.52 m in width, and approximately 0.25 m in height (Photo 13). The posthole measures 0.3 m in diameter and is filled with a mixture of tar/creosote and gravel. A remnant of the creosoted post and associated cables are present on the surrounding ground surface. The foundation is in good condition.

Photo 13. Feature 12, concrete pedestal foundation. View south.

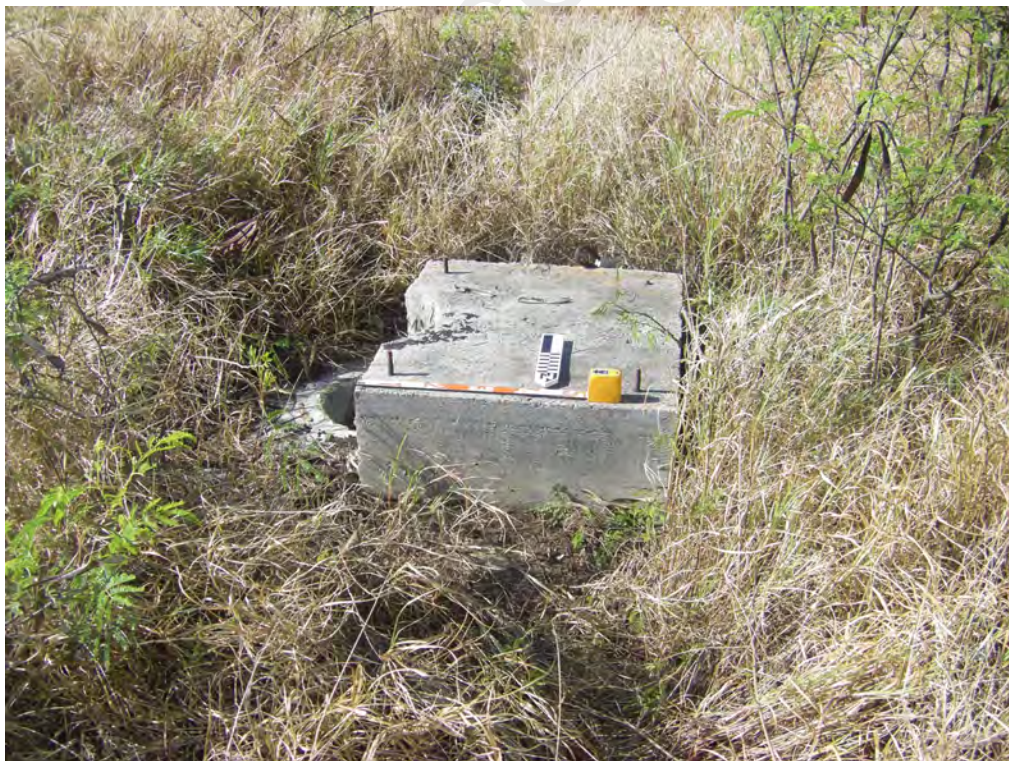
Feature 13 is a concrete pedestal foundation measuring 1.52 m in length, 1.52 m in width, and approximately 0.1 m in height (Photo 14). The upper surface of the pedestal is convex and a central posthole is present measuring approximately 0.4 m in diameter. The posthole is filled with a mixture of tar/creosote and gravel. A second, smaller concrete block measuring 0.8 m in length, 0.7 m in width, and 0.25 m in height is adjacent to the posthole to provide additional support for the pole. No additional components are present. The foundation is in good condition.

Photo 14. Feature 13, concrete pedestal foundation. View south.

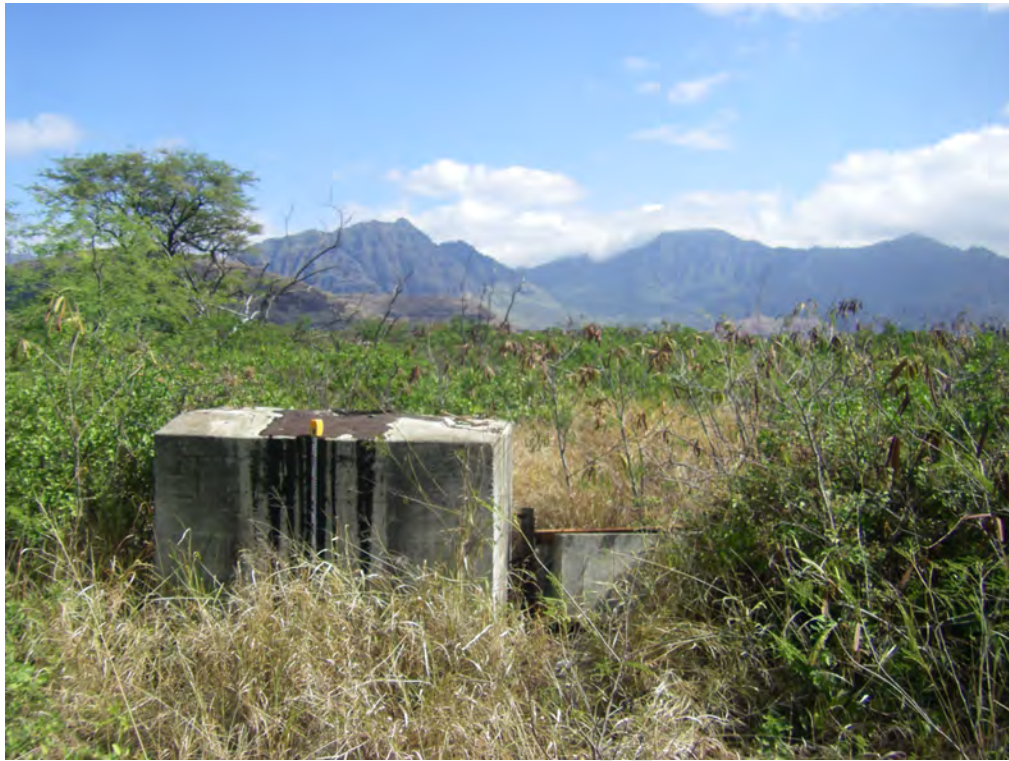
Feature 15 is a concrete pedestal foundation measuring 1.52 m in length, 1.52 m in width, and 0.95 m in height (Photo 15). The posthole measures 0.3 m in diameter and is filled with a mixture of tar/creosote and gravel. Along the east side of the upper surface is a rectangular impression measuring 0.72 m in length and 0.26 m in width. The metal support structure that was formerly attached to the pedestal at this point is fallen along the east side of the feature. The support consists of a steel plate measuring approximately 0.7 m in length and 0.3 m in width with two parallel steel bars projecting from either end approximately 2.0 m in height. A concrete block measuring 0.63 m in length, 0.47 m in width, and 0.46 m in thickness is secured between the two rails towards the base of the support, acting as a counterweight to stabilize the support structure. The remnant of the creosoted pole and steel jacket is located approximately 10.0 m to the east of the pedestal. The foundation is in good condition.

Photo 15. Feature 15, concrete pedestal foundation. View north.

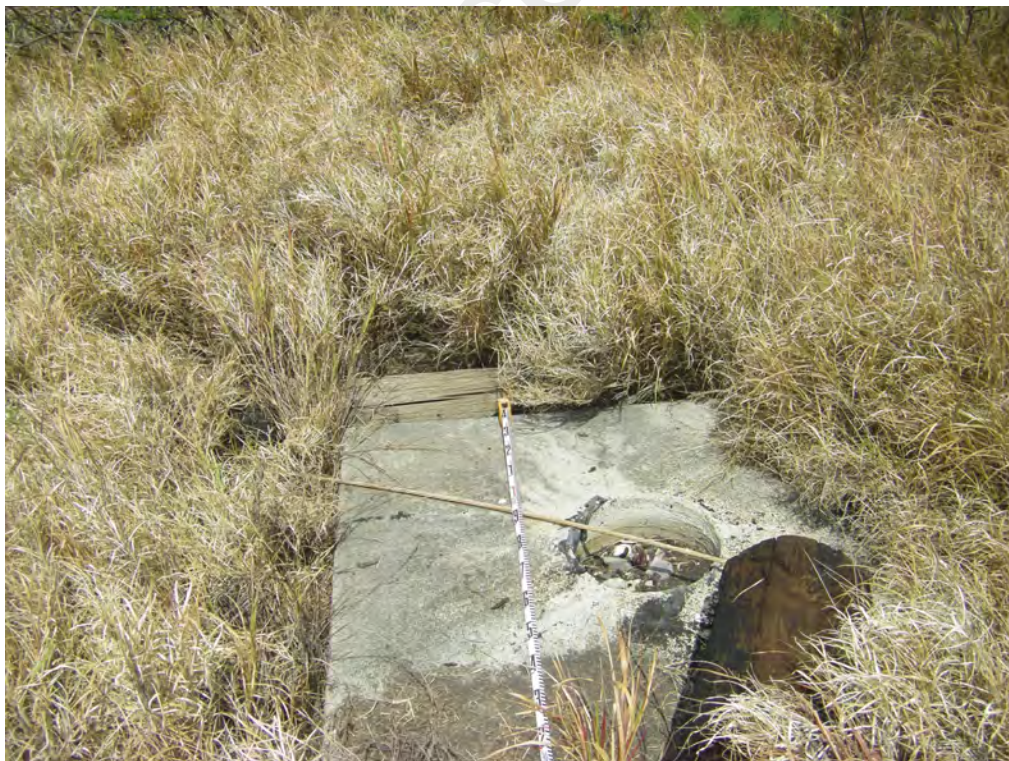
Feature 16 is a concrete pedestal foundation measuring 1.52 m in length, 1.52 m in width, and approximately 0.1 m in height (Photo 16). The posthole measures 0.3 m in diameter and is filled with a mixture of tar/creosote and gravel. The foundation is in good condition.

Photo 16. Feature 16, concrete pedestal foundation. View west.

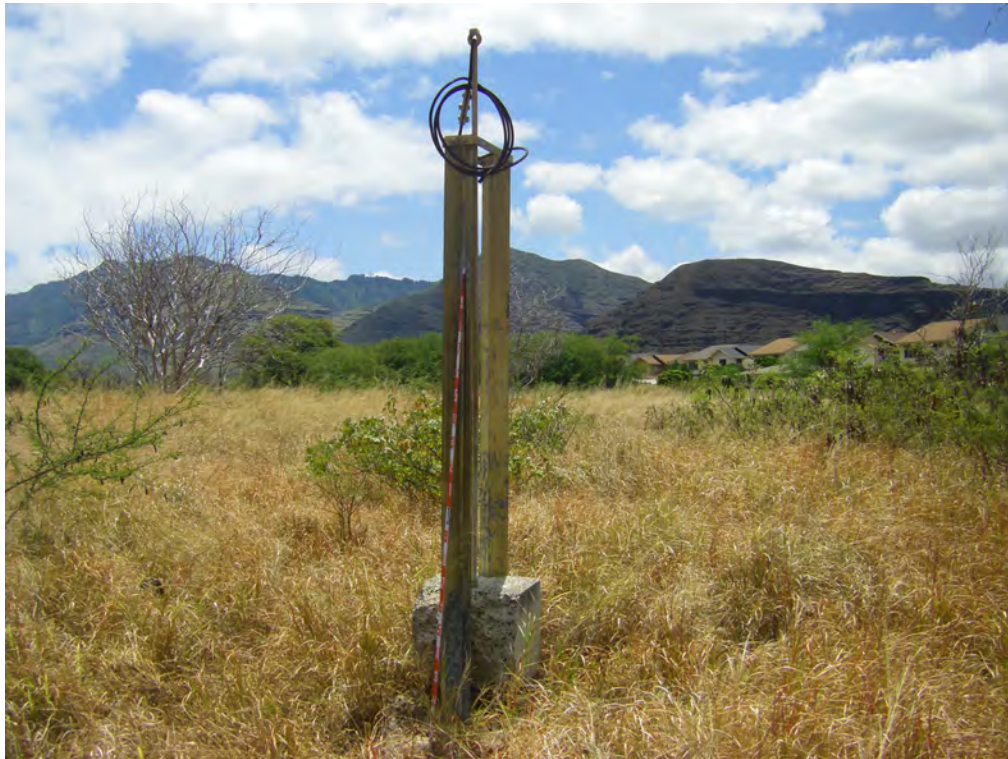
Feature 17 is a concrete pad and upright metal support structure. The concrete pad measures 1.2 m in length, 1.2 m in width, and is set at the surrounding grade (Photo 17). The metal support structure is identical to the components recorded at Features 6, 11, and 15. The support consists of a steel plate measuring 0.66 m in length and 0.25 m in width with two parallel steel bars projecting from either end 2.57 m in height. A concrete block measuring approximately 0.6 m in length, 0.5 m in width, and 0.5 m in thickness is secured between the two rails towards the base of the support, acting as a counterweight to stabilize the support structure. The feature is in good condition.

Photo 17. Feature 17, concrete pad foundation with metal support. View east.

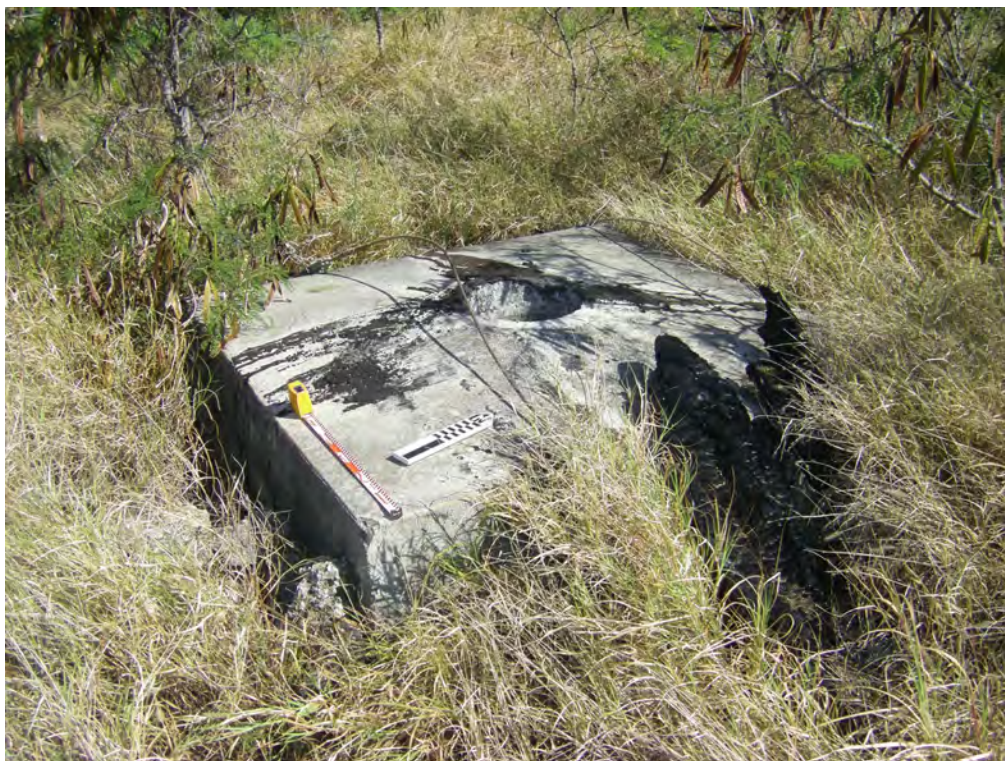
Feature 18 is a concrete pedestal foundation measuring 1.52 m in length, 1.52 m in width, and approximately 0.45 m in height (Photo 18). The posthole measures 0.32 m in diameter and is filled with a mixture of tar/creosote and gravel. No additional components are present. The remnant of the creosoted pole and its steel jacket lie on the ground several meters to the east. The foundation is in good condition.

Photo 18. Feature 18, concrete pedestal foundation. View northwest.

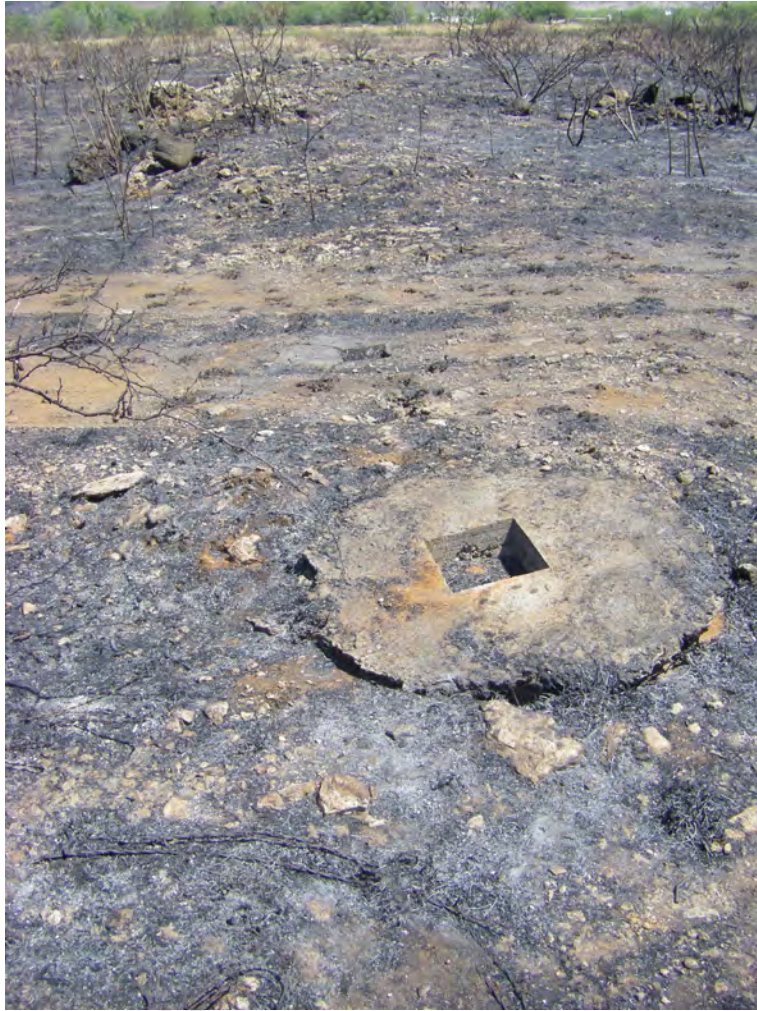
Feature 7 includes multiple square concrete posthole structures that are distributed across the project area (Photo 19). One of these postholes retains the base of a wooden 7-inch by 7-inch (0.18 m by 0.18 m) post. Heavy vegetation in most of the parcel likely obscures numerous additional postholes. As the remnant of a fence line(s) support system the feature is in poor condition.

Photo 19. Example of the Feature 7 concrete fence postholes. View north.

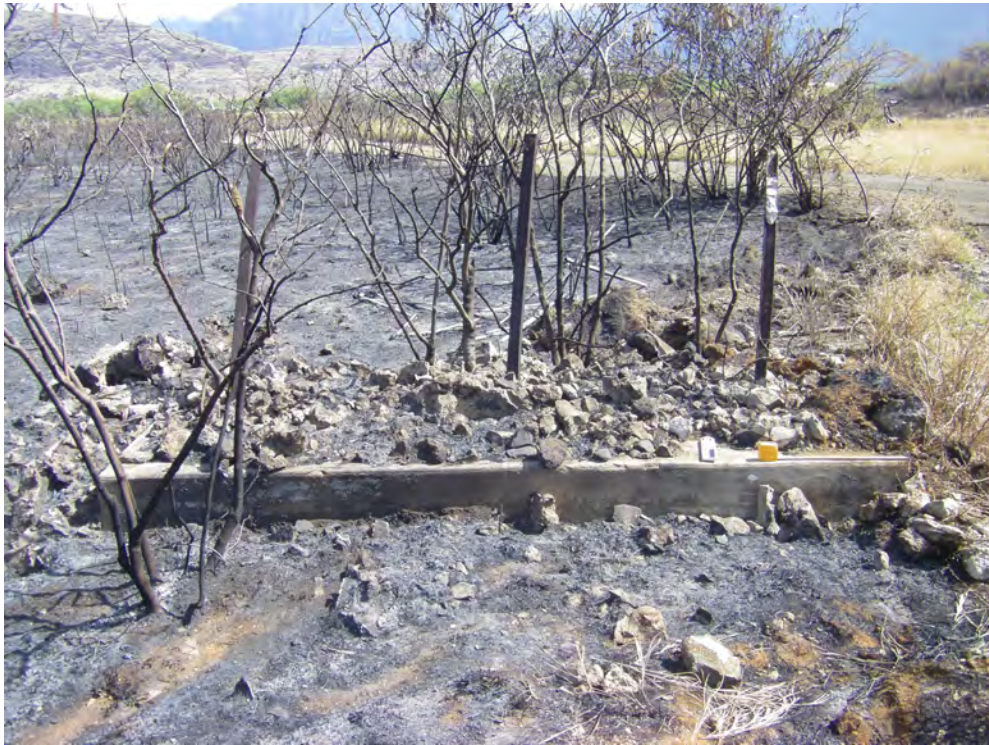
Feature 14 is a concrete pad measuring 3.1 m in length, 1.2 m in width, and 0.2 m in height (Photo 20). Three metal posts project from the center of the pad, spaced approximately 0.6 m apart. The posts are secured with a coarse concrete that postdates construction of the underlying slab. Feature 14 is located along the west side of the transmitter building complex and appears to relate to these structures (Features 19 and 20). The feature is in good condition.

Photo 20. Feature 14, concrete pad. View north.

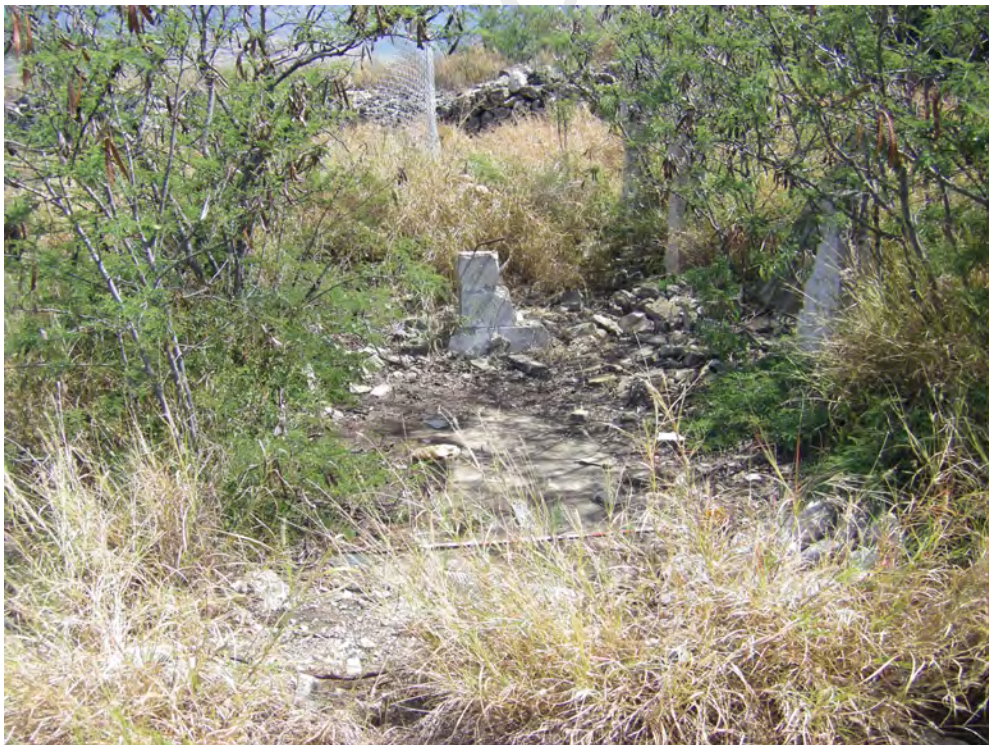
Feature 19 is the remnant of a cement block structure measuring 6.7 m in length, 3.05 m in width, and at least 1.78 m in height (Photo 21). The structure has a poured concrete slab foundation with cement block exterior and interior walls. Most of these walls have been demolished to their base course of blocks. The structure is partitioned into two rooms, with the south room measuring 3.48 m in length and 2.85 m in width and the north room measuring 2.85 m in length and 2.6 m in width. The feature is located approximately 10.0 m northeast of Feature 20, the remnant of the main transmitter building. The feature is in poor condition.

Photo 21. Feature 19, remnant of the cement block ancillary structure that is part of the VOA transmitter complex. View west.

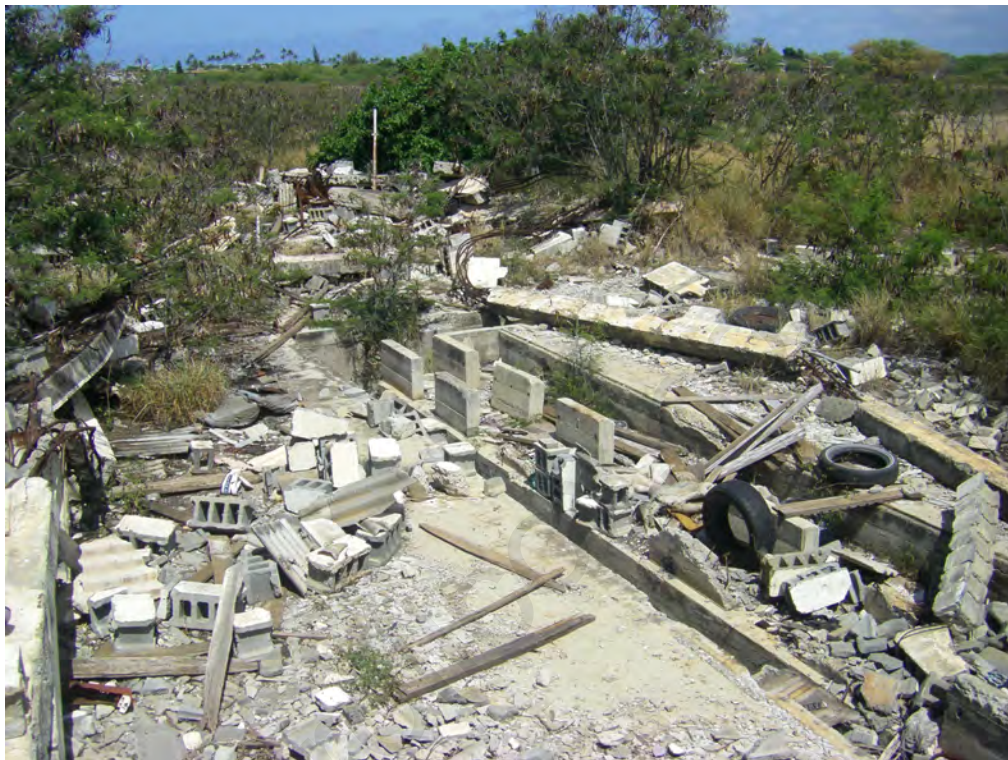
Feature 20, the remnant of the main transmitter building, is approximately 32.0 m in length and 10.0-15.0 m in width (Photo 22). The superstructure has been demolished, but the concrete slab foundation is mostly intact. A large channel or conduit is in the slab presumably to hold electrical wires for the antenna array. The building's walls were constructed with reinforced cement blocks capped with reinforced concrete bondbeams. An asphalt road and a concrete curb separate Features 19 and 20 and provided access to these structures. The feature is in poor condition.

Photo 22. Feature 20, remnant of the main VOA transmitter building. View northwest.

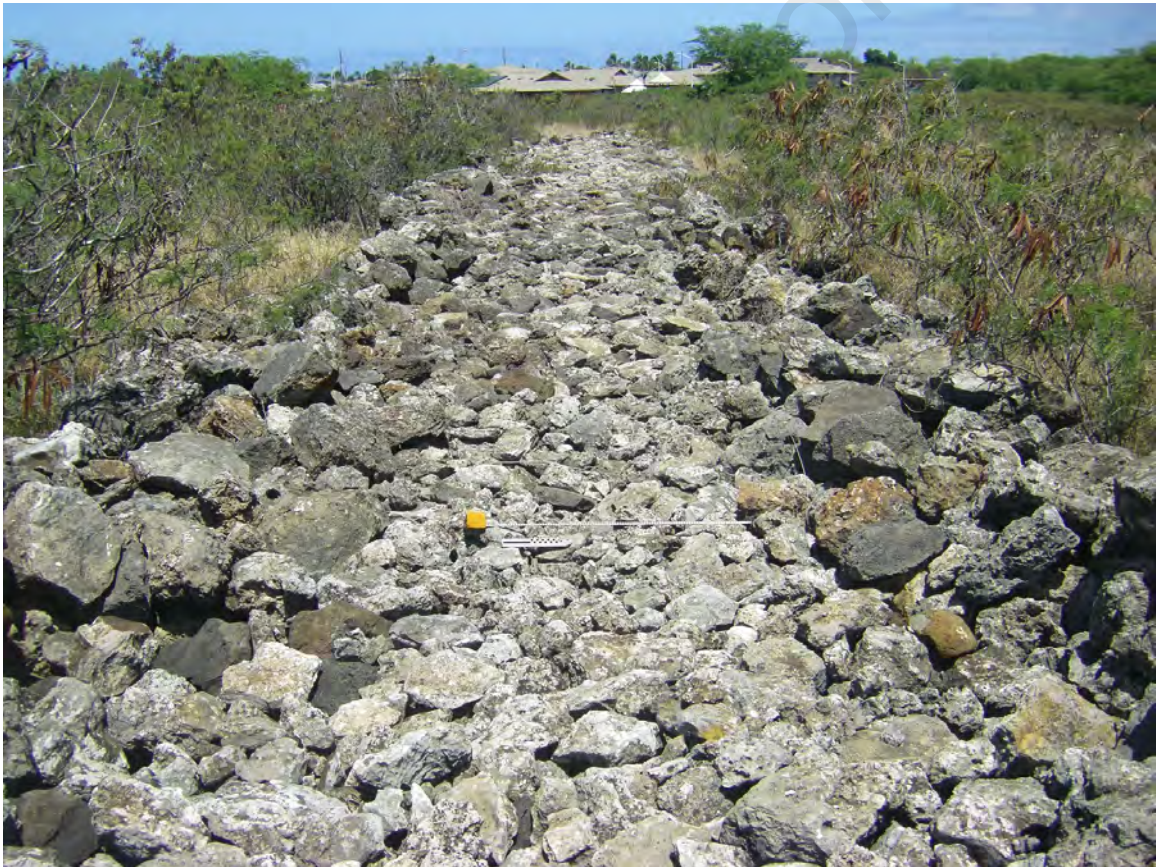
Feature 10 includes three segments of an originally continuous railroad bed (Photos 23-25; Fig. 5). The railroad had been destroyed in places during construction of the VOA station, producing 40.0-85.0 m wide gaps between the three remaining segments of the railroad bed. The feature segments are constructed with dry laid angular and tabular basalt and coral boulders and cobbles. The exterior edges have a slight batter angle. Basalt boulders are often present as the lower courses, with the majority of the railroad bed constructed with limestone boulders and slabs. Intact edges retain up to nine courses of stone. The interior fill of the feature is primarily limestone boulders and cobbles. The upper surfaces vary between the segments: the western segment is paved with limestone slabs and exhibits a slightly concave surface; the central segment lacks the formal paving but exhibits a concave surface; and the eastern segment has a relatively even surface partially paved with small cobbles and pebbles. The western segment measures 48.0 m in length, 4.9 m in width, and 0.7-1.5 m in height. The central segment measures 17.0 m in length, 4.7 m in width, and 0.9-1.2 m in height. The eastern segment measures 52.0 m in length, 5.4 m in width, and 1.4-2.0 m in height.

Photo 23. Feature 10, railroad bed, western segment. View west.

Site 50-80-08-7083, the railroad bed (Feature 10), is eligible for nomination to the NR following significance criteria C and D and moderately altered integrity. Construction of the former VOA station resulted in the discontinuous nature of the railroad bed within the project area, yet the individual segments retain well preserved dry laid masonry. The site is relevant for an understanding of the plantation-era history of Hawai'i and is evocative of that time and the sugar industry. Preservation is recommended for this site, although this could consist of preserving a single segment of the railroad bed, preferably either the northwest or southeast sections which are in the best condition.

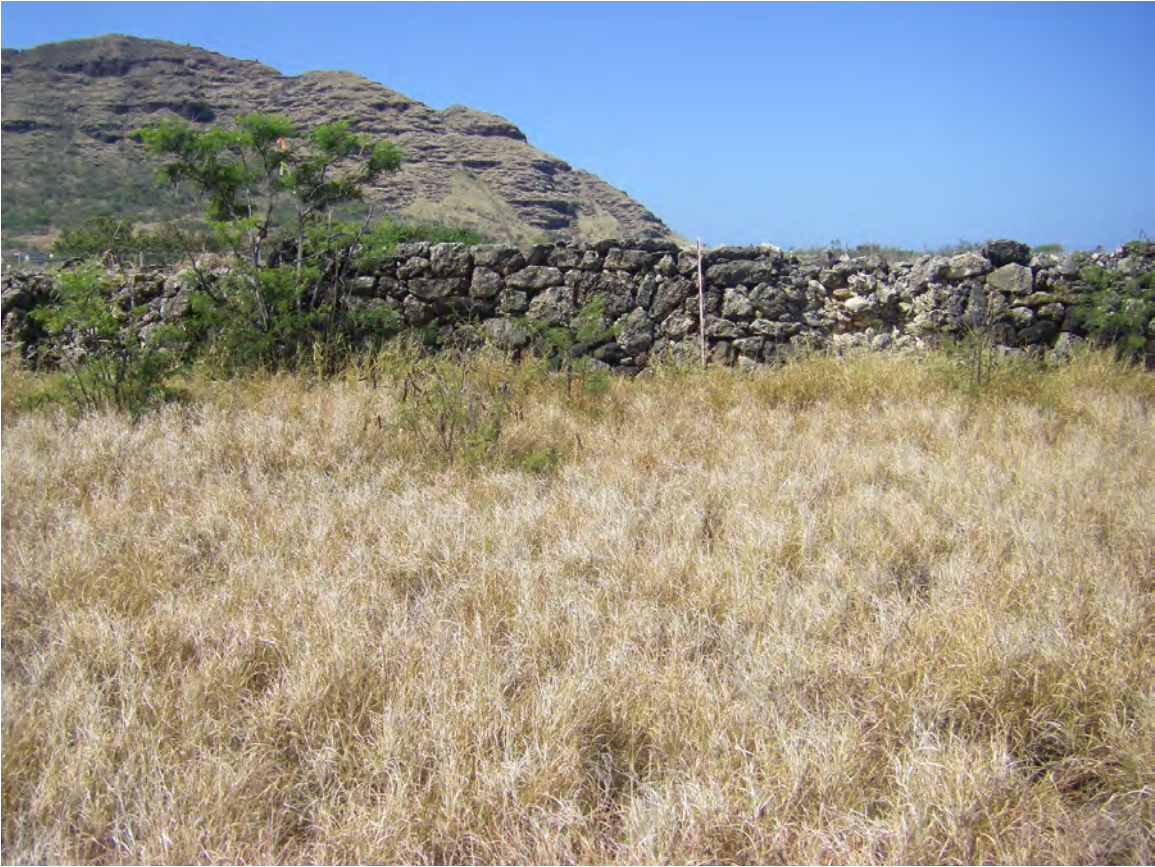
Photo 24. Feature 10, railroad bed, eastern segment north face. View southwest.
