An Archaeological Inventory Survey
of the Former Voice of America Site,
Mā‘ili, Lualualei Ahupua‘a, Wai‘anae District, O‘ahu
TMK:(1) 8-7-010:007

AUGUST 2009

TMK:(1) 8-7-010:007

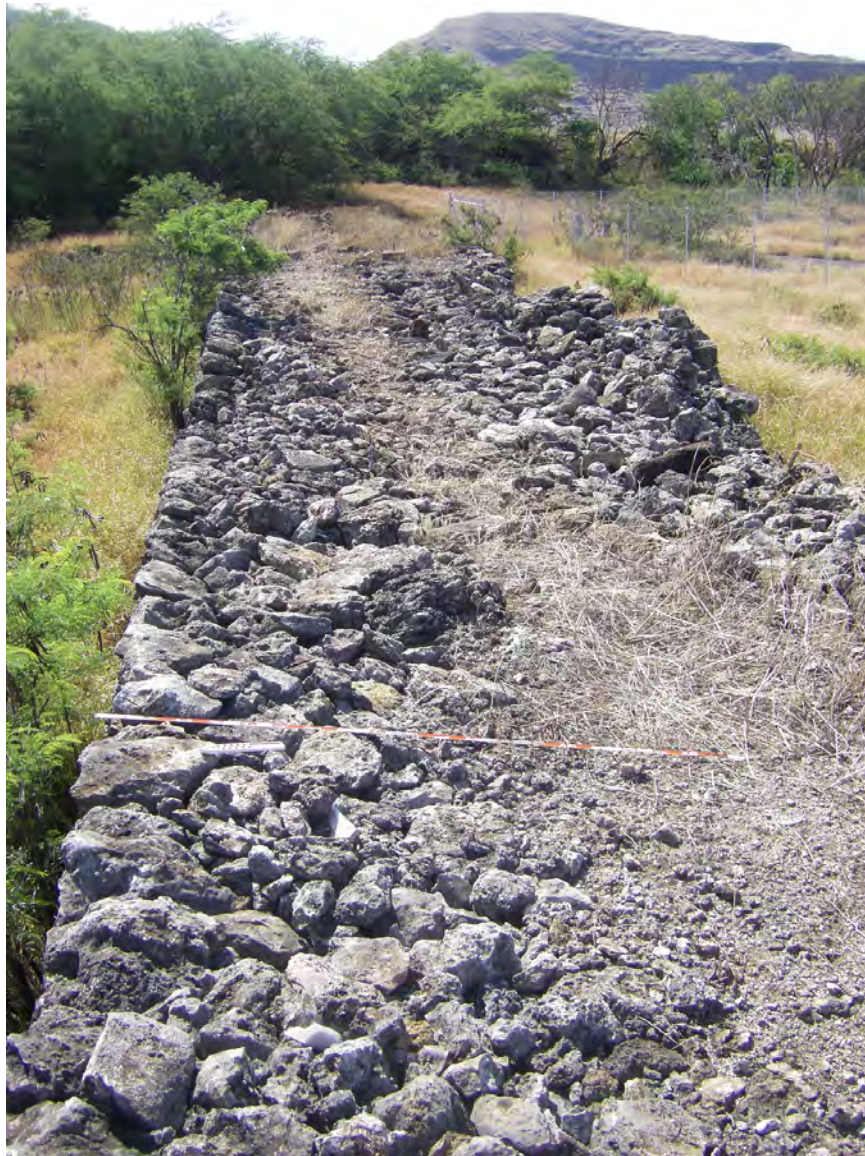
Feature 10 includes three segments of an originally continuous railroad bed (Photos 23-25; Fig. 5). The railroad had been destroyed in places during construction of the VOA station, producing 40.0-85.0 m wide gaps between the three remaining segments of the railroad bed. The feature segments are constructed with dry laid angular and tabular basalt and coral boulders and cobbles. The exterior edges have a slight batter angle. Basalt boulders are often present as the lower courses, with the majority of the railroad bed constructed with limestone boulders and slabs. Intact edges retain up to nine courses of stone. The interior fill of the feature is primarily limestone boulders and cobbles. The upper surfaces vary between the segments: the western segment is paved with limestone slabs and exhibits a slightly concave surface; the central segment lacks the formal paving but exhibits a concave surface; and the eastern segment has a relatively even surface partially paved with small cobbles and pebbles. The western segment measures 48.0 m in length, 4.9 m in width, and 0.7-1.5 m in height. The central segment measures 17.0 m in length, 4.7 m in width, and 0.9-1.2 m in height. The eastern segment measures 52.0 m in length, 5.4 m in width, and 1.4-2.0 m in height.

Photo 25. Feature 10, railroad bed, eastern segment. View east.

Site 50-80-08-7083, the railroad bed (Feature 10), is eligible for nomination to the NR following significance criteria C and D and moderately altered integrity. Construction of the former VOA station resulted in the discontinuous nature of the railroad bed within the project area, yet the individual segments retain well preserved dry laid masonry. The site is relevant for an understanding of the plantation-era history of Hawai'i and is evocative of that time and the sugar industry. Preservation is recommended for this site, although this could consist of preserving a single segment of the railroad bed, preferably either the northwest or southeast sections which are in the best condition.
