Subject: Notice of Violation and Order (NOVO)
Docket No. 2017-CW-EO-08
Hawaii Water Pollution Rules and Regulations
Big Island Dairy
O'okala, Island of Hawaii, Hawaii

DEPARTMENT OF HEALTH
NOTICE OF VIOLATION AND ORDER

Concentrated Animal Feeding Operation
NPDES Inspection Report
Facility Name: Big Island Dairy
Photograph Log

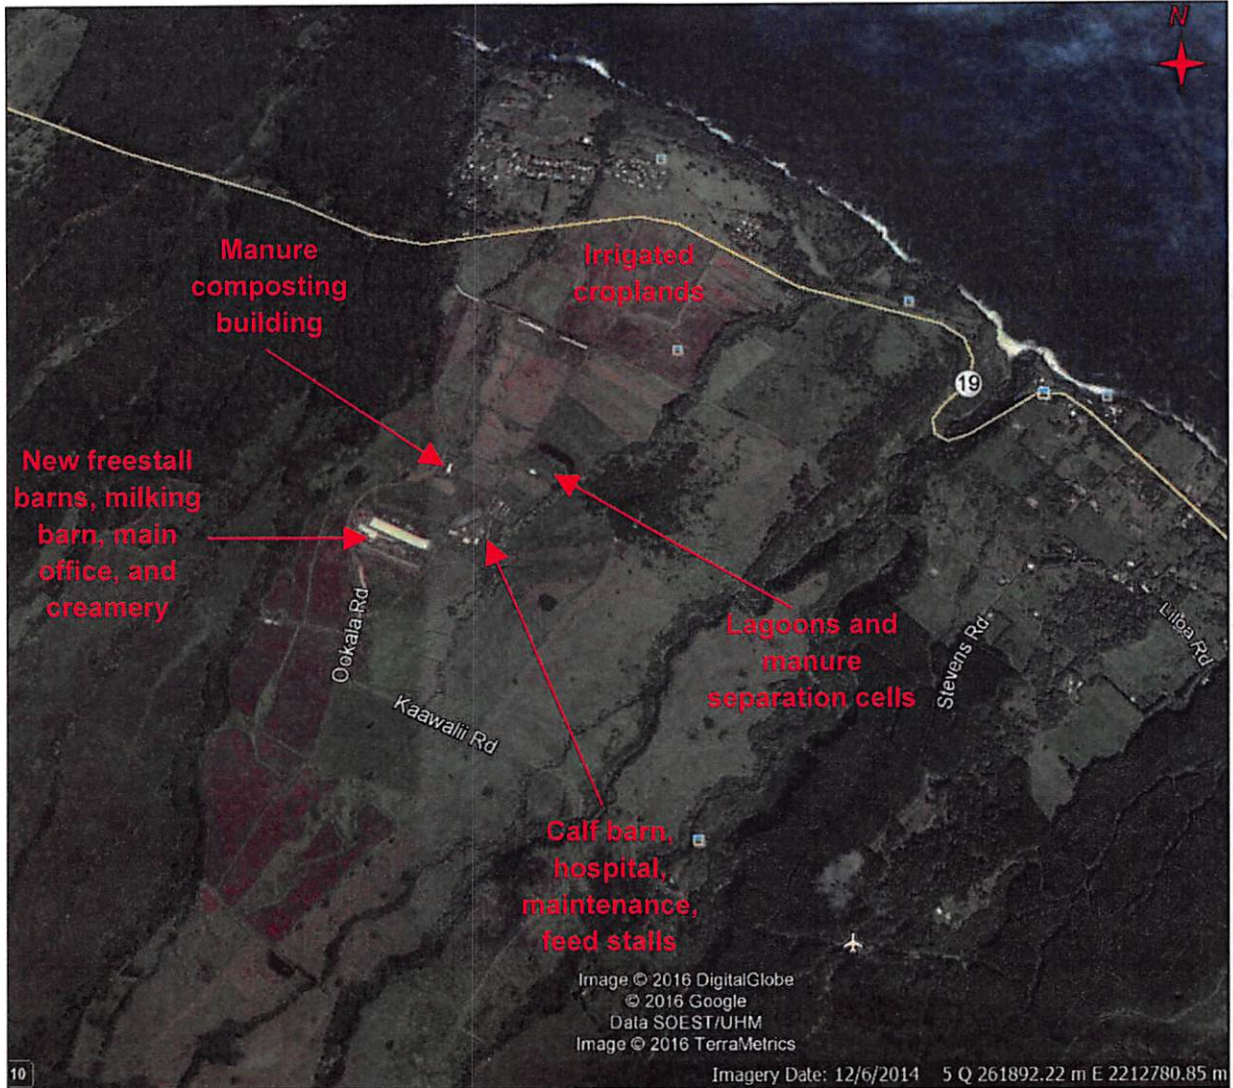
Figure 1. GoogleEarth aerial image of the BID Facility, imagery date December 6, 2014. The red arrows and callouts identify the various areas of the Facility visited during the inspection.

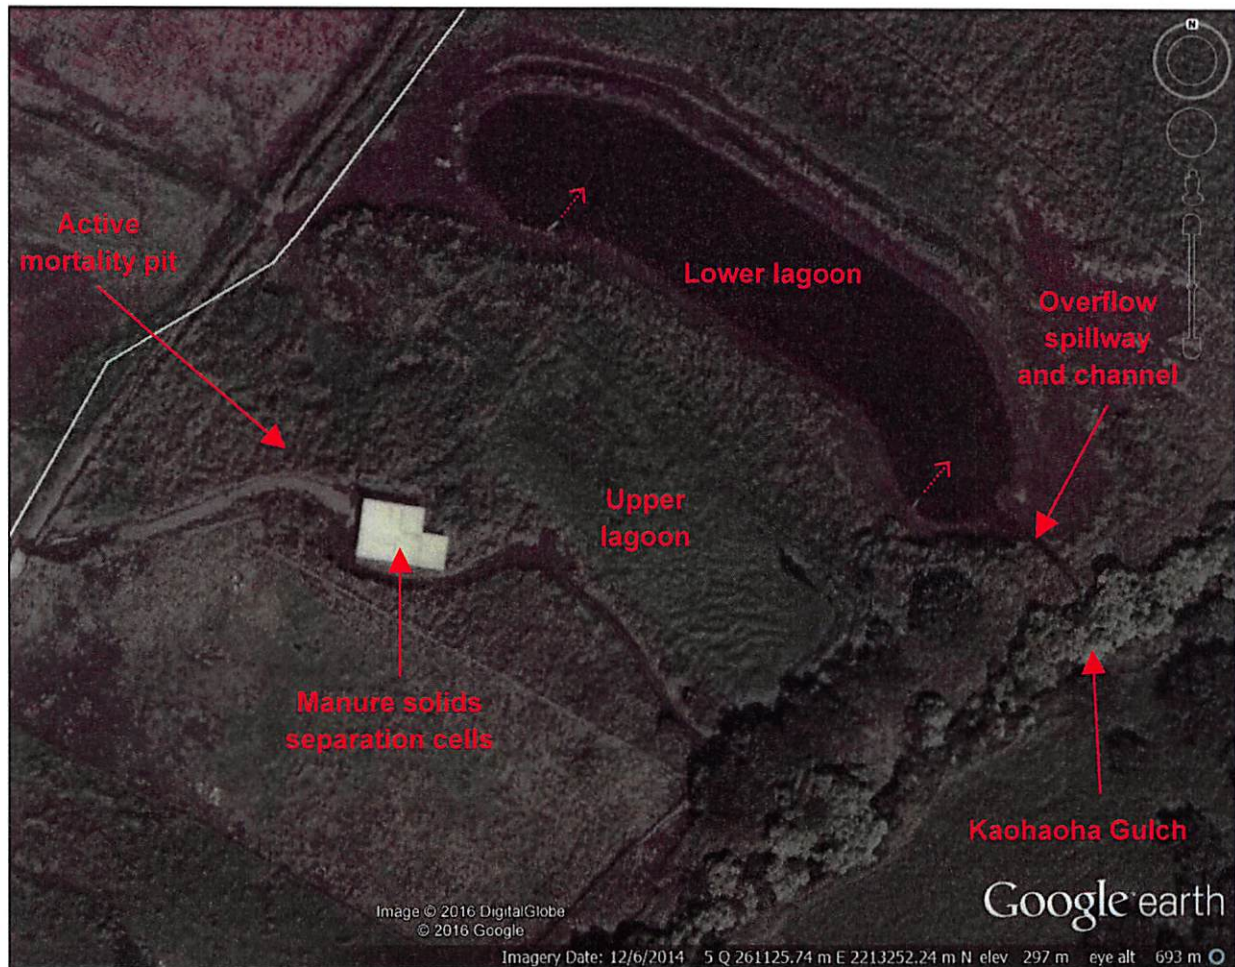
Figure 2. *GoogleEarth* aerial image of the BID manure separation cells and wastewater lagoons, imagery date December 6, 2014. The red arrows and callouts are approximate location estimations of Facility features observed during the inspection, described in the report, and shown in the Photograph Log.

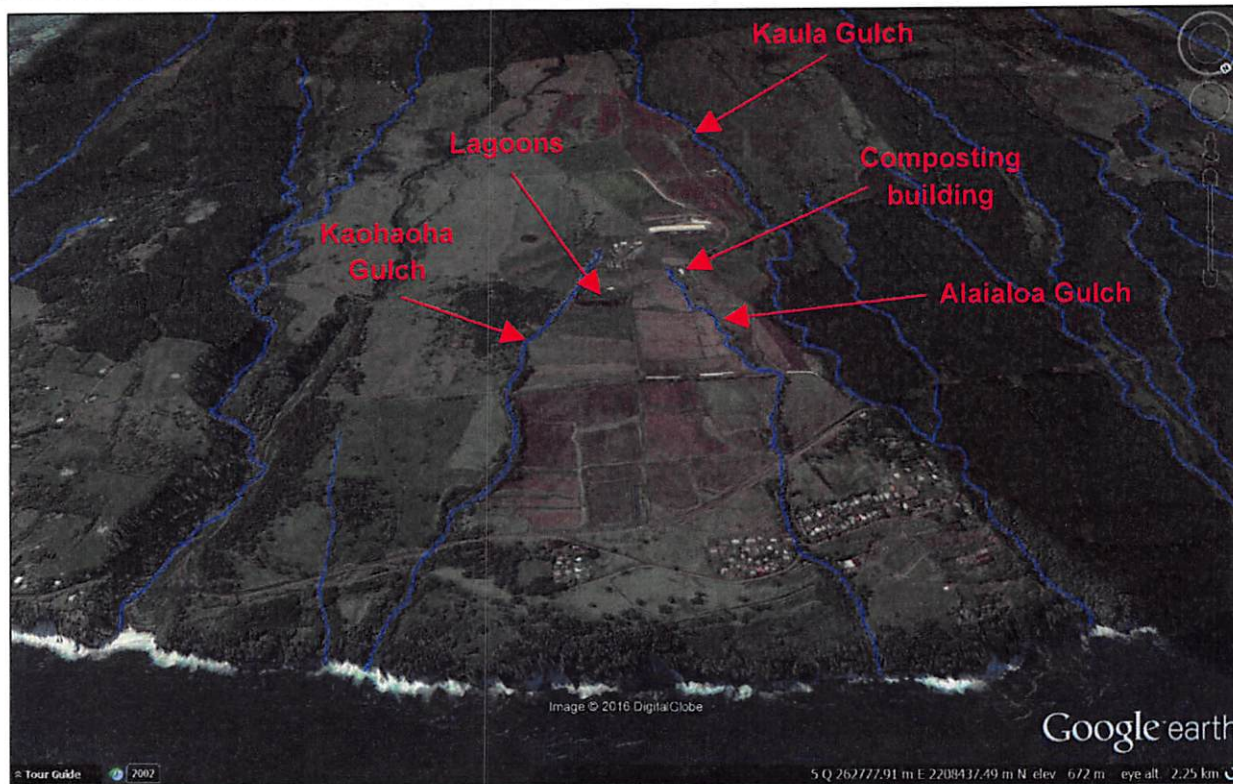
Figure 3. *GoogleEarth* aerial image, oriented southwest, of BID and Ookala, HI, imagery date December 6, 2014. The blue lines designate streams identified on the EPA My Waters Mapper application. The red arrows and callouts identify the Facility's main three receiving waters: Kaohaoha Gulch, Alaialoa Gulch, and Kaula Gulch, as well as the lagoons located adjacent to Kaohaoha Gulch and manure composting building near the origin of Alaialoa Gulch.

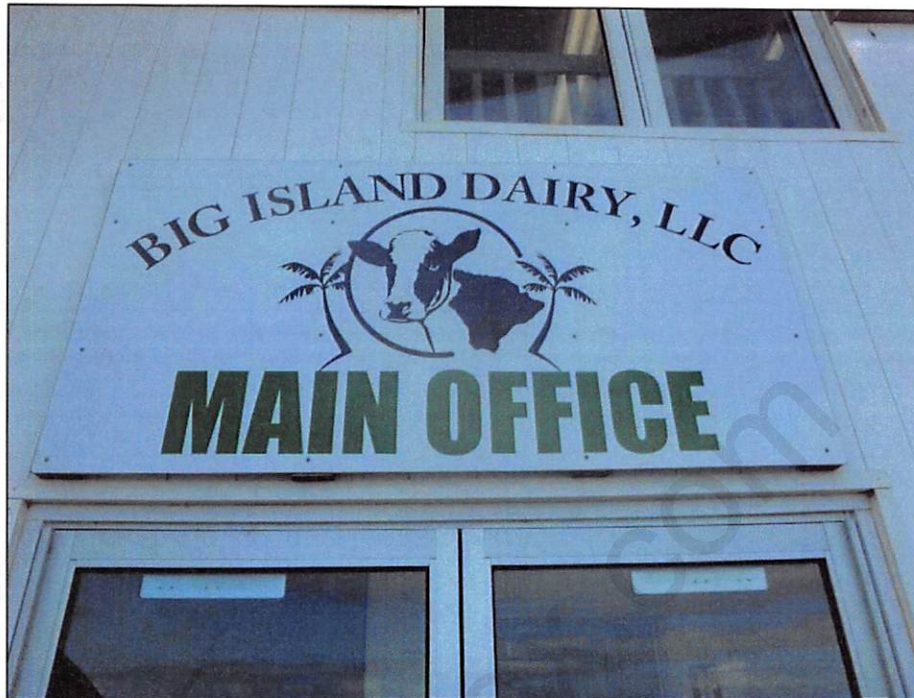
Photograph 1. Big Island Dairy main office sign. Photo by A. D'Angelo; 12/14/16.

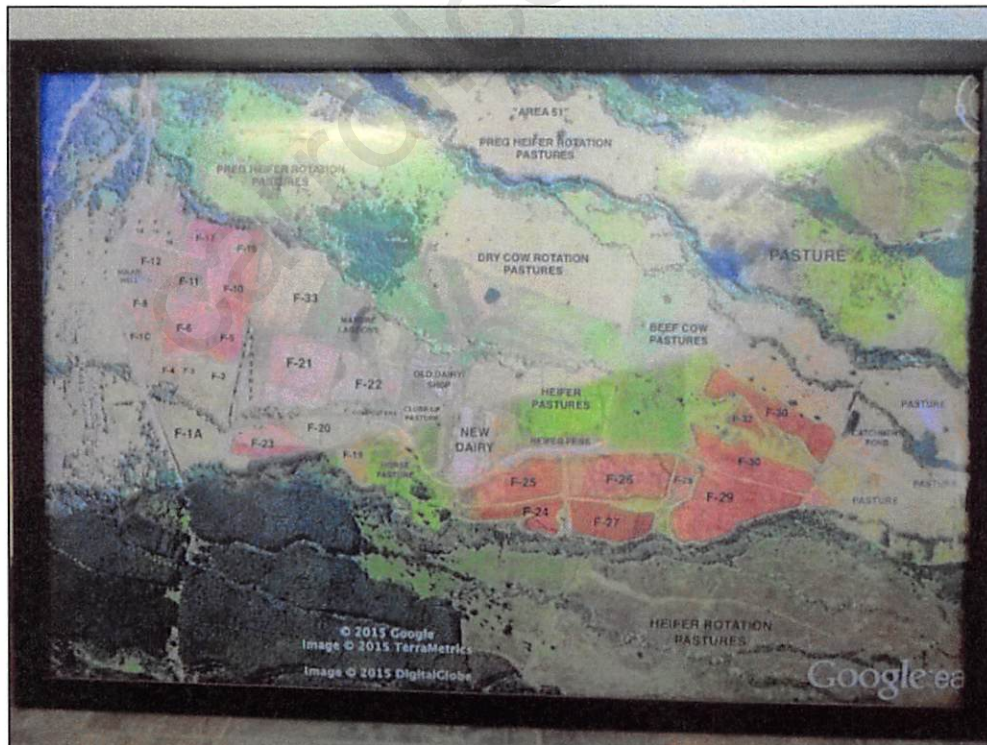
Photograph 2. BID map in main office identifying cropland and pasturelands, dairy facilities, manure composting building, and lagoons. Map oriented to the southeast. Photo by A. D'Angelo; 12/14/16.

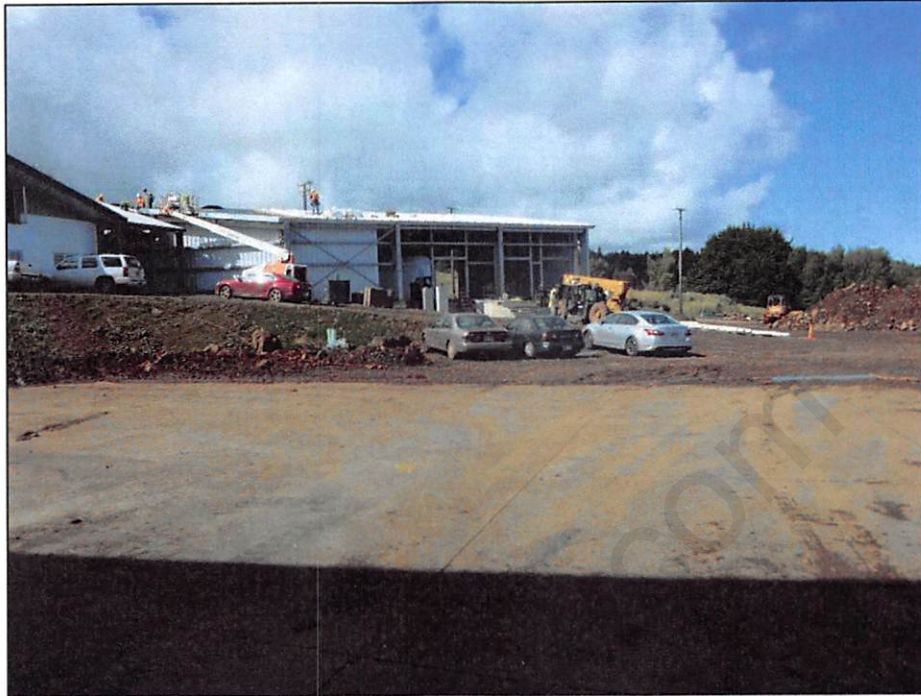
Photograph 3. View of the Facility's new building that was under construction at the time of the inspection. Photo by A. D'Angelo; 12/14/16.

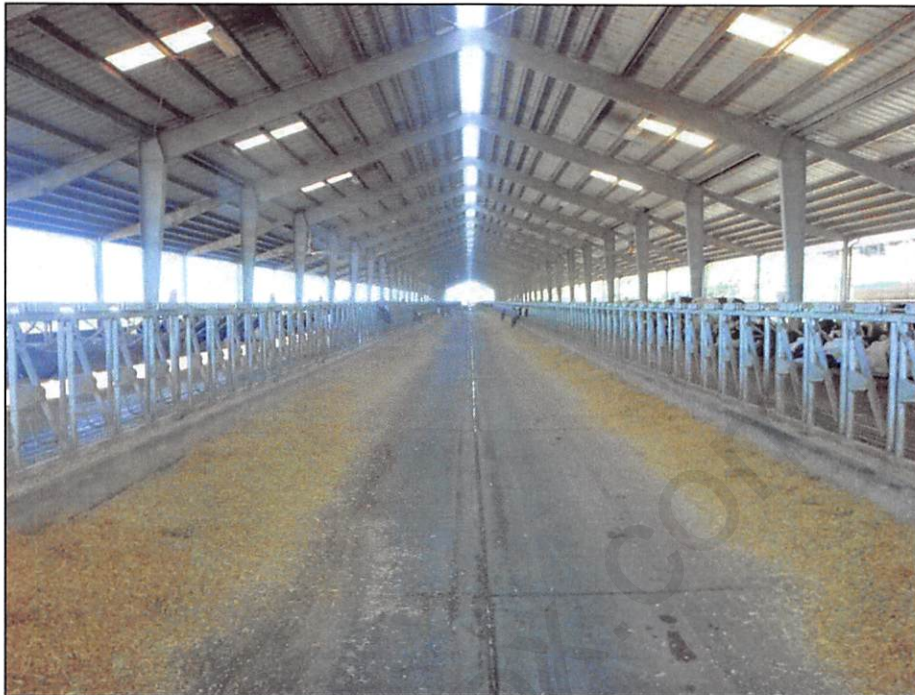
Photograph 5. View down the central feeding alley of the lower 1,000-cow freestall barn. Photo by A. D'Angelo; 12/14/16.

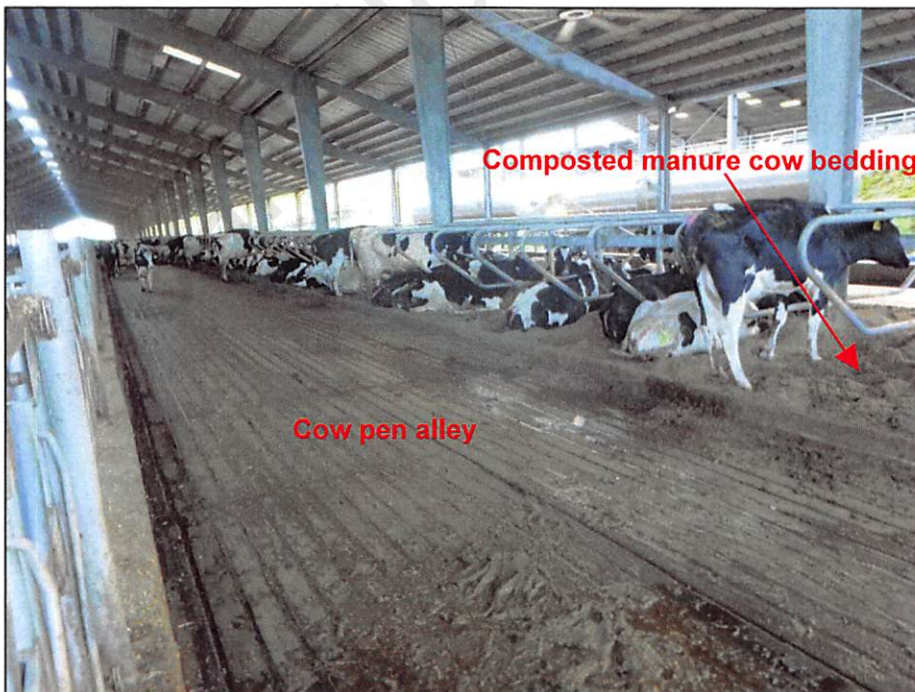
Photograph 6. The cow pen alleys of the freestall barns contain mechanically operated manure scraping systems that scraped manure toward and into a collection trough in the center of each barn. The cow pens were lined with composted manure bedding that is made onsite using recovered manure solids. Photo by A. D'Angelo; 12/14/16.

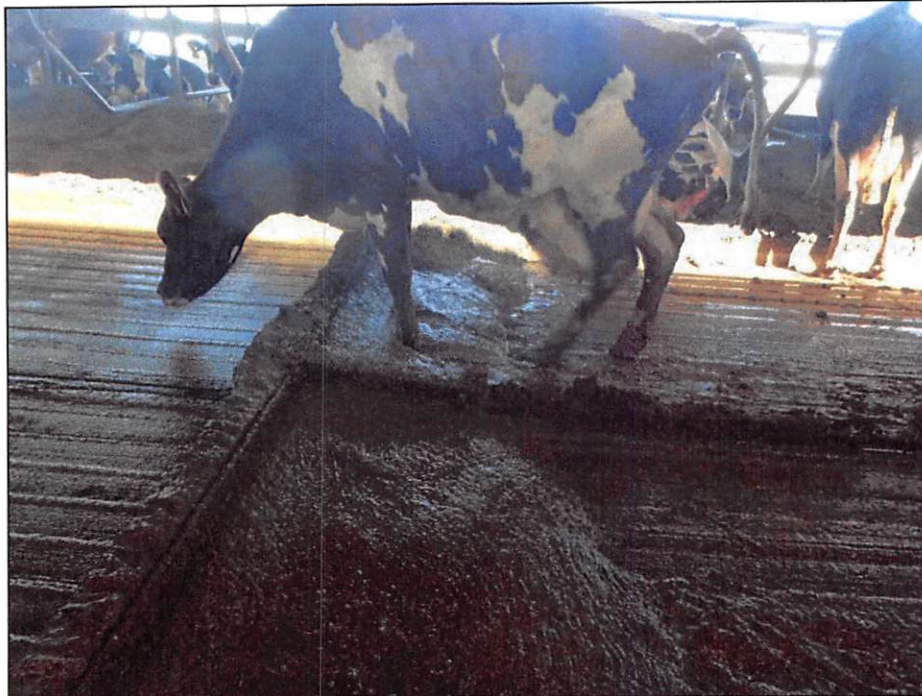
Photograph 7. Close-up view of the freestall barn manure scraping system in action. Photo by A. D'Angelo; 12/14/16.

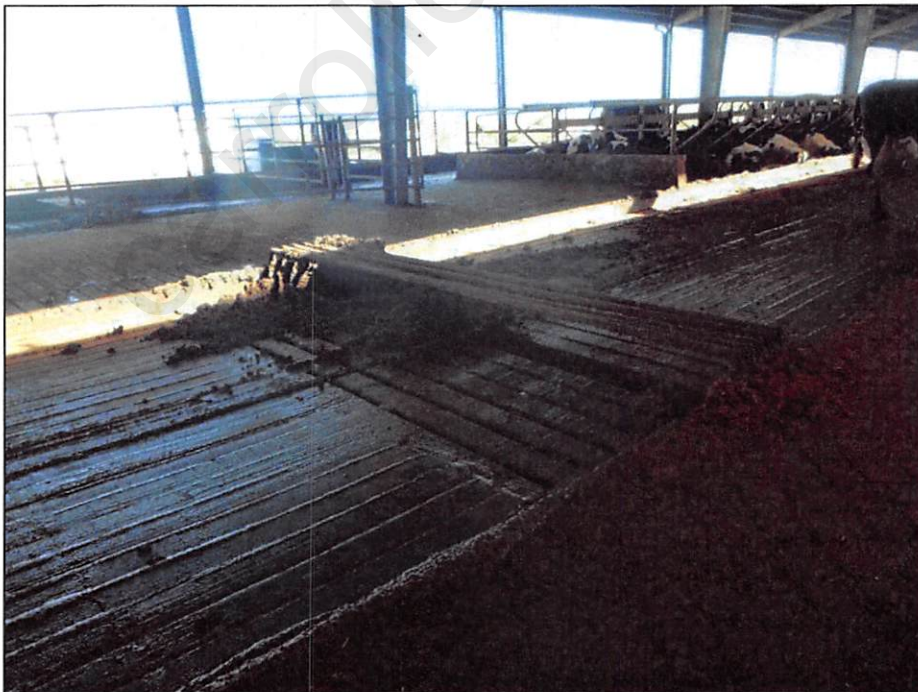
Photograph 8. View of the manure collection trough in the center of the lower freestall barn. The contents of the collection trough gravity flow into a collection pit located at the manure composting building, shown in Photographs 15 and 16. Photo by A. D'Angelo; 12/14/16.

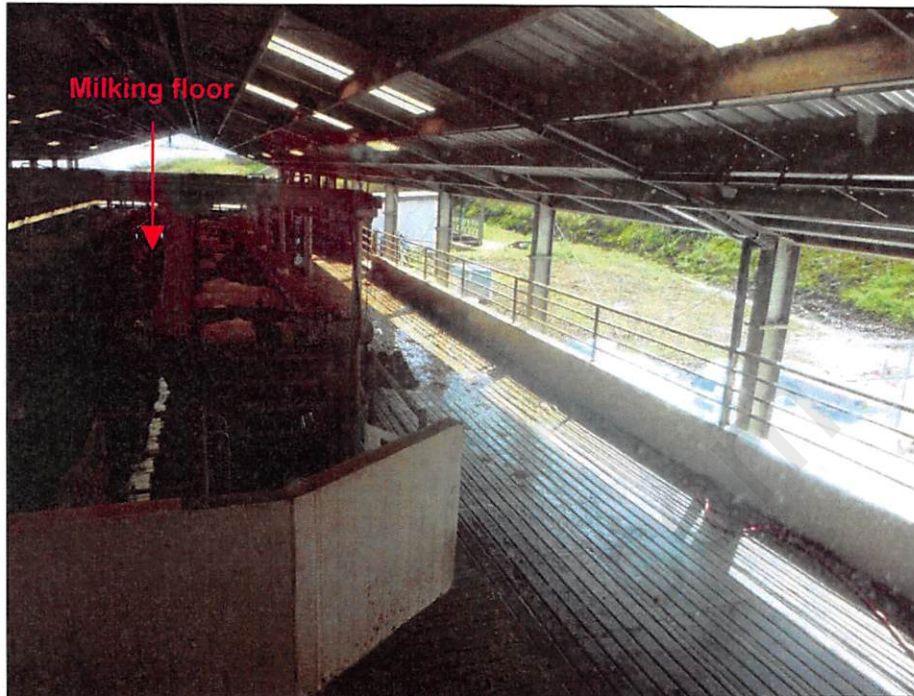
Photograph 9. View of the milking floor inside the Facility's recently constructed milking barn. Photo by A. D'Angelo; 12/14/16.

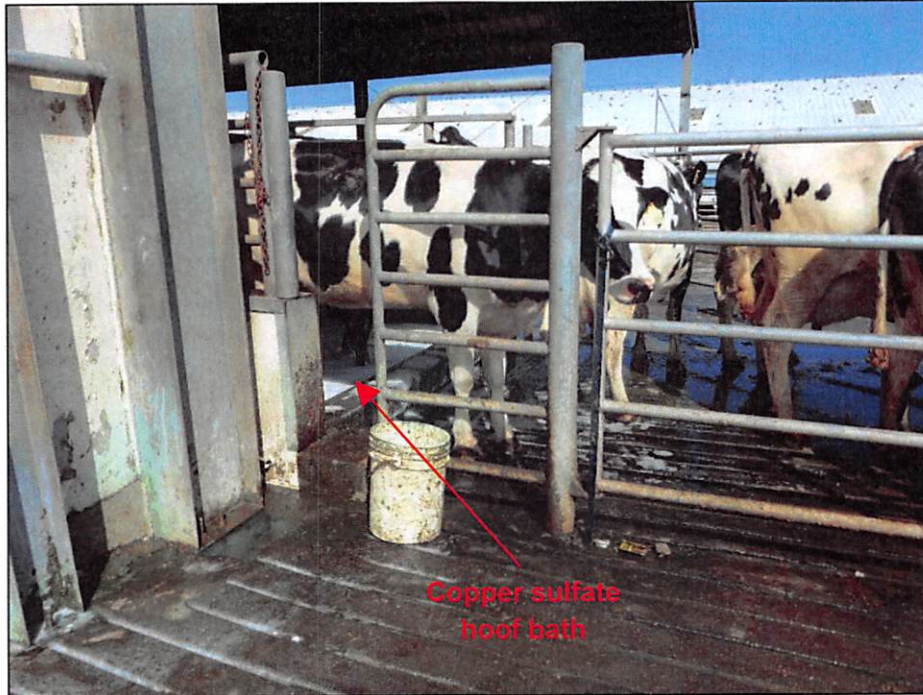
Photograph 11. View of the milking barn copper sulfate hoof bath. Photo by A. D'Angelo; 12/14/16.

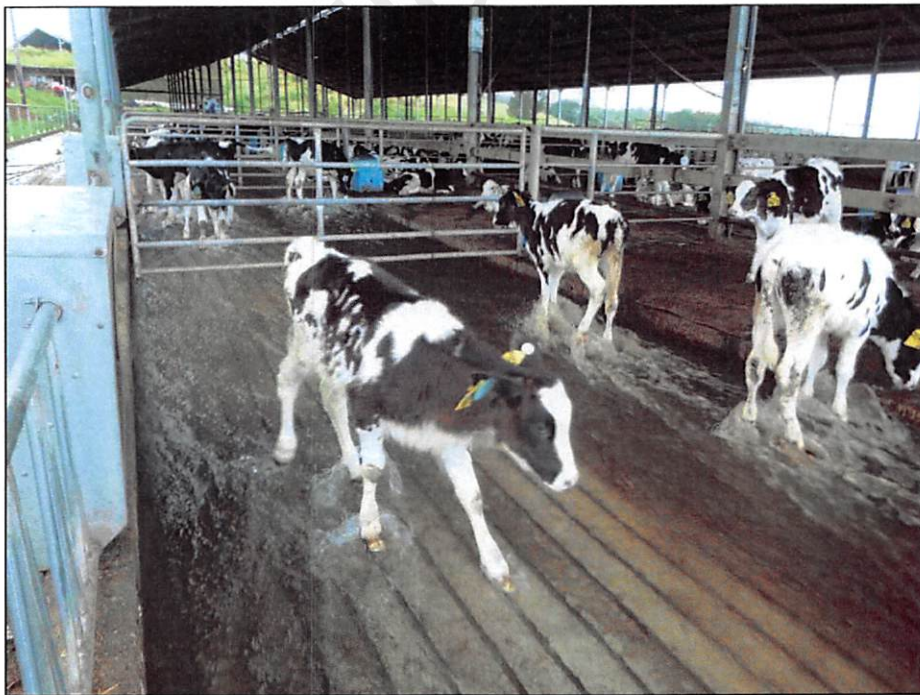
Photograph 12. View of active flushing occurring in the 380-head calf barn. Photo by A. D'Angelo; 12/14/16.

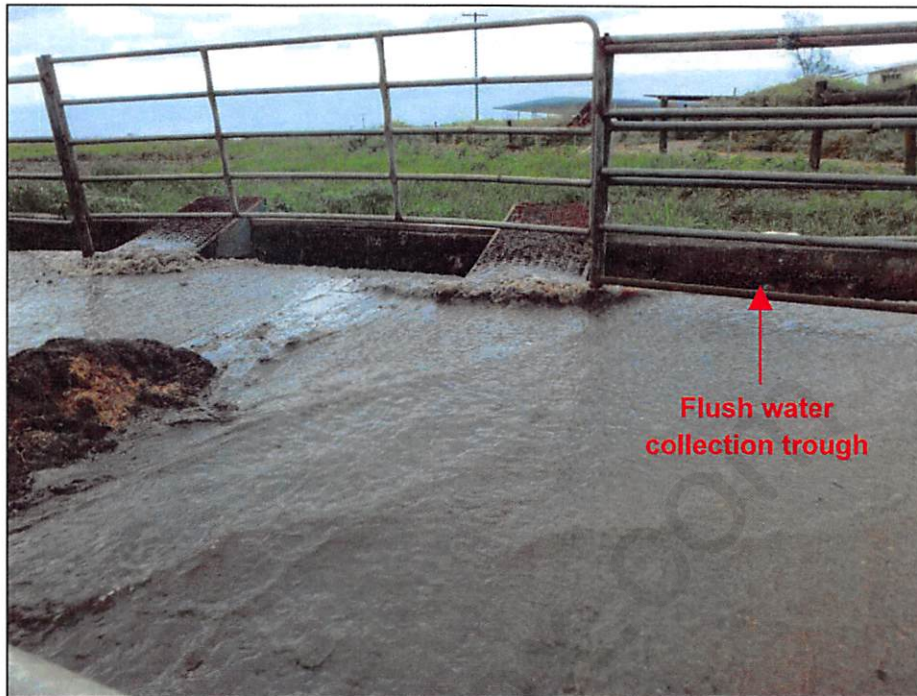
Photograph 13. Flush water from the 380-head calf barn is captured in a collection trough located at the end of the barn and conveyed to the manure composting building collection pit, shown in Photographs 15 and 16. Photo by A. D'Angelo; 12/14/16.

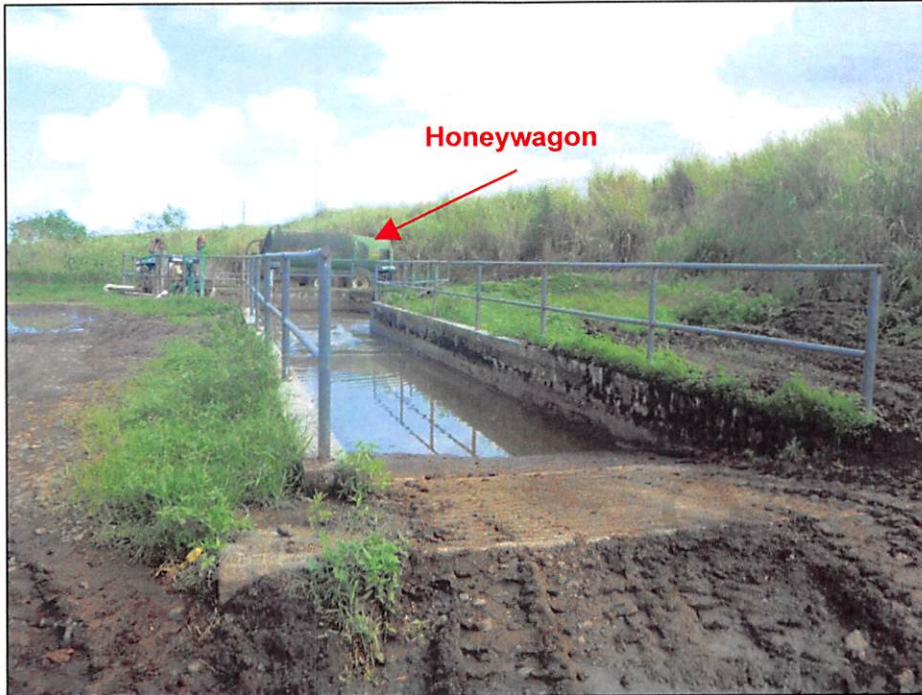
Photograph 15. View of the Facility's manure composting building collection pit. Waste streams from the freestall barns, calf barn, and milking barn gravity flow into this collection pit. Note the honeywagon stored behind the collection pit. Photo by A. D'Angelo; 12/14/16.

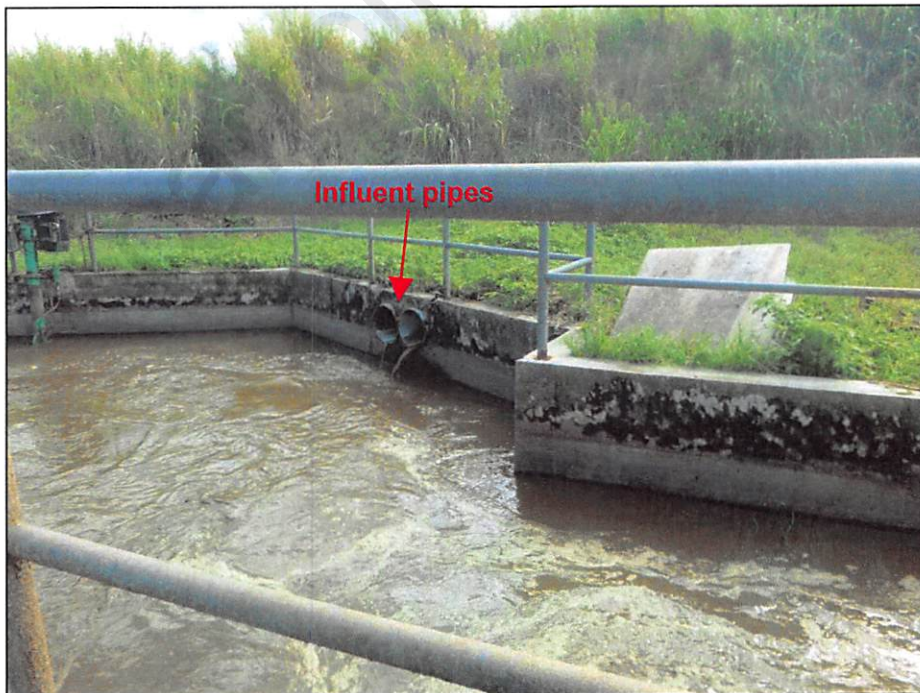
Photograph 16. View of the manure composting building collection pit influent pipes. Photo by A. D'Angelo; 12/14/16.

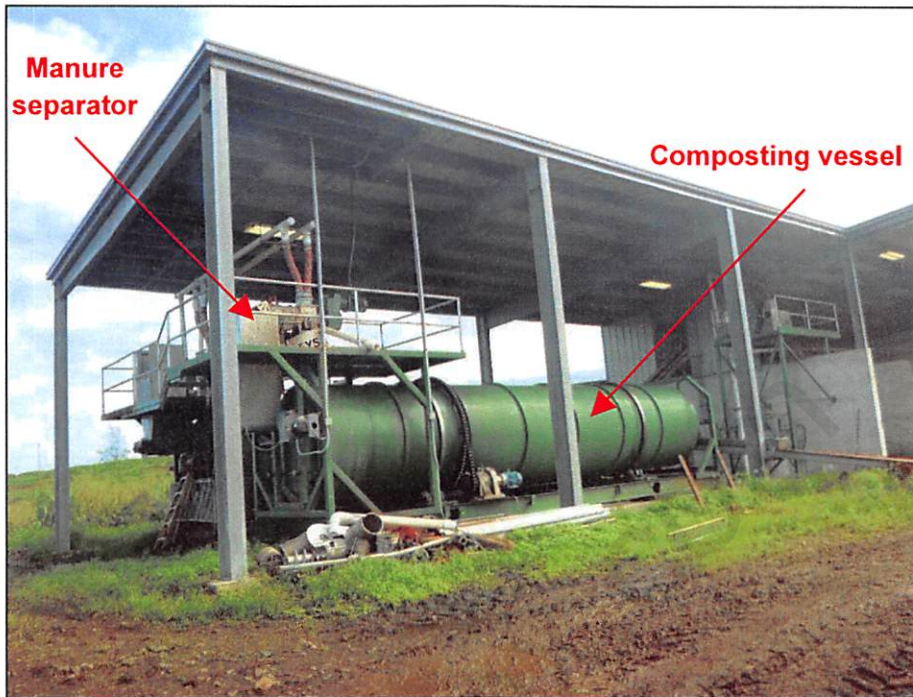
Photograph 17. View of the Facility's manure composting building which included two manure separator units, and two composting digester vessels. Photo by A. D'Angelo; 12/14/16.

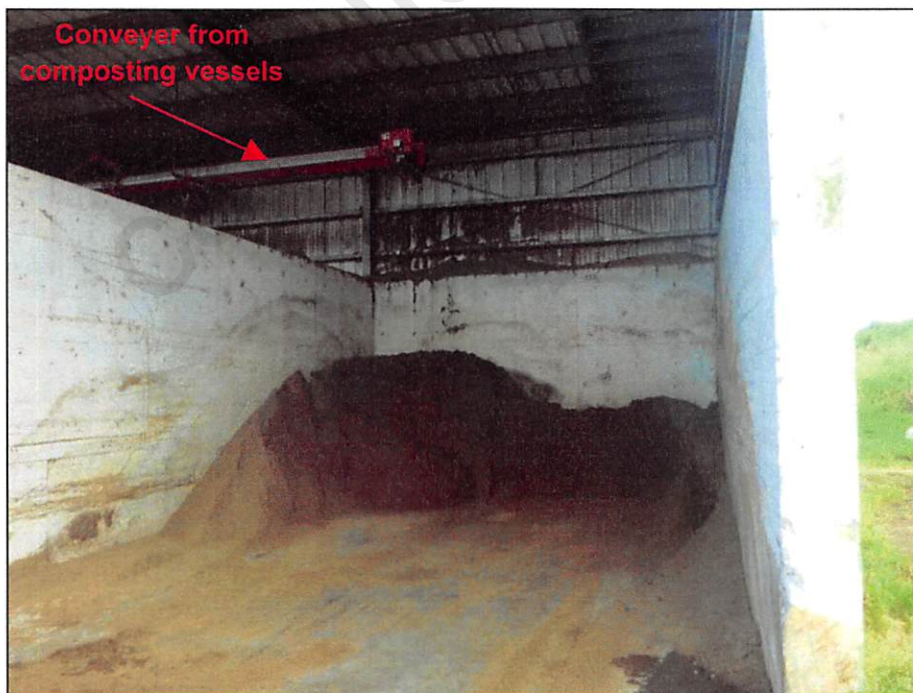
Photograph 18. A conveyor belt on the back end of the composting vessels conveys composted manure (i.e., cow bedding) into a covered stockpile stall. Photo by A. D'Angelo; 12/14/16.

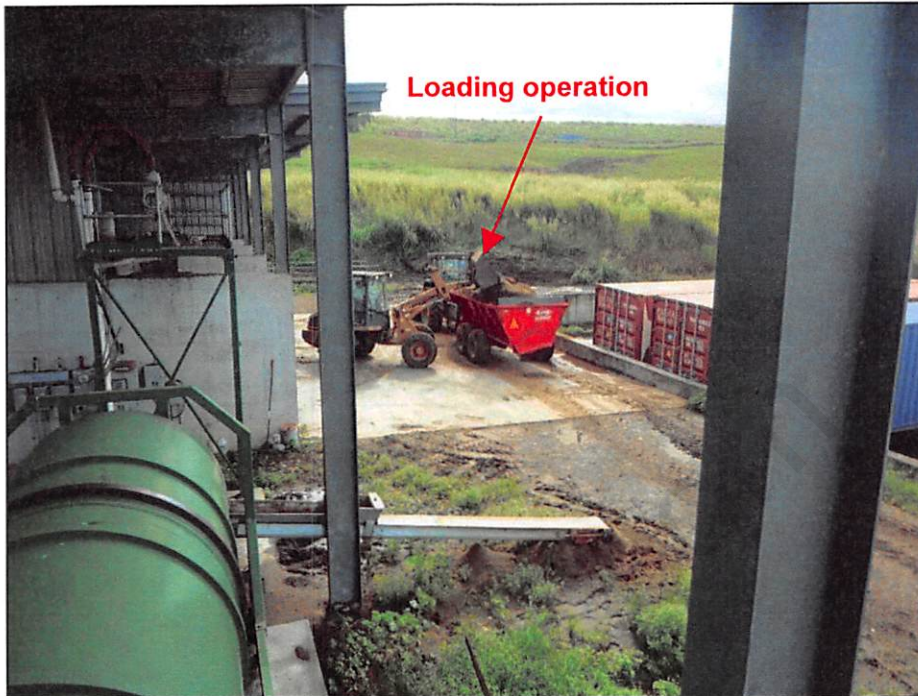
Photograph 19. View of BID staff actively loading cow bedding from the covered bedding stockpile stall into a trailer. Photo by A. D'Angelo; 12/14/16.

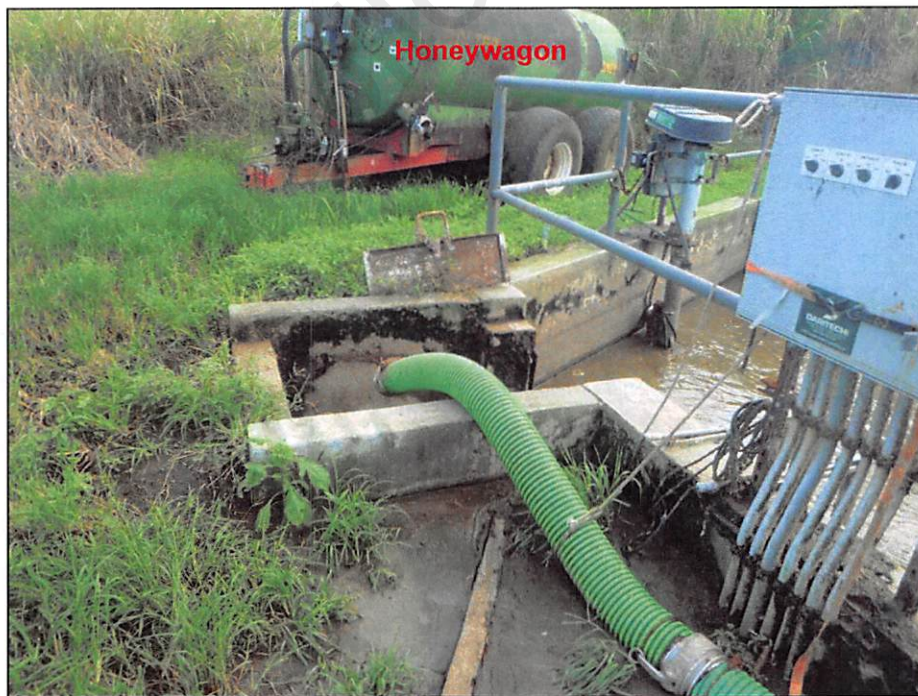
Photograph 20. View of the manure composting building collection pit overflow point. Overflow flows into the manure separation cells shown in Photographs 22 and 23. Note the honeywagon. Photo by A. D'Angelo; 12/14/16.

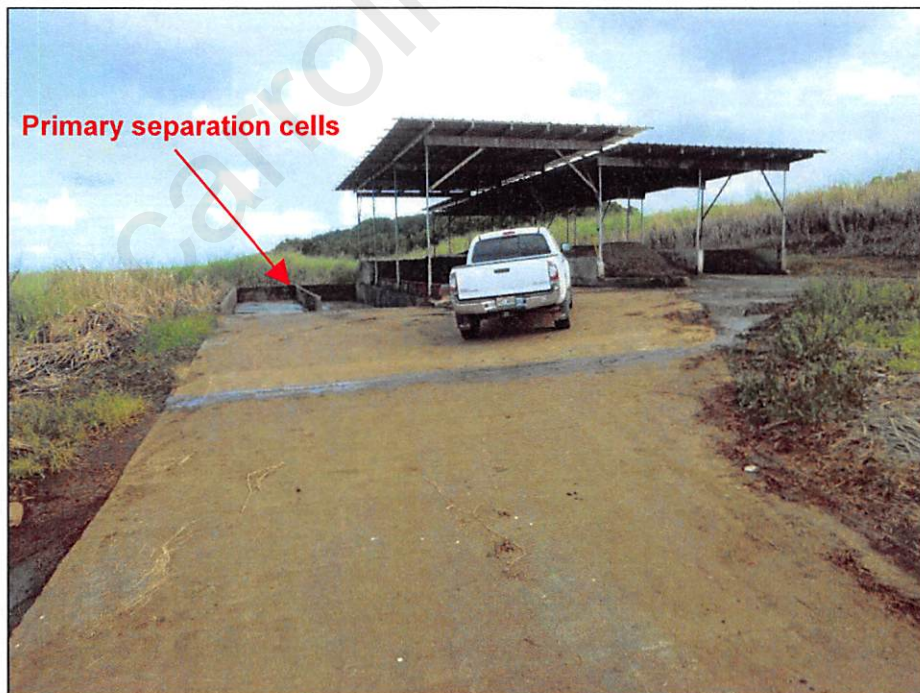
Photograph 22. View, facing east, of the Facility's manure solids separation cells located adjacent to the upper lagoon (refer to Figure 2). The uncovered cells on the left serve as the primary cells and liquid waste discharge points. Photo by A. D'Angelo; 12/14/16.

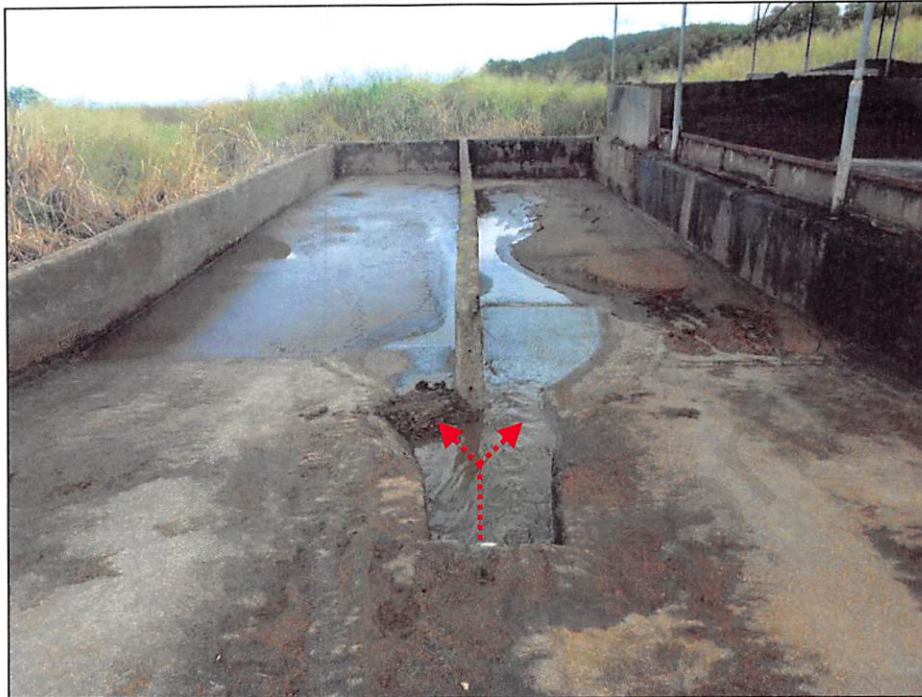
Photograph 23. View of flow from the manure composting collection pit entering the primary cells of the manure solids separation cells shown in Photograph 22. Photo by A. D'Angelo; 12/14/16.

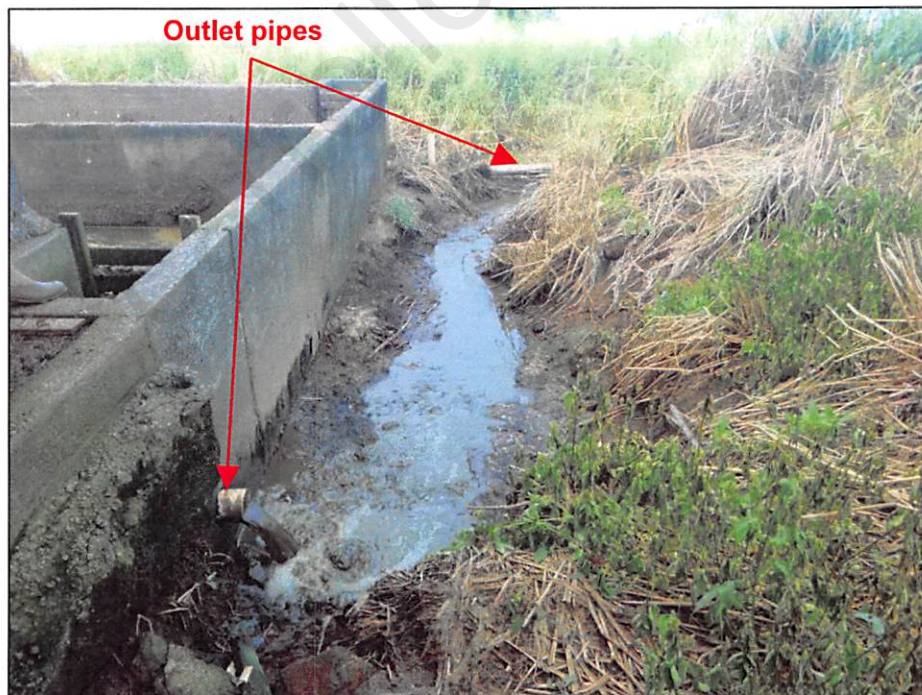
Photograph 24. View of the two pipes that drain separated liquid from the manure solids separation cells. Liquid from the cells surface flows, via an earthen conveyance channel, into the northwest side of the upper lagoon. Photo by A. D'Angelo; 12/14/16.

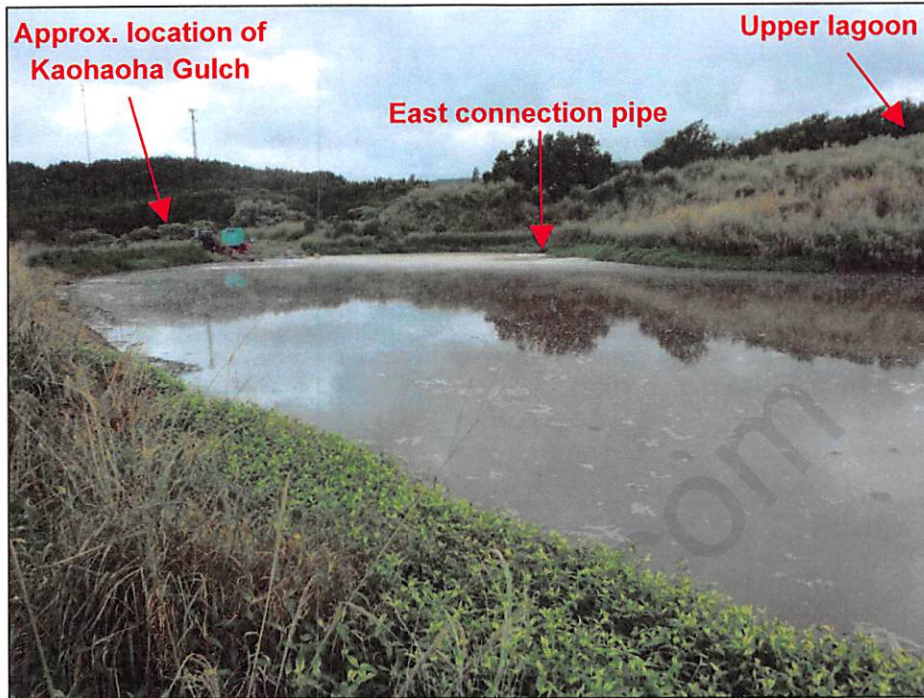
Photograph 27. View, facing southeast, of the lower lagoon. I observed a floating agitator unit, draw pumping system, and overflow spillway on the southeast side of the lagoon. Photo by A. D'Angelo; 12/14/16.

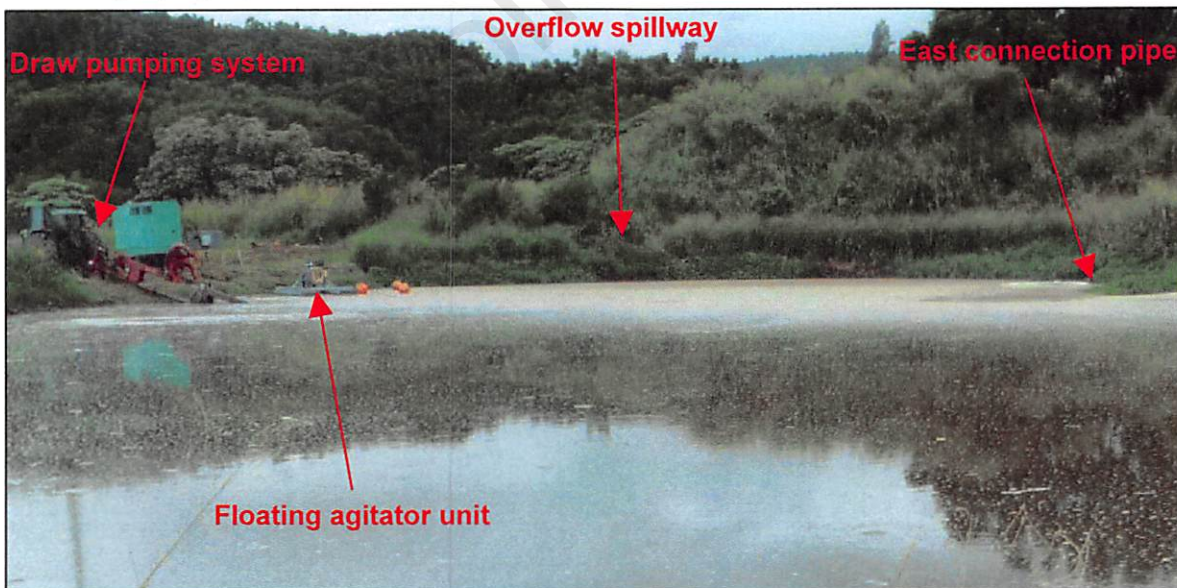
Photograph 28. Zoomed-in version of Photograph 27, showing the floating agitator unit, draw pumping system, and overflow spillway of the lower lagoon. Photo by A. D'Angelo; 12/14/16.

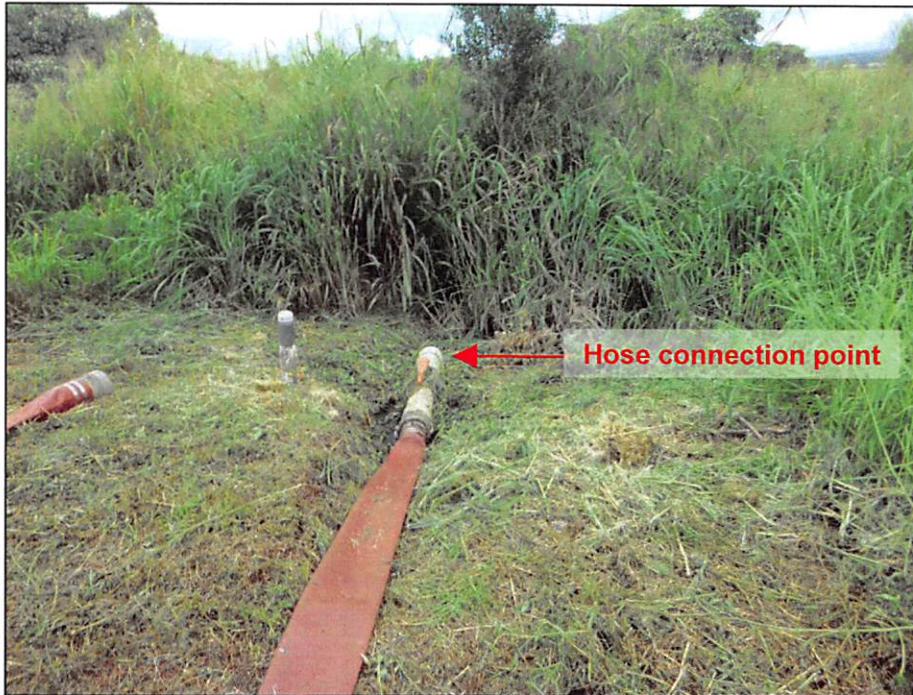
Photograph 29. View of the draw pumping system hose connection point to the Facility's irrigation system. Photo by A. D'Angelo; 12/14/16.

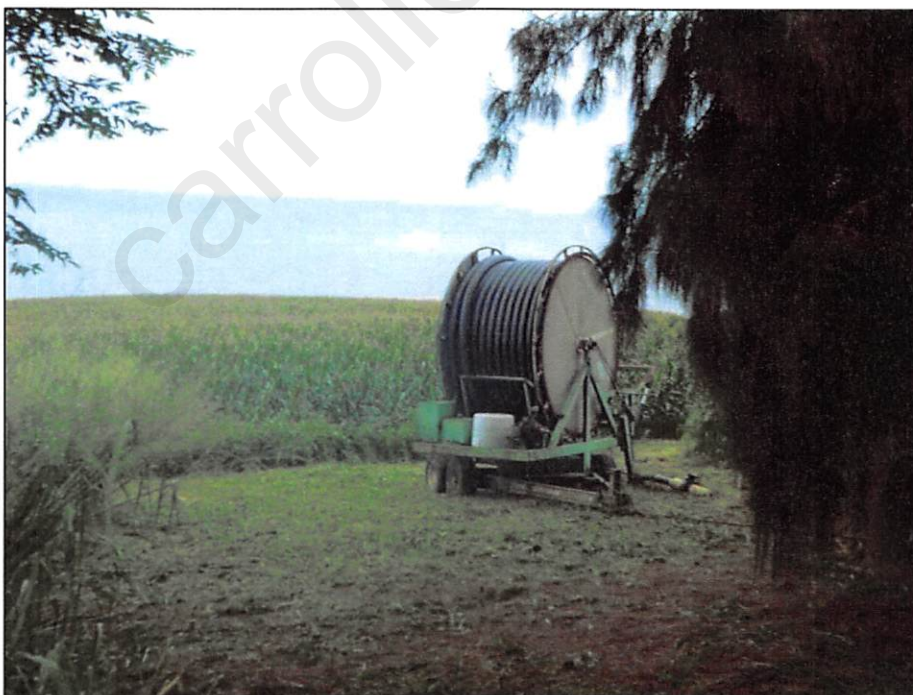
Photograph 30. View of one of the Facility's retractable irrigation distribution equipment which receives flow from the lower lagoon draw pumping system. Photo by A. D'Angelo; 12/14/16.

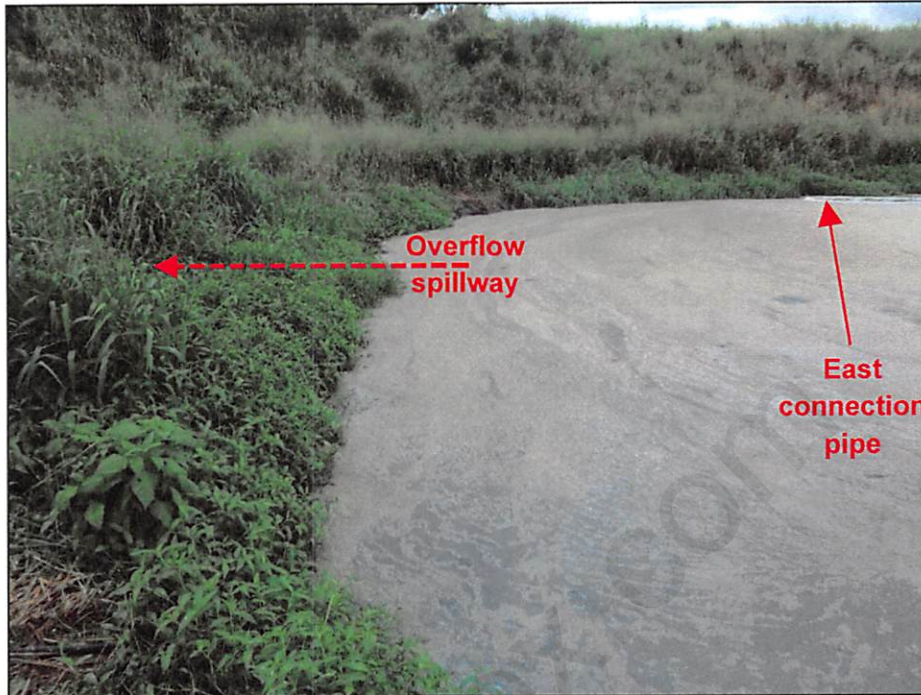
Photograph 31. View, facing south, of the approximate location of the lower lagoon overflow spillway. Photo by A. D'Angelo; 12/14/16.

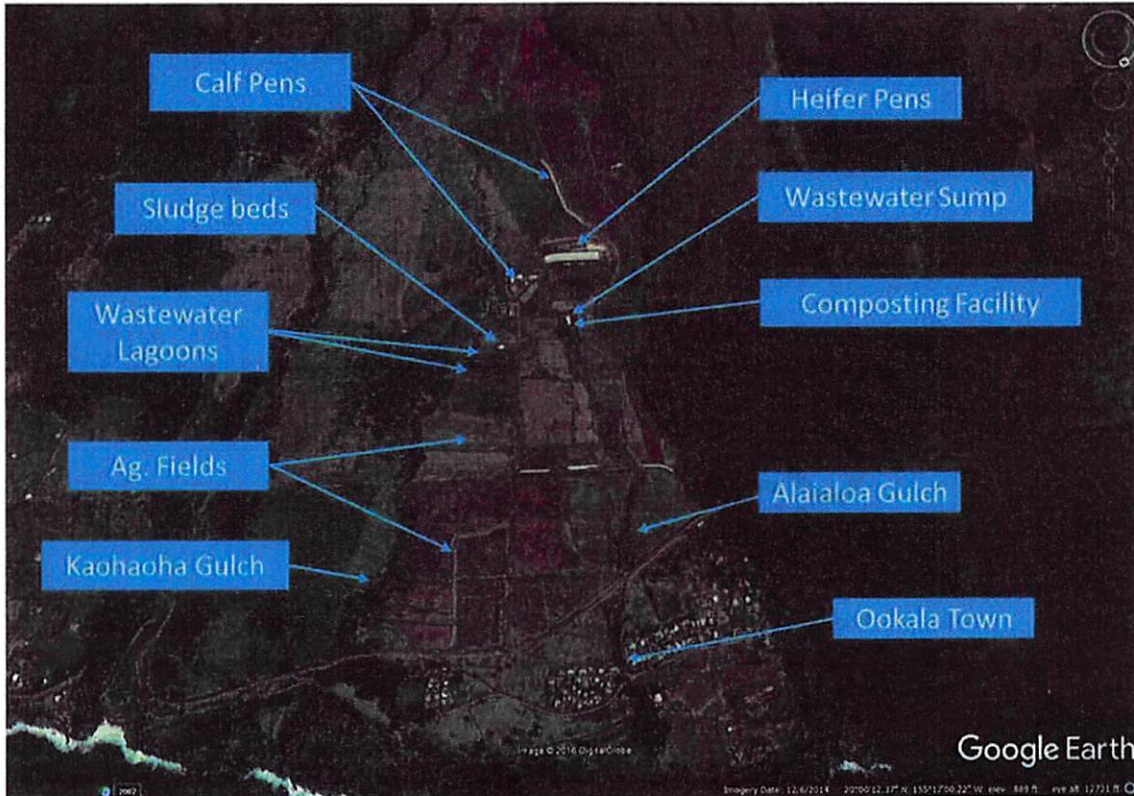
Figure 1: Overview of Big Island Dairy
Image Source: Google Earth (Saved 4/4/2017)
Call Outs Overlaid By: M. Kurano

Description: Notable features include single family homes located in Ookala Town, the location of the animal pens, wastewater lagoons, sludge separation, composting facility, wastewater sump and State waters (Kaohaoha Gulch and Alaialoa Gulch).
