Subject: Notice of Violation and Order (NOVO)
Docket No. 2017-CW-EO-08
Hawaii Water Pollution Rules and Regulations
Big Island Dairy
O'okala, Island of Hawaii, Hawaii

DEPARTMENT OF HEALTH
NOTICE OF VIOLATION AND ORDER

Concentrated Animal Feeding Operation
NPDES Inspection Report
Facility Name: Big Island Dairy
Photograph Log

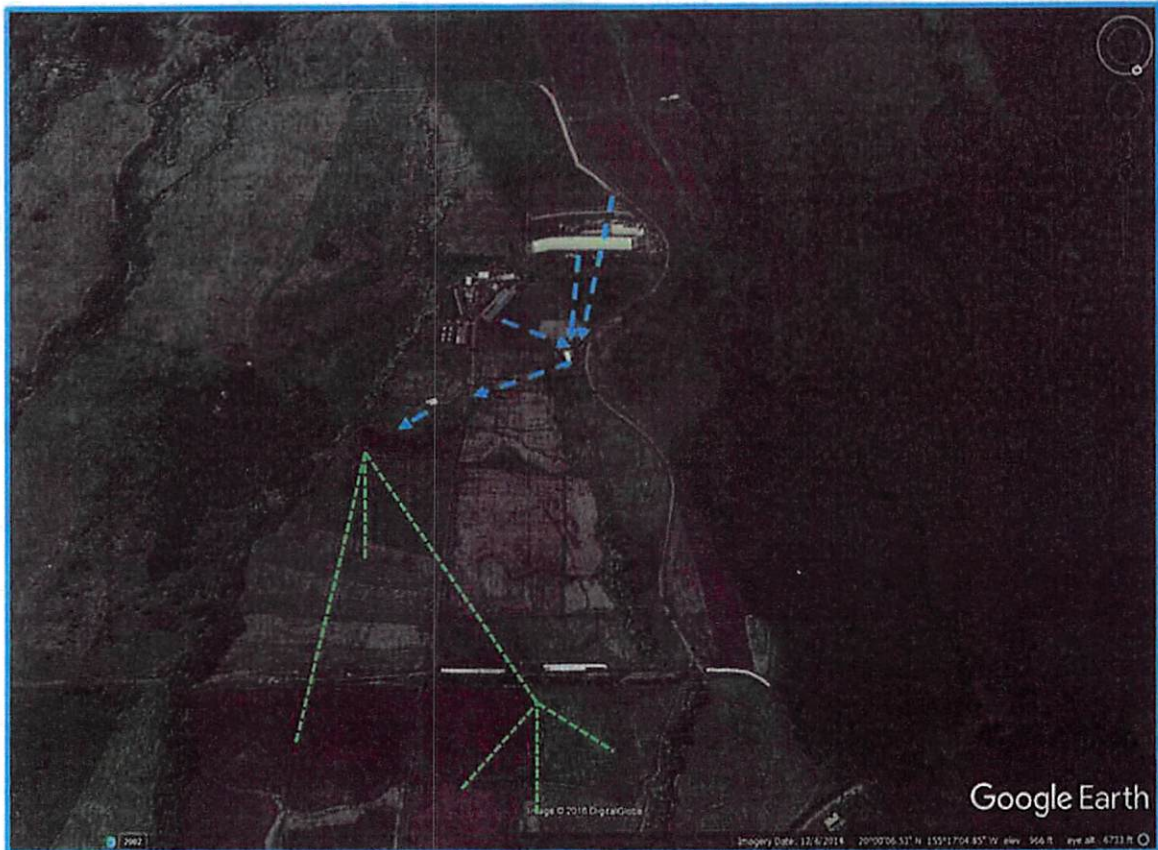
Figure 2: Overview and Simplified Diagram of Dairy Wastewater Irrigation System

As stated above, wastewater from the lagoons is re-used for crop irrigation. The green dotted lines represent a simplified diagram of the Dairy's irrigation system (Figure 2). The Dairy uses a pump to pressurize the wastewater used for crop irrigation. The Dairy utilizes a combination of water cannons and hoses to distribute the wastewater throughout the Dairy's crop fields. Crop

fields, pasture areas and the wastewater lagoons all contain drainage features such as ditches or grades that are potential pathways for wastewater to discharge from the Dairy to the nearby gulches.

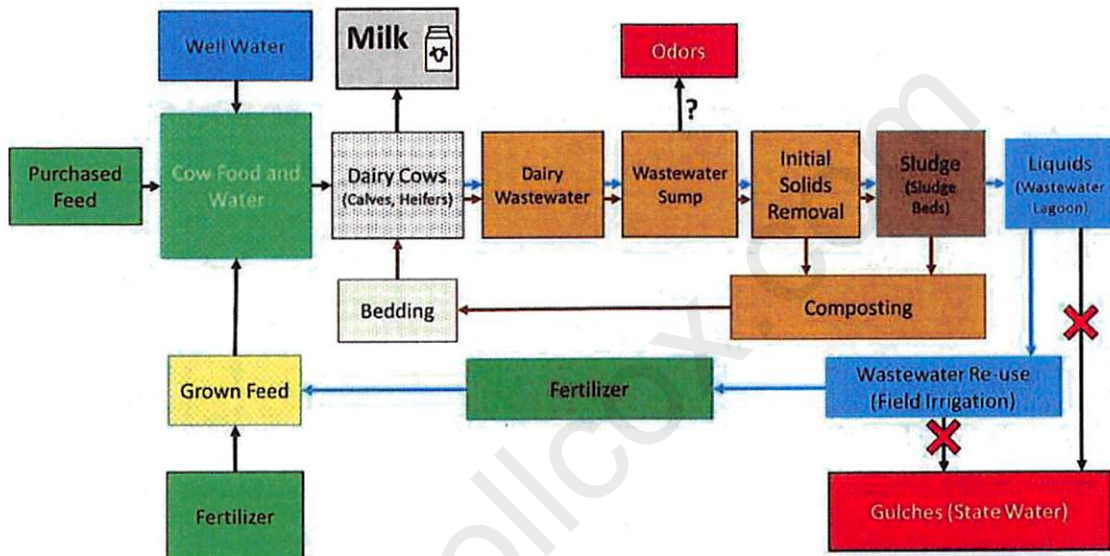
Figure 3: Simplified schematic of the Dairy's operations. Note that discharges to State waters are prohibited.

Figure-3 (below) is a diagram generated by the DOH-CWB, that depicts the Dairy's waste streams. As depicted below, raw materials including feed, cows and fertilizer are either cultivated onsite, or imported. Mature dairy cows are confined and used to produce milk for local sale. The primary waste stream from the dairy operation is the wastewater produced from feeding and housing the cows. The Dairy currently uses a wastewater system designed to

recover waste products for reuse as bedding (solids) and fertilizer (liquids) to improve efficiency from an operational and business standpoint. Of note, there are three (3) waste streams which constituted areas of focus for the March 28-29, 2017, investigation. The three (3) waste streams include odors potentially resulting from wastewater handling, unauthorized discharges from the wastewater lagoons, and unauthorized discharge of wastewater from crop irrigation. As stated before, Hawaii water pollution laws prohibit the unauthorized discharge of wastewater to State waters.

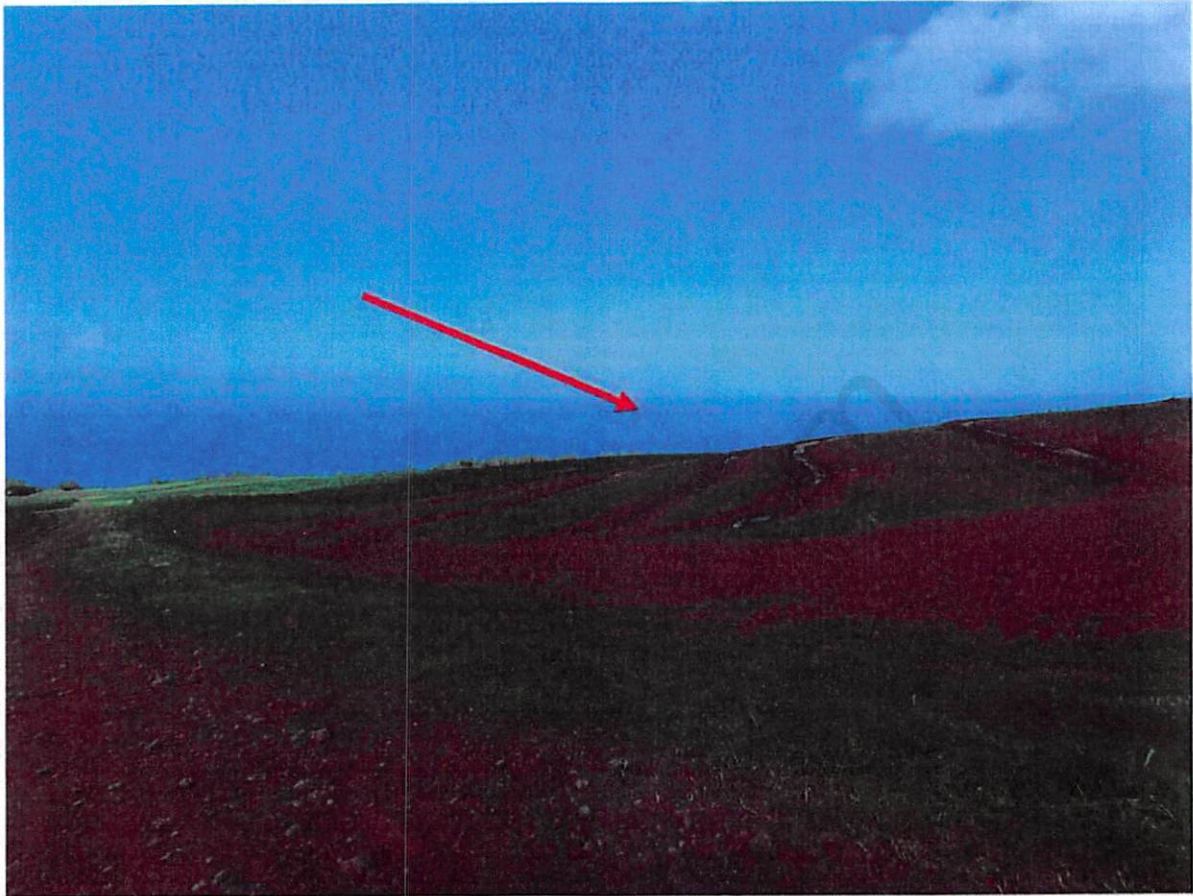
- 1) The crop fields, immediately North (makai) of the "airstrip" appeared to be recently graded (Photograph 3). I observed corn growing in the fields in rows perpendicular to the slope of the property. What appeared to be small trenches were cut perpendicular to the slope of the property such that any excess irrigation water would stay onsite. Further, the fields sloped up towards Alailoa Gulch such that there was a low potential for storm water or irrigation water to discharge from the fields. Of note, the grading and terrace-like features was not ubiquitous throughout the Dairy's fields. The field pictured in Photograph 3 depicts one (1) of the fields B. Duff stated was modified following the DOH inspection in December 2016.

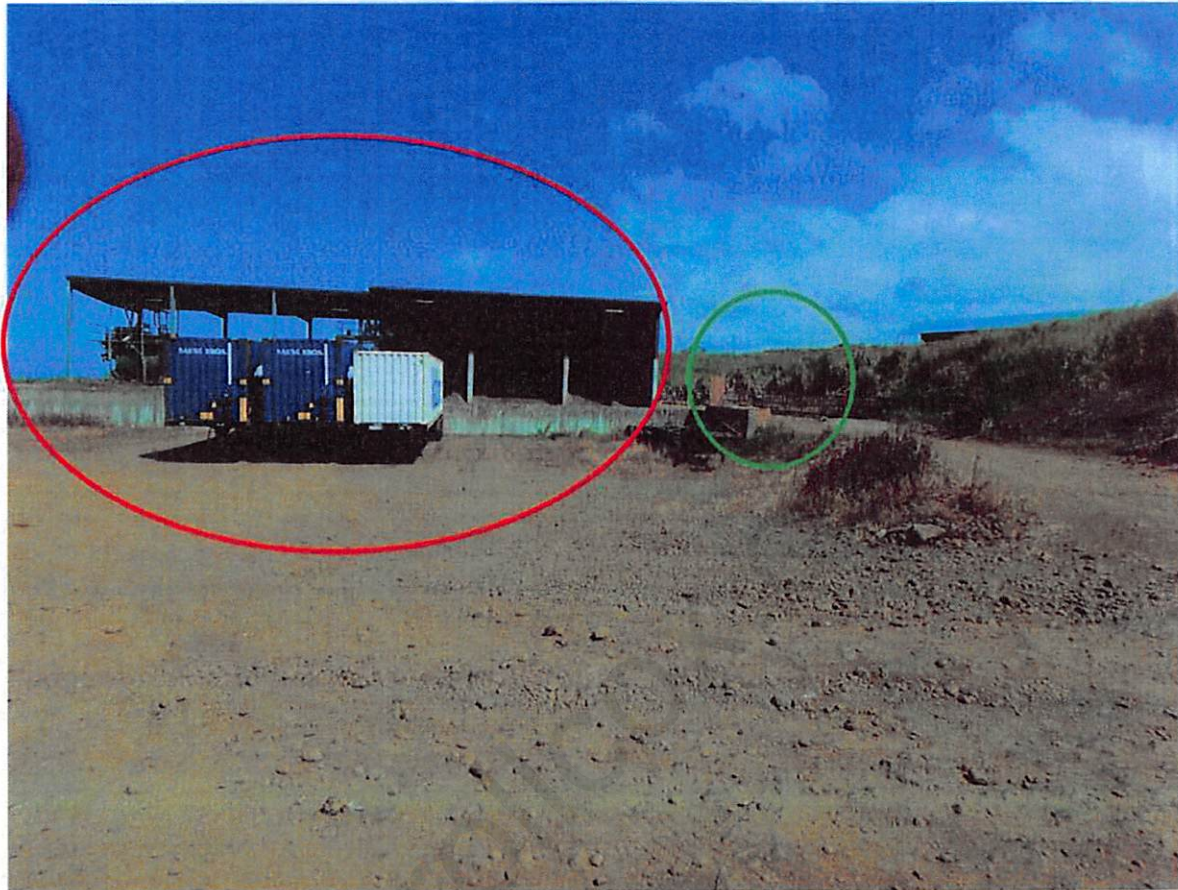
Photograph 4

- 2) As detailed in the December 2016, report, the Dairy's composting facility (Photograph 4) is located adjacent to Alailoa Gulch. I walked to the compost bays to make

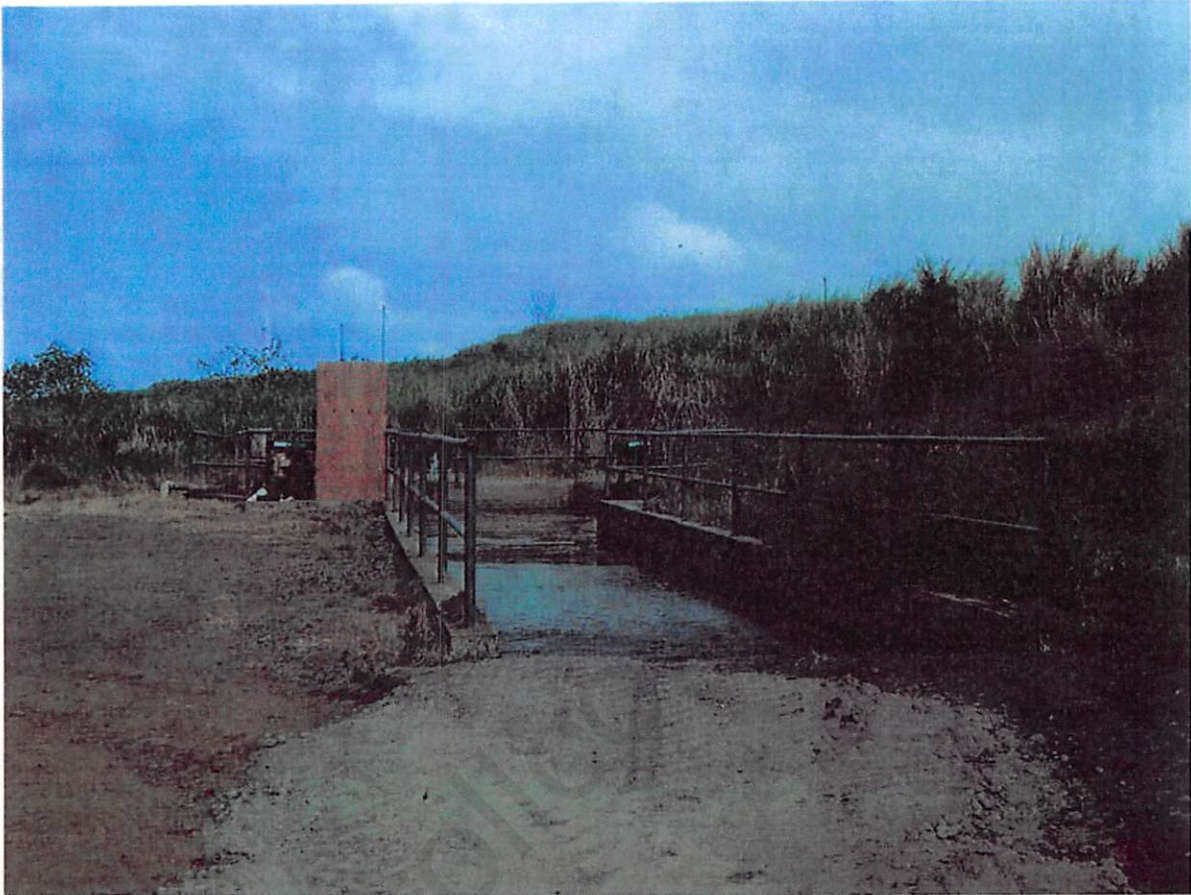
Photograph 5

- 3) While at the compost bays, I smelled a strong odor emanating from the Dairy's wastewater sump (Photograph 5). The wastewater collected in the wastewater sump was being agitated to suspend wastewater solids as is routine. The odor was very pungent and easily traced to the wastewater sump. Solids from the wastewater sump is separated to be processed as compost while remaining wastewater flows to the Dairy's sludge beds. Sludge separated in the sludge beds is then routed back to the wastewater sump for re-separation.
- 4) N. Mukai and I left the Dairy at approximately 4:00pm.

- d. I observed a strong odor at the Dairy's wastewater sump. I could not definitively determine if the odor was the source of the odors which area residents have stated is a problem. However, based on the odor emanating from the Dairy's wastewater sump, the Dairy should investigate this issue further to determine if odor control units are necessary.

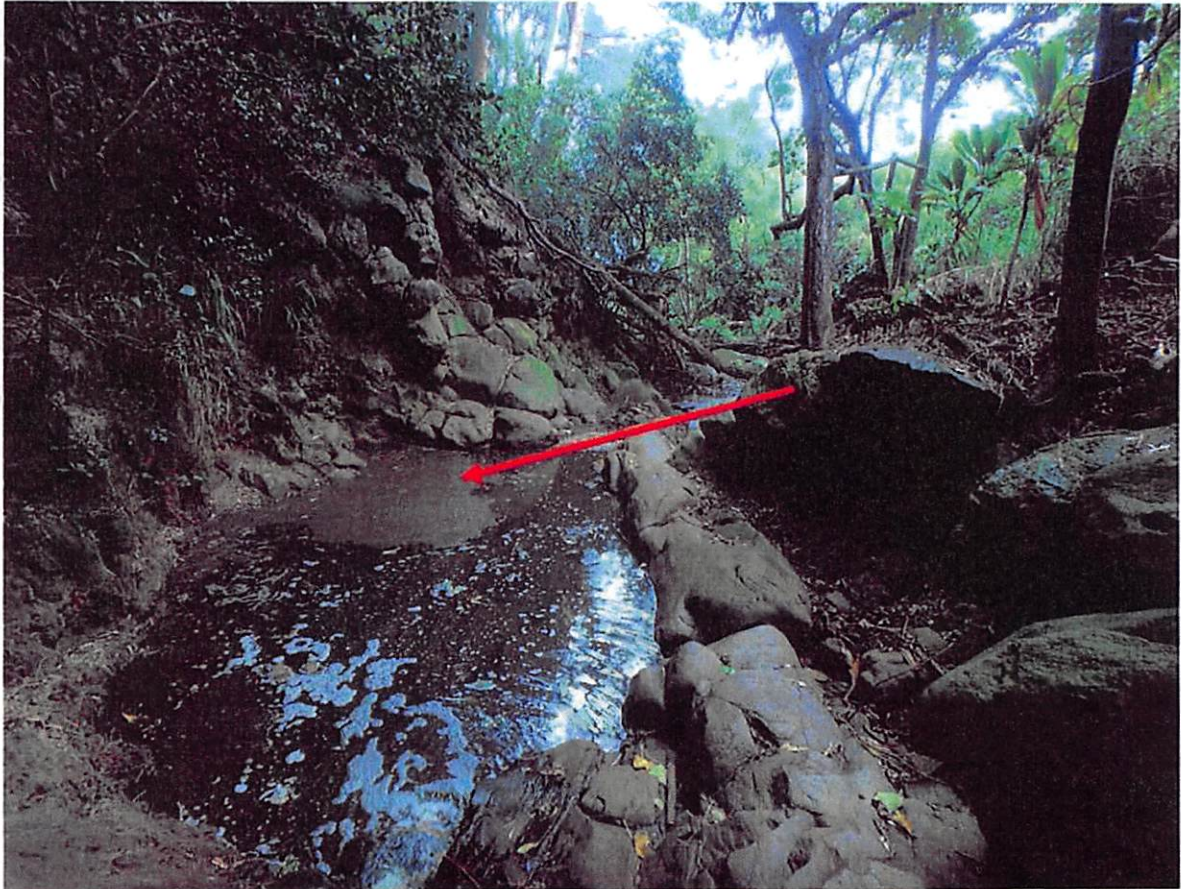
Photograph 6

- 3) Upon descent into Kaohaoha Gulch, pools of what appeared to be polluted water (Photograph 6) was observed. The water appeared to have a scum layer with accumulated floatable sludge. The sludge appeared to be organic material. Ordinary water marks on the sides of the stream were easily viewed due to a brown stain.

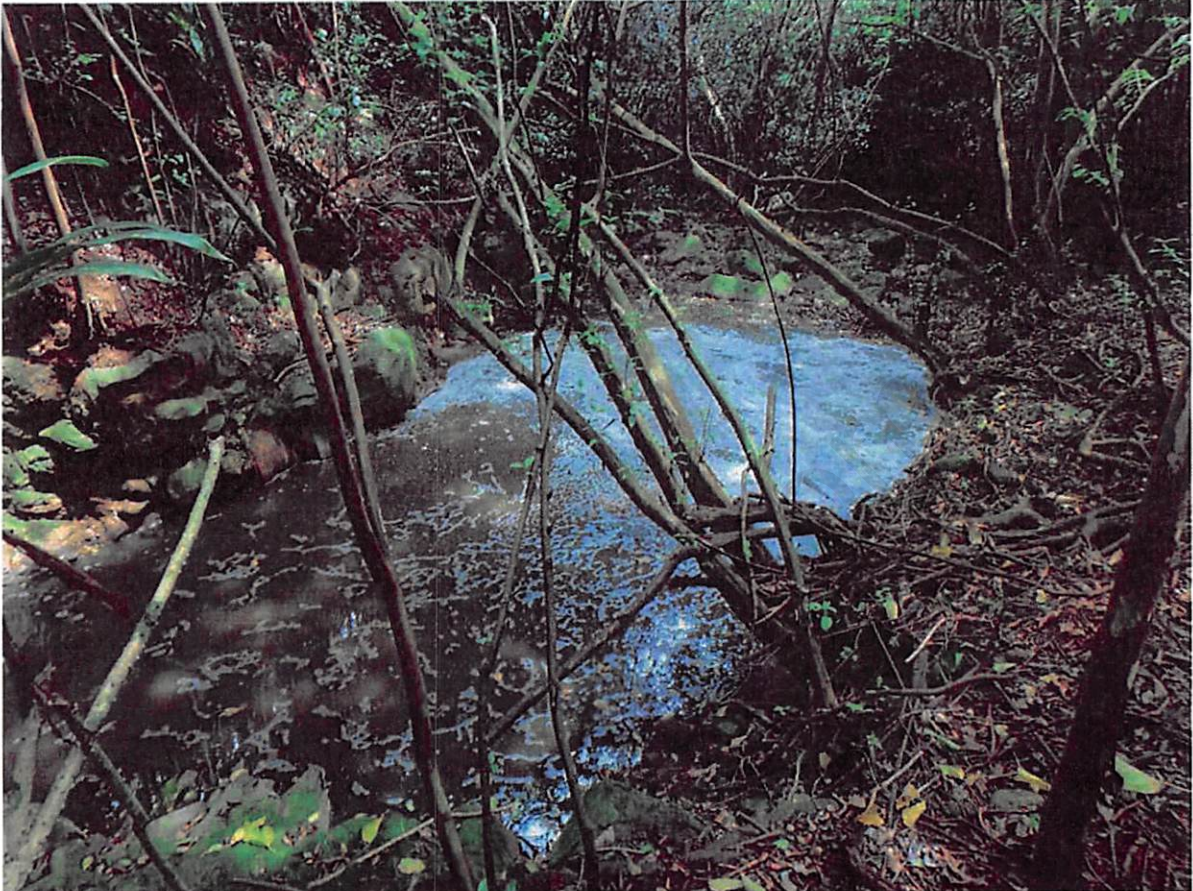
Photograph 7

- 4) N. Mukai, B. Duff and I continued to hike upstream (southwest). Stream water was markedly impaired (Photograph 7). In natural ponds, the water accumulated was cloudy with a layer of what appeared to be foam.

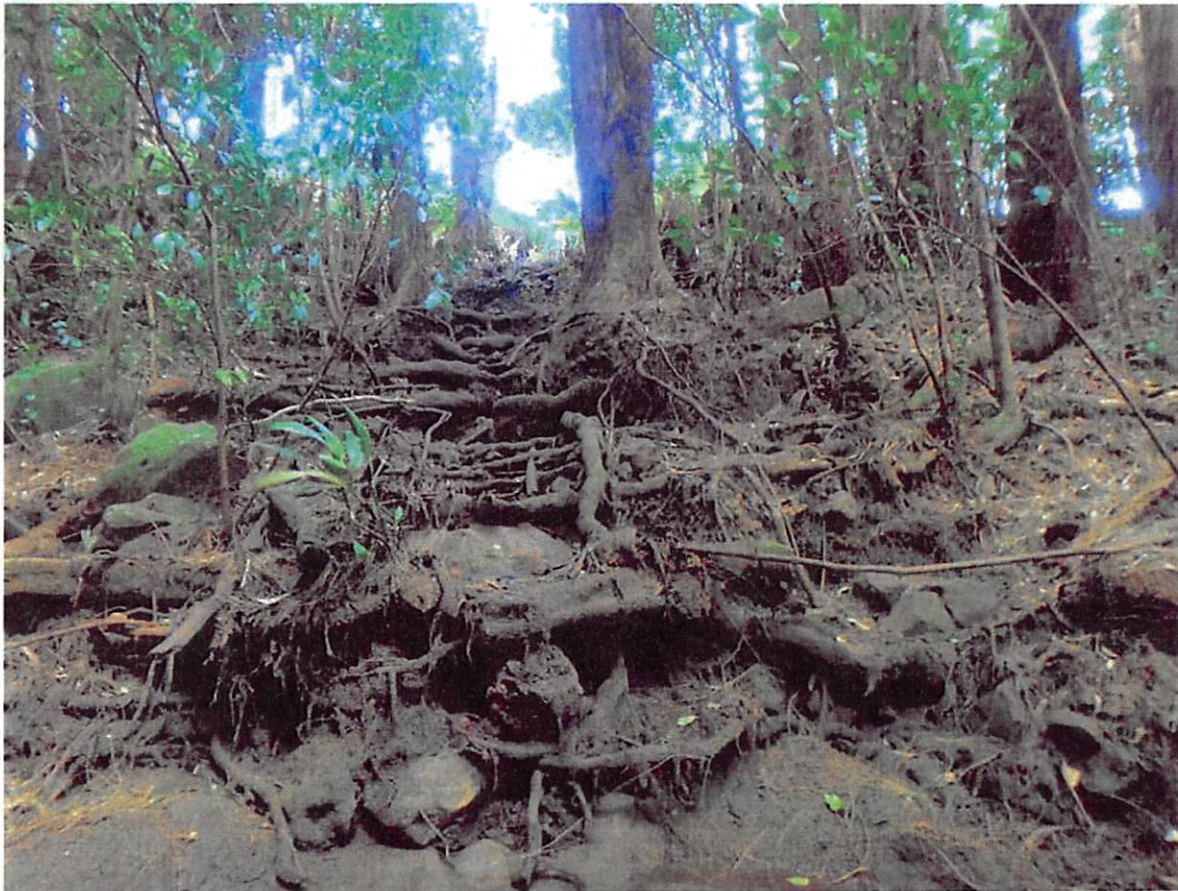
Photograph 8

- 5) On the east bank of Kaohaoha Gulch, I observed clear evidence of erosion due to a concentrated flow (Photograph 8). The flow path was covered by a layer of what appeared to be a sludge-like cake. Within the layer of sludge, I observed residual fibrous material that looked like short segments of straw, similar to the compost I observed at the Dairy's composting facility.

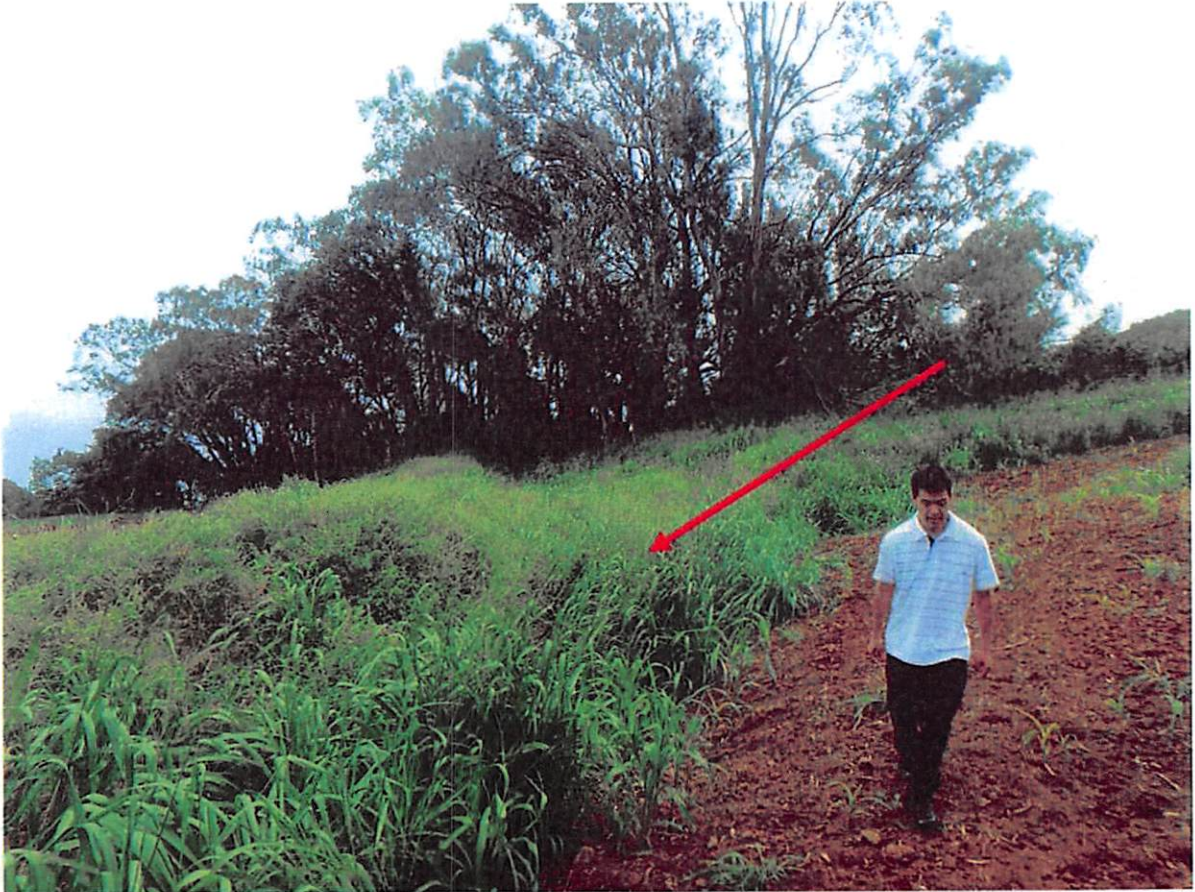
- 6) N. Mukai, B. Duff and I followed the trail of what appeared to be sludge up the east bank of Kaohaoha Gulch and emerged in one of the Dairy's fields (Photograph 9). The location pictured in Photograph 9 is located at approximately 20°0'8.91"N, 155°16'35.80"W. At this location, I observed a heavily vegetated drainage ditch cut perpendicular to the slope of the field. The ditch appeared to be designed to receive excess irrigation and/or storm water and direct excess water to Kaohaoha Gulch. The ditch was very damp with small ponds of standing water.

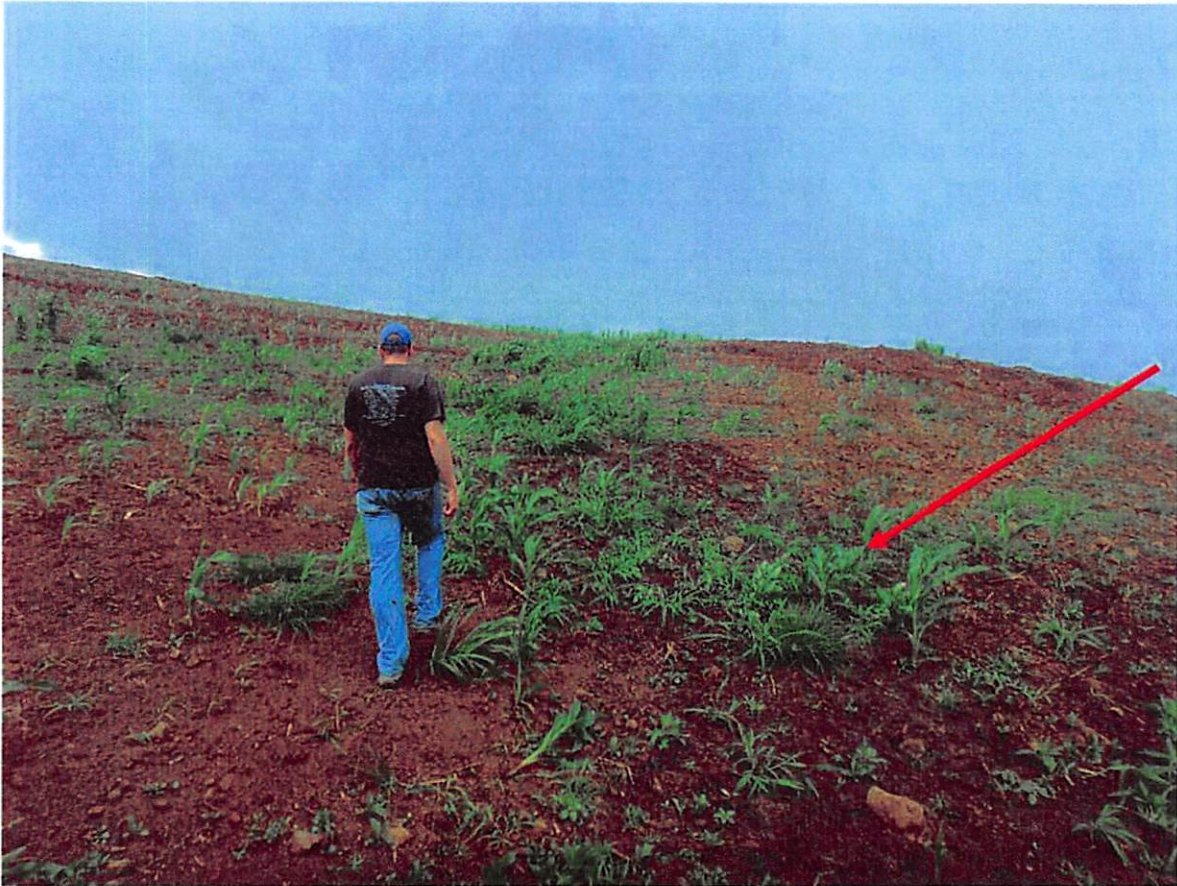
Photograph 10

- 7) I observed a black trail of what appeared to be dried wastewater solids running from the fields to the ditch that directs excess water to Kaohaoha Gulch. The black trail of solids (Photograph 10) is clear evidence that irrigation water is flowing off of the Dairy's fields and ultimately into Kaohaoha Gulch. After recording clear visual evidence that wastewater used to fertilize and irrigate the field was discharging into Kaohaoha Gulch, N. Mukai, B. Duff and I traced the excess wastewater from the fields back into Kaohaoha Gulch to resume the inspection (Photograph 11).

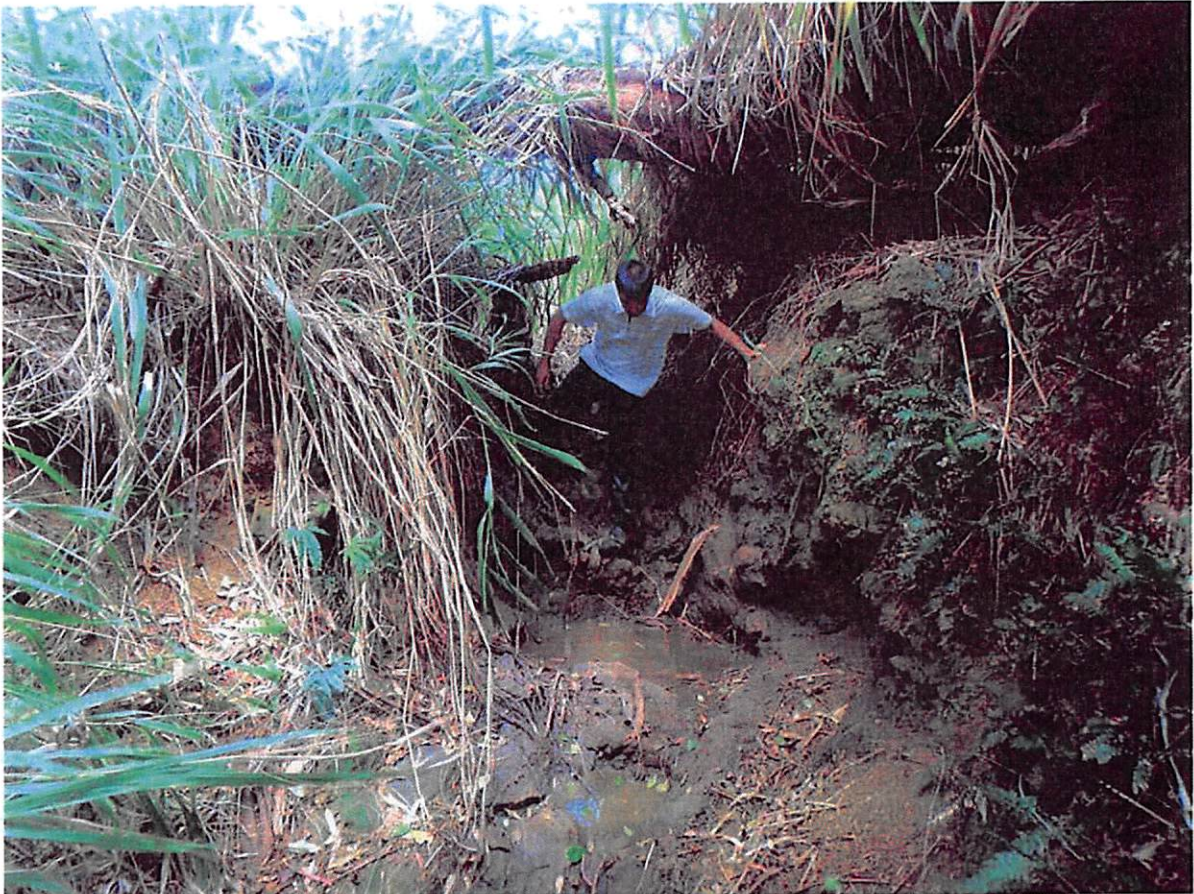
Photograph 11

Description: View of the source of the transition between the Dairy's crop fields and Kaohaoha Gulch. Wastewater from the field pictured in Photograph 10 discharged into Kaohaoha Gulch at this location. N. Mukai, pictured, is traversing the transition between the Dairy's fields and Kaohaoha Gulch. A layer of wet organic material covered the areas where erosion was observed.

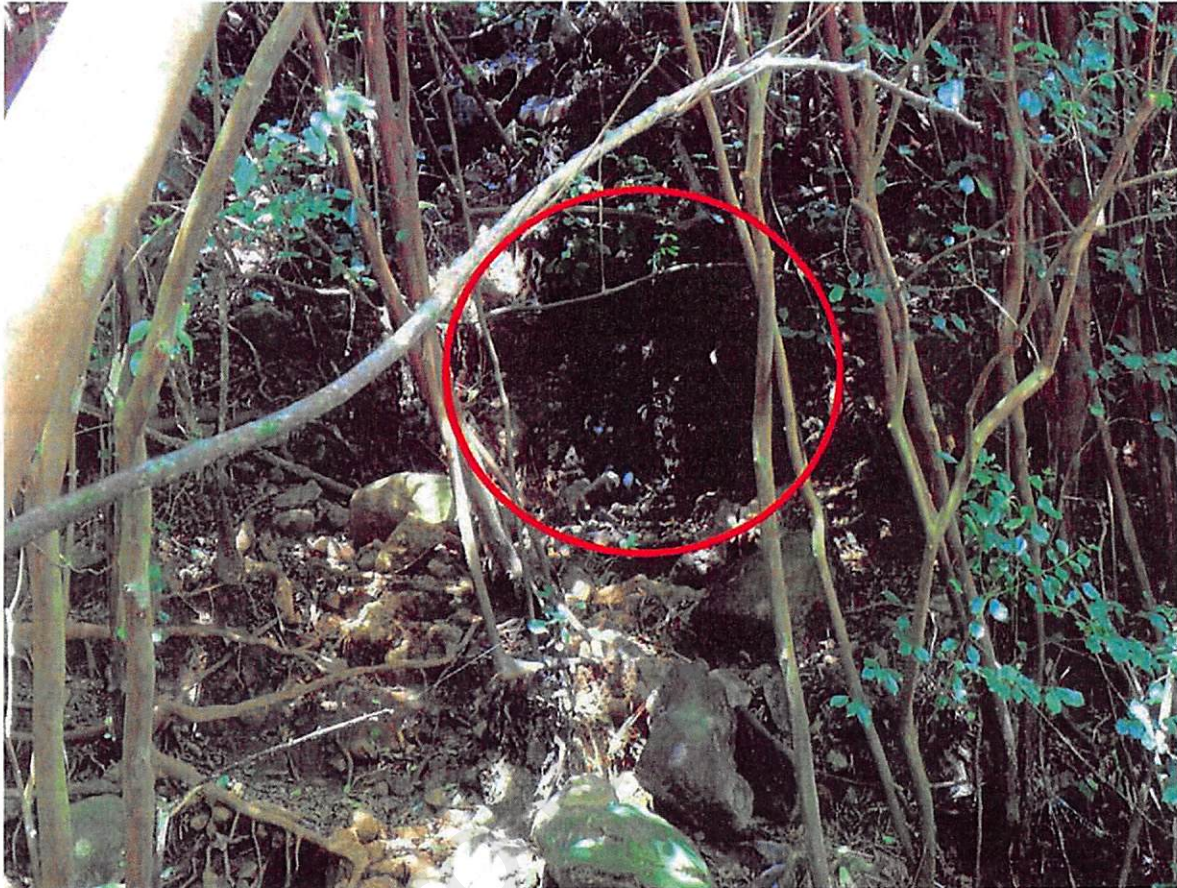
Photograph 12

- 8) At multiple locations between where I entered Kaohaoha Gulch at the "airstrip" and where I ultimately exited Kaohaoha Gulch at a location near the calf pens, I observed evidence of locations where wastewater used to fertilize the Dairy's fields entered into Kaohaoha Gulch. The locations showed clear signs of erosion and dried sludge-like solids (Photograph 12).

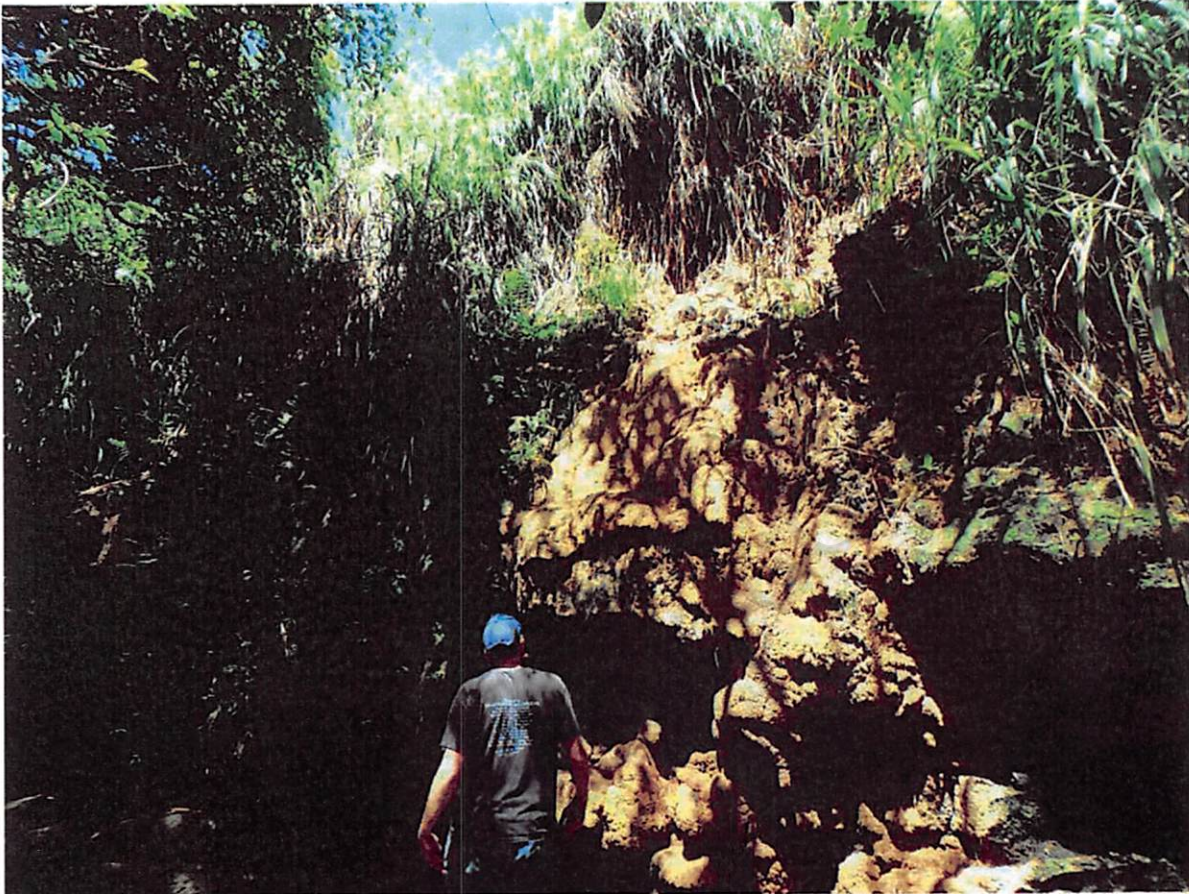
Photograph 13

- 9) At the location where the Dairy's wastewater lagoon's spillway connects to Kaohaoha Gulch, I observed clear evidence of previous discharges. A cascade (Photograph 13) of

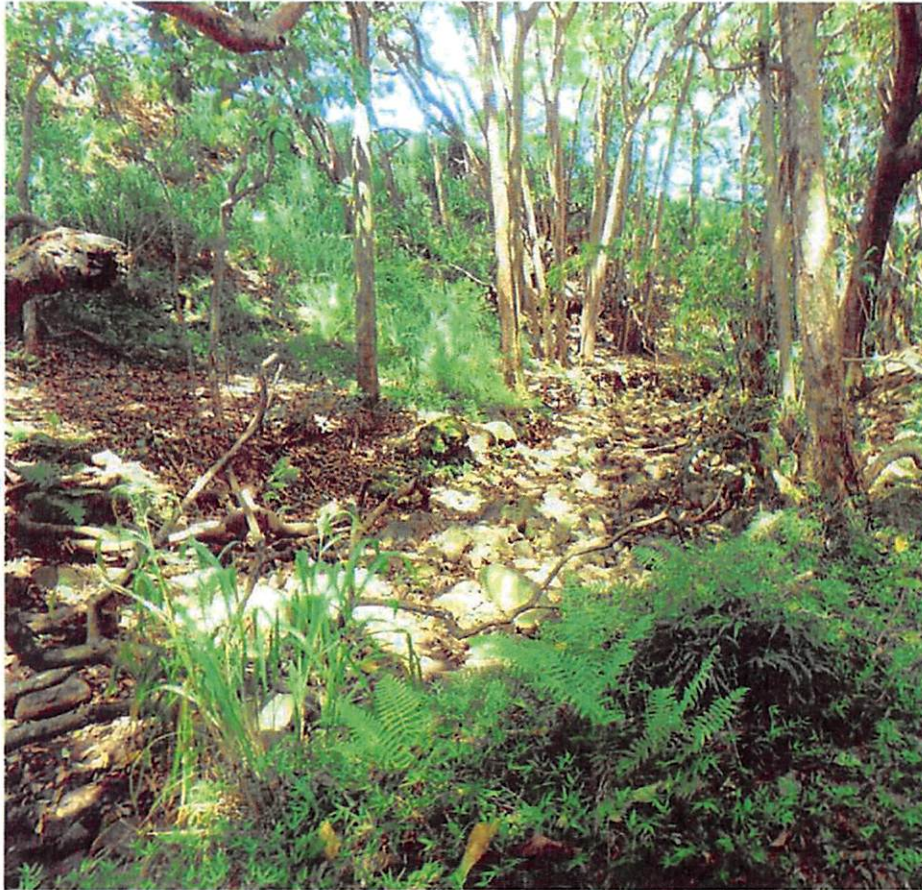
Photograph 14

- 10) Near the area where N. Mukai, B. Duff and I exited Kaohaoha Gulch at approximately 19°59'46.97"N, 155°16'58.50"W, Kaohaoha Gulch was dry (Photograph 14). B. Duff stated that Kaohaoha Gulch doesn't always flows at elevations above the Dairy but will always flow in lower areas due to overflow water from the Dairy's well (Photograph 15). Based on the lack of flow in Kaohaoha Gulch near the location I exited the gulch, the flow observed lower in Kaohaoha Gulch was due to discharges from the Dairy.

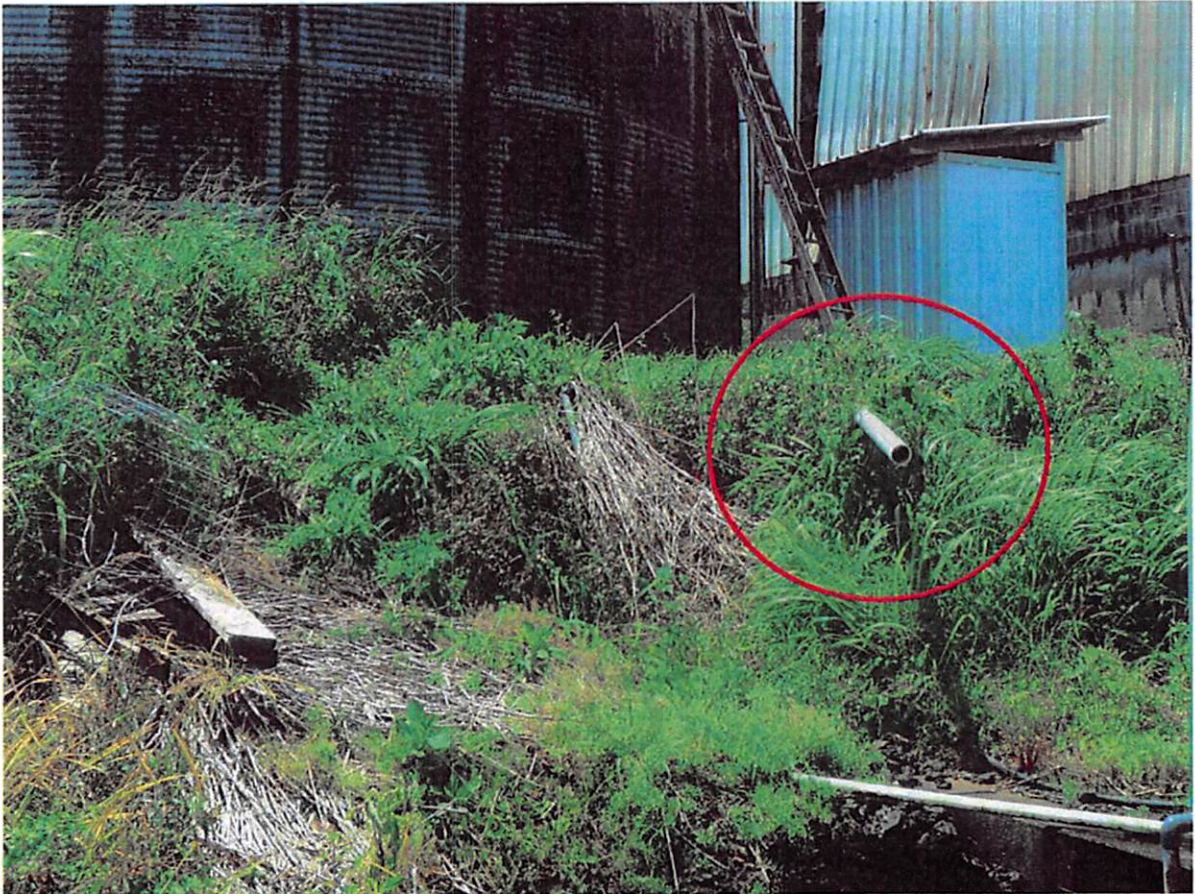
Photograph 15

- 11) After exiting Kaohaoha Gulch, N. Mukai, B. Duff and I walked to the location where the Dairy's well overflow pipe (Photograph 15) is located. B. Duff stated that discharge from the overflow pipe was variable depending on the amount of water used in the Dairy operation. B. Duff stated that during the day, the Dairy consumes more water for Dairy operations and as such, less water discharges into Kaohaoha Gulch.

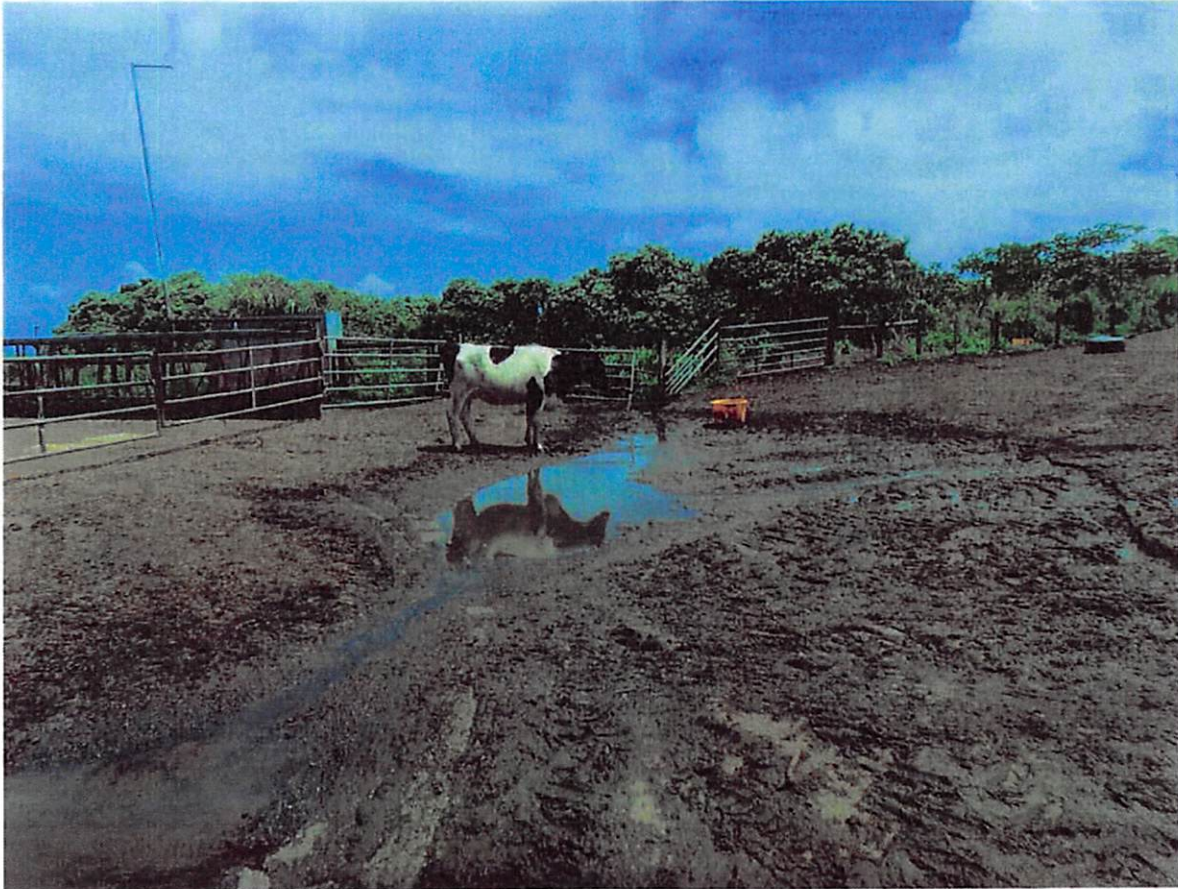
Photograph 16

- 12) Between the Dairy's well overflow pipe and Kaohaoha Gulch, I observed that the Dairy's overflow water flows through an area where cows were confined (Photograph 16). The confined area had a layer of cow waste and the waste was discharging into Kaohaoha Gulch at the time of inspection. Though the volume of discharge was relatively low at the time of inspection, during the times of day when less water is consumed by Dairy operations, discharges from this area would likely be greater.
