DEPARTMENT OF HEALTH
NOTICE OF VIOLATION AND ORDER

TO: Big Island Dairy, LLC 695 N 700 E Rupert, Idaho 83350 Respondent Attn: Steve Whitesides Manager	NOVO No. 2017-CW-EO-08 <i>Please write this NOVO number on all correspondence</i> Re: Unauthorized Discharge of Pollutants from Big Island Dairy, Concentrated Animal Feeding Operation to State waters Property/Facility: Big Island Dairy, Near Mile Marker 30, O'okala, HI
--	--

Concentrated Animal Feeding Operation
NPDES Inspection Report
Facility Name: Big Island Dairy
Photograph Log

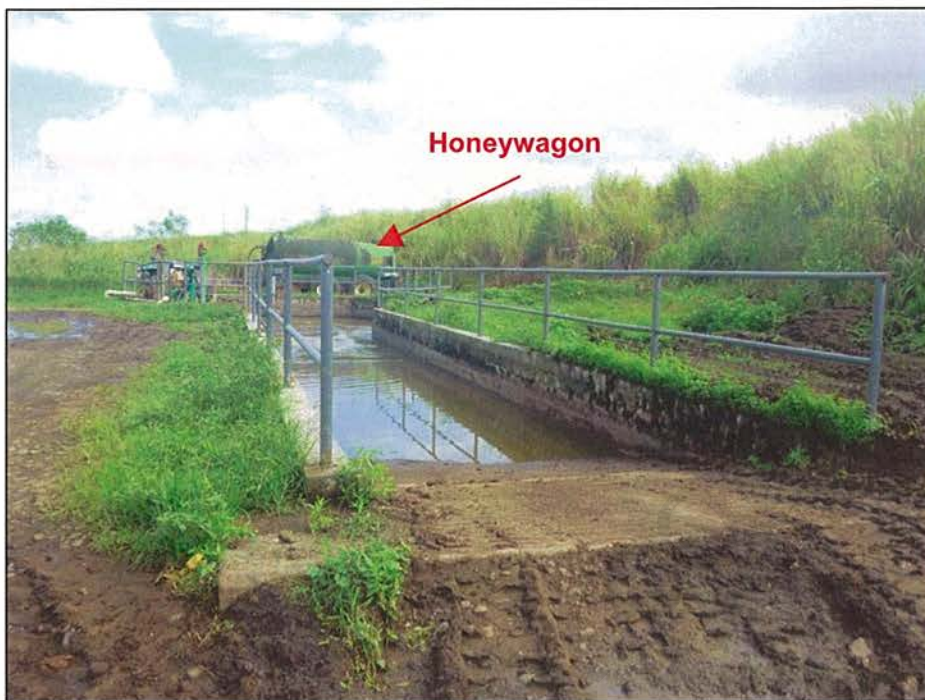
Photograph 15. View of the Facility's manure composting building collection pit. Waste streams from the freestall barns, calf barn, and milking barn gravity flow into this collection pit. Note the honeywagon stored behind the collection pit. Photo by A. D'Angelo; 12/14/16.

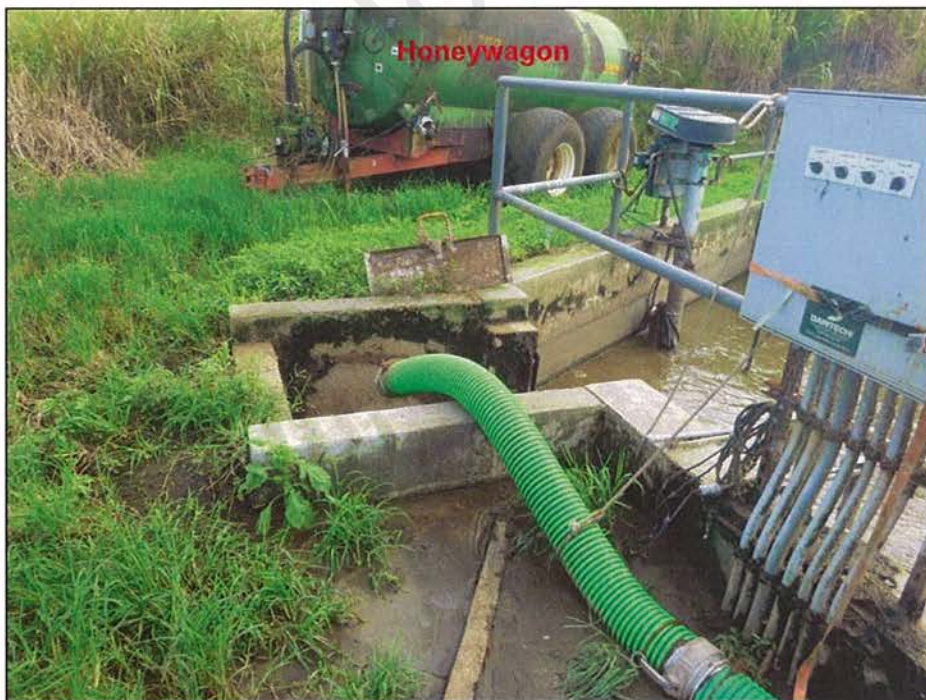
Photograph 20. View of the manure composting building collection pit overflow point. Overflow flows into the manure separation cells shown in Photographs 22 and 23. Note the honeywagon. Photo by A. D'Angelo; 12/14/16.

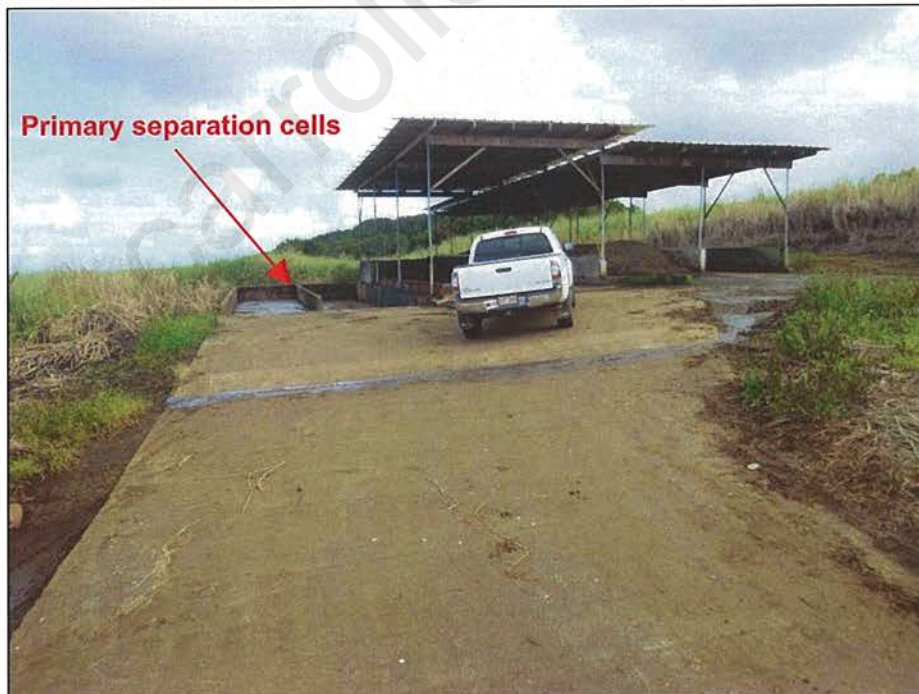
Photograph 22. View, facing east, of the Facility's manure solids separation cells located adjacent to the upper lagoon (refer to Figure 2). The uncovered cells on the left serve as the primary cells and liquid waste discharge points. Photo by A. D'Angelo; 12/14/16.

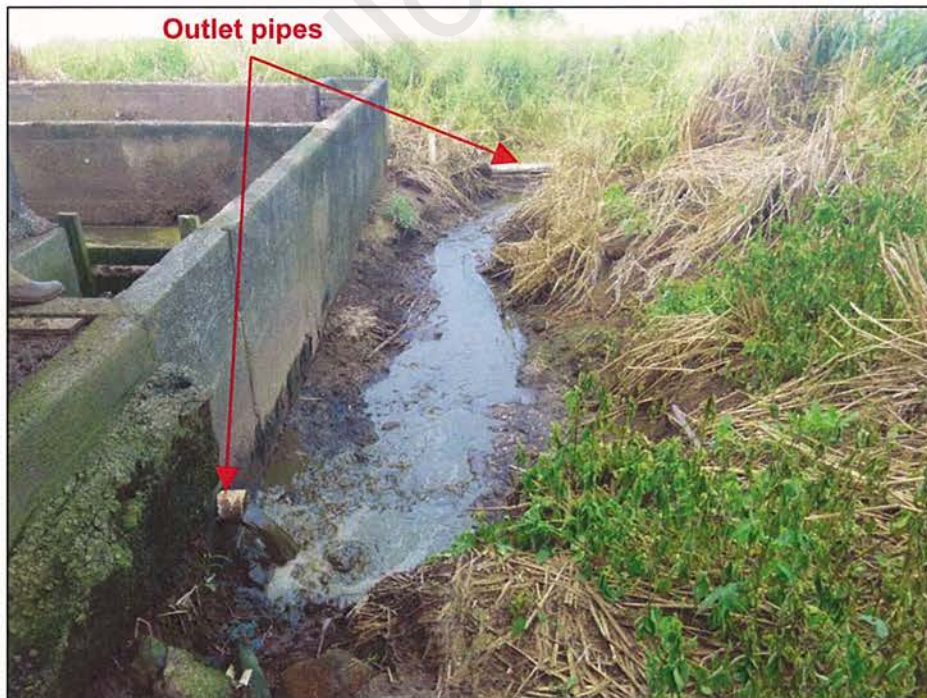
Photograph 24. View of the two pipes that drain separated liquid from the manure solids separation cells. Liquid from the cells surface flows, via an earthen conveyance channel, into the northwest side of the upper lagoon. Photo by A. D'Angelo; 12/14/16.

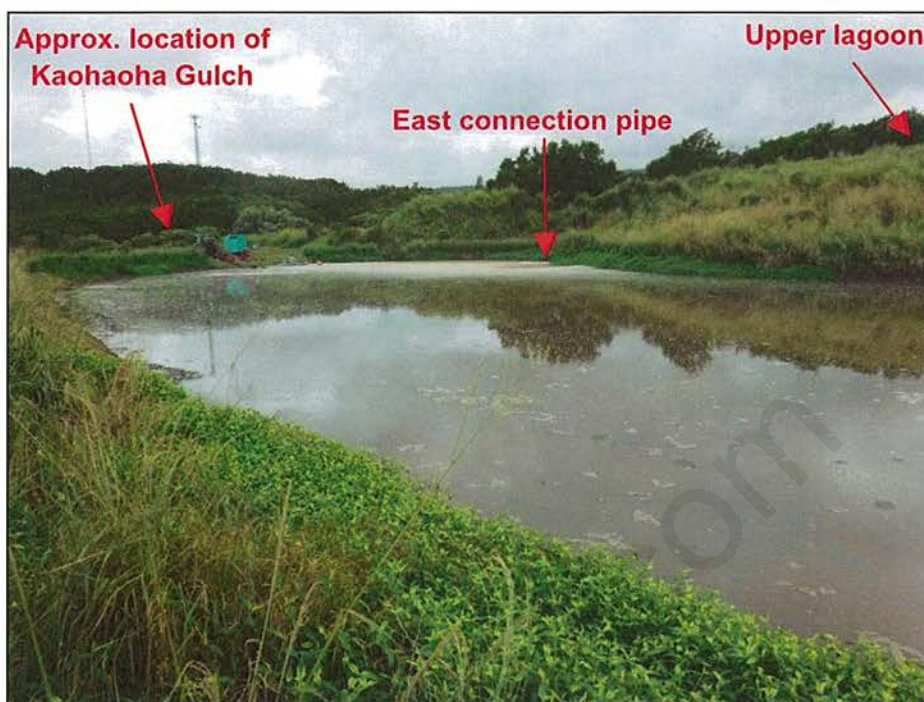
Photograph 27. View, facing southeast, of the lower lagoon. I observed a floating agitator unit, draw pumping system, and overflow spillway on the southeast side of the lagoon. Photo by A. D'Angelo; 12/14/16.

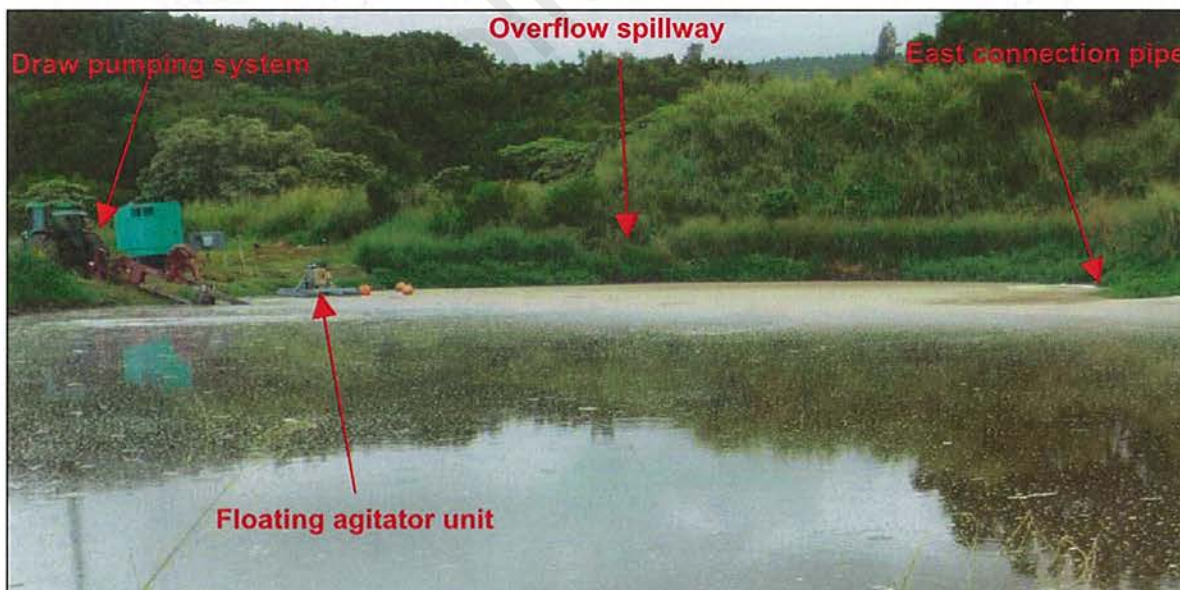
Photograph 28. Zoomed-in version of Photograph 27, showing the floating agitator unit, draw pumping system, and overflow spillway of the lower lagoon. Photo by A. D'Angelo; 12/14/16.

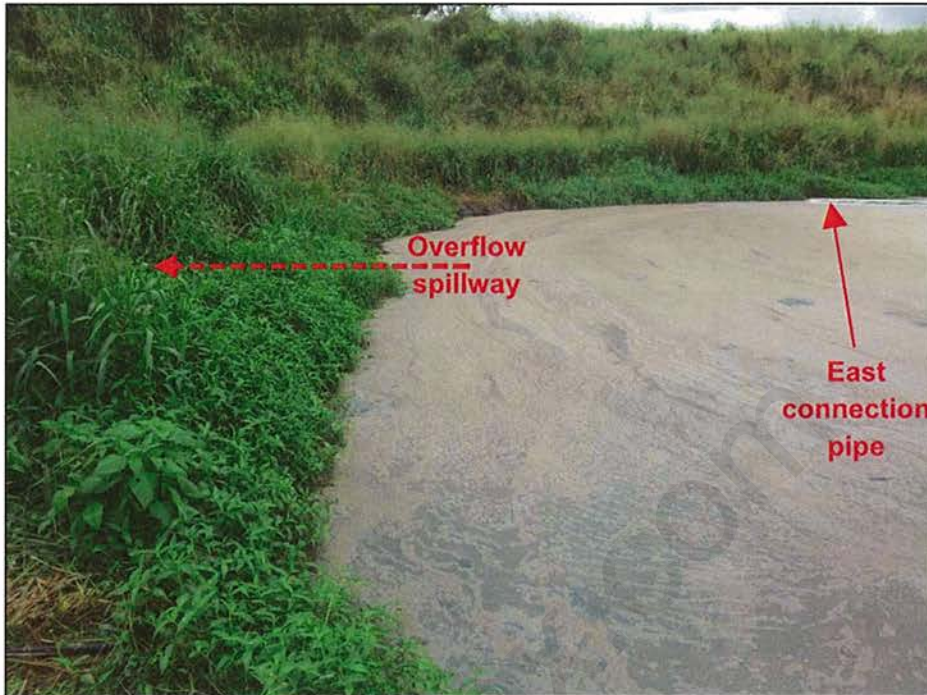
Photograph 31. View, facing south, of the approximate location of the lower lagoon overflow spillway. Photo by A. D'Angelo; 12/14/16.

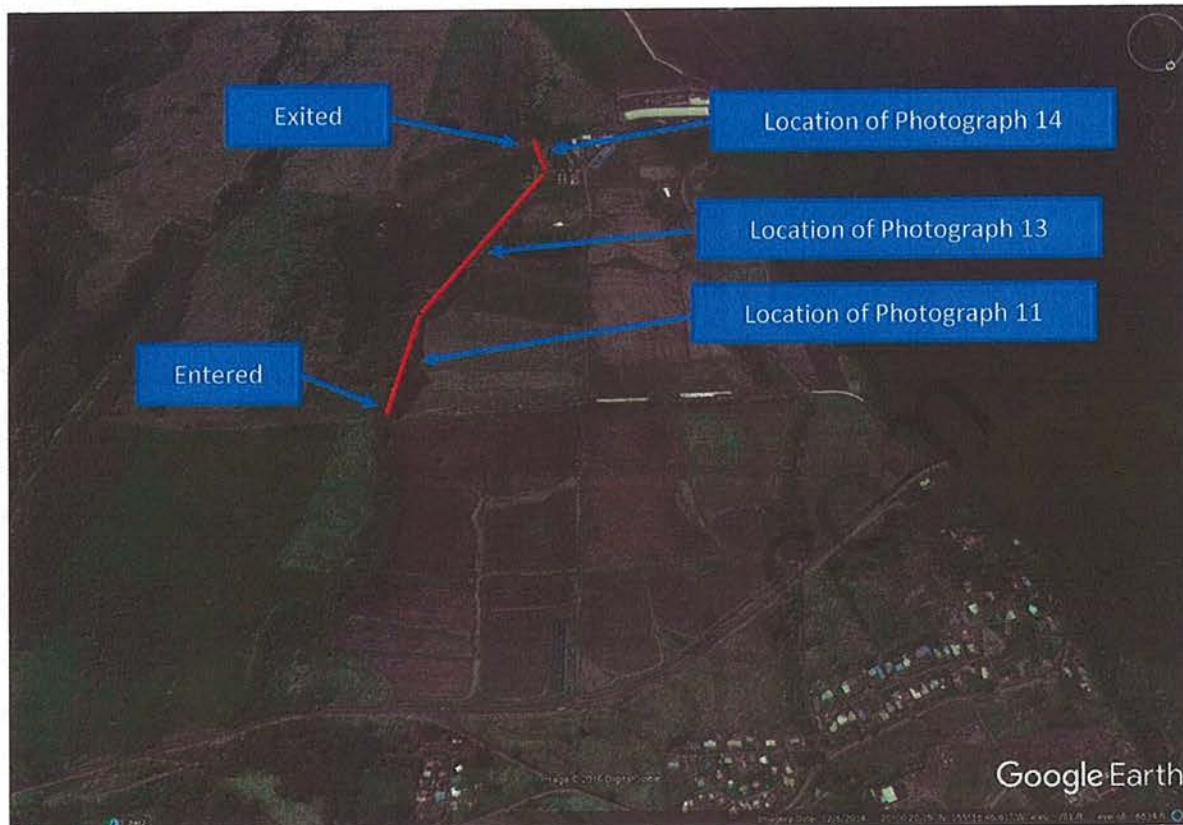
Figure 4: View of the segment of Kaohaoha Gulch inspected on March 29, 2017

Description: The red line is the path upon which N. Mukai, B. Duff and I followed in the inspection of Kaohaoha Gulch. Photograph 11 is the location where a discharge of wastewater from fertilization of the fields was observed. Photograph 13 is the location where evidence of discharge from the wastewater lagoons was observed. Photograph 14 is the location where the dry streambed was observed.

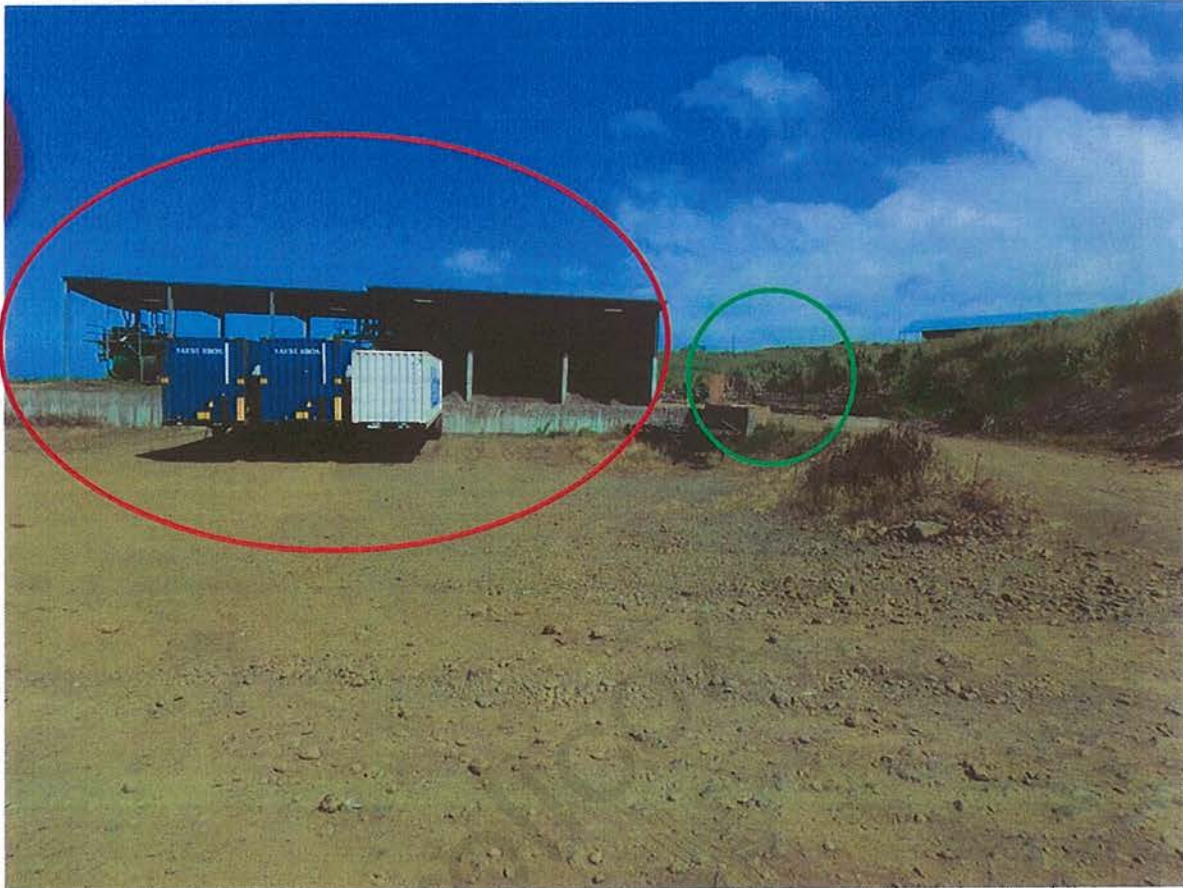
Photograph 4

- 2) As detailed in the December 2016, report, the Dairy's composting facility (Photograph 4) is located adjacent to Alailoa Gulch. I walked to the compost bays to make

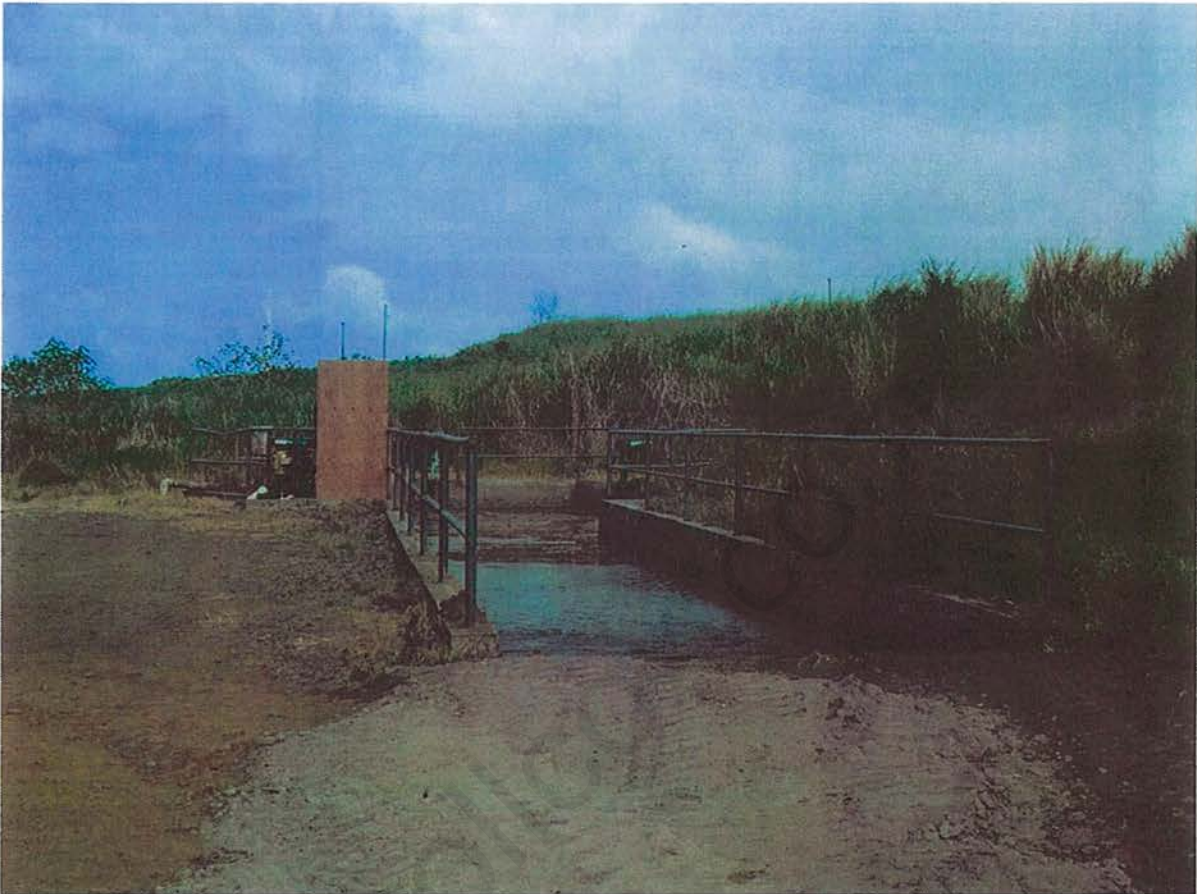
Photograph 5

- 3) While at the compost bays, I smelled a strong odor emanating from the Dairy's wastewater sump (Photograph 5). The wastewater collected in the wastewater sump was being agitated to suspend wastewater solids as is routine. The odor was very pungent and easily traced to the wastewater sump. Solids from the wastewater sump is separated to be processed as compost while remaining wastewater flows to the Dairy's sludge beds. Sludge separated in the sludge beds is then routed back to the wastewater sump for re-separation.
- 4) N. Mukai and I left the Dairy at approximately 4:00pm.

- d. I observed a strong odor at the Dairy's wastewater sump. I could not definitively determine if the odor was the source of the odors which area residents have stated is a problem. However, based on the odor emanating from the Dairy's wastewater sump, the Dairy should investigate this issue further to determine if odor control units are necessary.

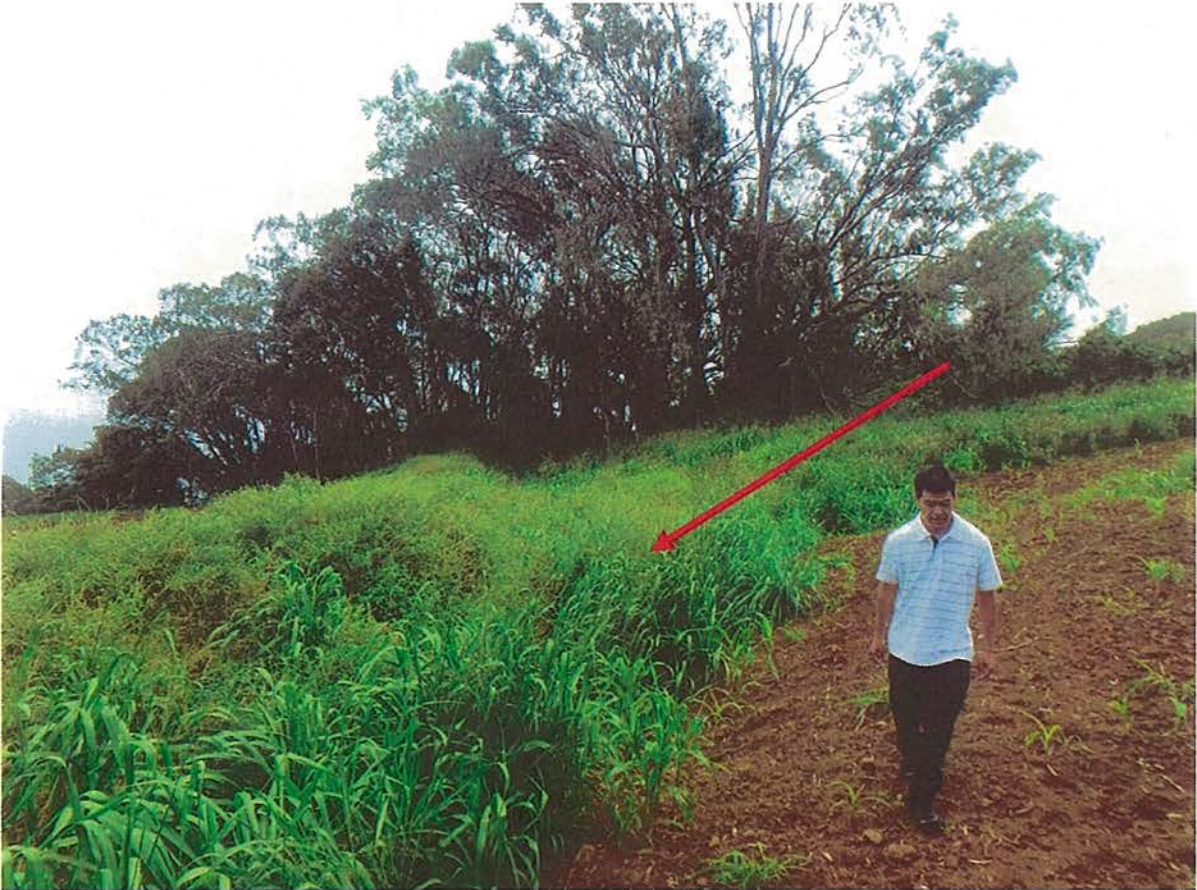
- 6) N. Mukai, B. Duff and I followed the trail of what appeared to be sludge up the east bank of Kaohaoha Gulch and emerged in one of the Dairy's fields (Photograph 9). The location pictured in Photograph 9 is located at approximately 20°0'8.91"N, 155°16'35.80"W. At this location, I observed a heavily vegetated drainage ditch cut perpendicular to the slope of the field. The ditch appeared to be designed to receive excess irrigation and/or storm water and direct excess water to Kaohaoha Gulch. The ditch was very damp with small ponds of standing water.

Description: View of the location where N. Mukai, B. Duff and I emerged from Kaohaoha Gulch after flowing the trail of sludge from the streambed up the gulch's east bank. This location is one of the Dairy's crop fields where wastewater is used to irrigate feed crops. The vegetation pictured is growing in a ditch (Red Arrow) that drains into Kaohaoha Gulch. The eroded bank observed in Photograph 8, was caused due to discharges of wastewater from the heavily vegetated ditch pictured.

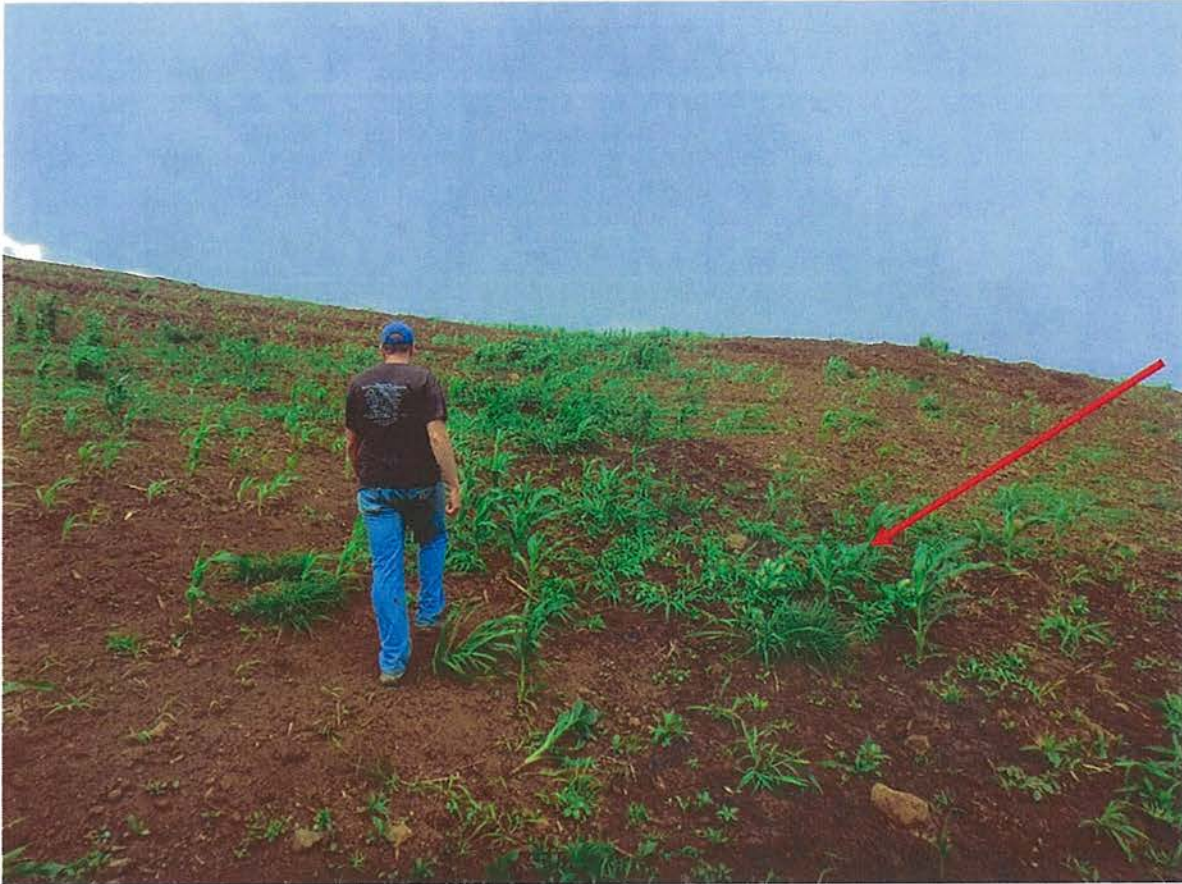
Photograph 10

- 7) I observed a black trail of what appeared to be dried wastewater solids running from the fields to the ditch that directs excess water to Kaohaoha Gulch. The black trail of solids (Photograph 10) is clear evidence that irrigation water is flowing off of the Dairy's fields and ultimately into Kaohaoha Gulch. After recording clear visual evidence that wastewater used to fertilize and irrigate the field was discharging into Kaohaoha Gulch, N. Mukai, B. Duff and I traced the excess wastewater from the fields back into Kaohaoha Gulch to resume the inspection (Photograph 11).

Description: View of the fields immediately uphill from the vegetated ditch pictured in Photograph 9. Evidence of wastewater used to irrigated the fields running off into the vegetated ditch was observed. The dark colored material (Red Arrow) pictured was damp wastewater runoff that originated from the Dairy's irrigation system. Due to the grade of the field, wastewater not absorbed by the field flows into the vegetated ditch that drains into Kaohaoha Gulch.

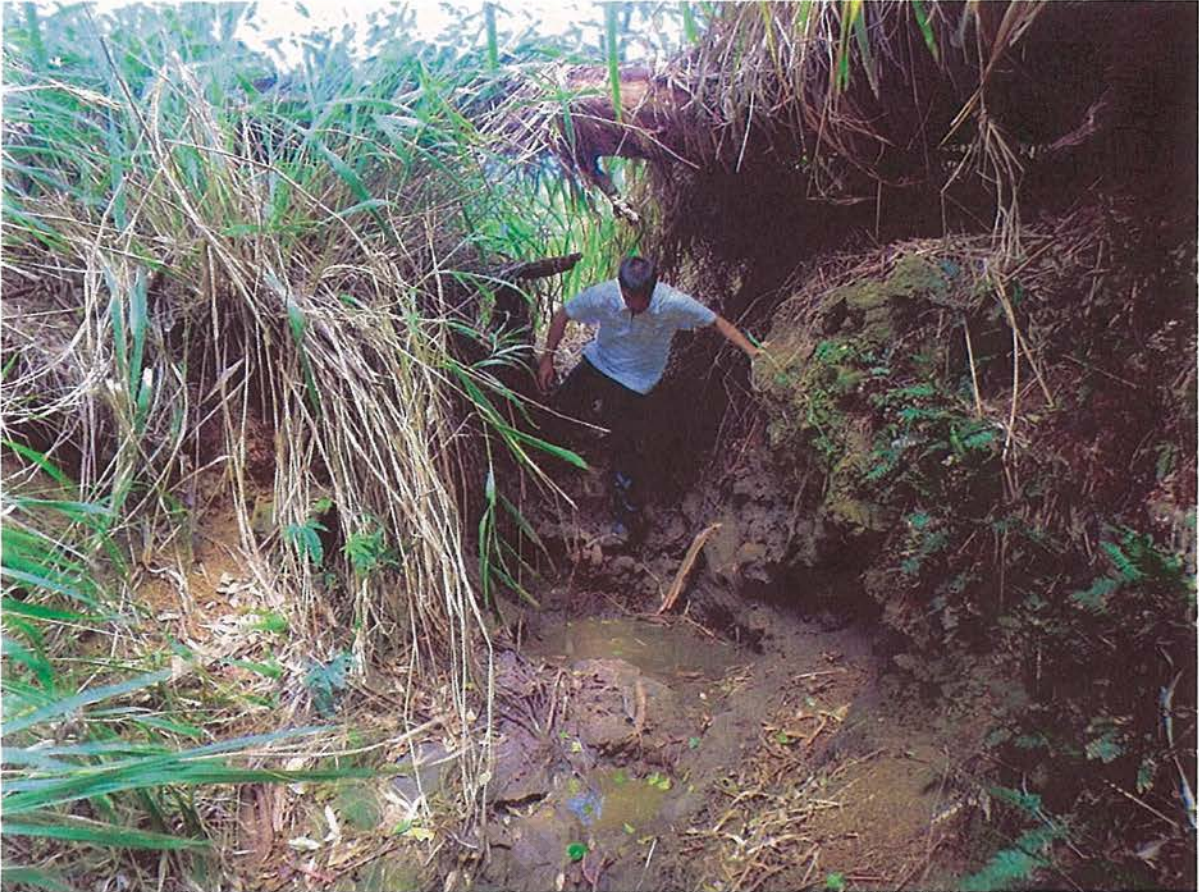
Photograph 11

- a. I observed evidence of ongoing discharges of wastewater associated with the irrigation of the fields.
 - b. I observed clear evidence of discharges from the Dairy's wastewater lagoon at the location near the lagoon spillway into Kaohaoha Gulch. It was clear to me at the time that the Dairy had not recently discharged. I estimated that it likely had not discharged for a number of weeks but could not be certain based on limited study of the area.

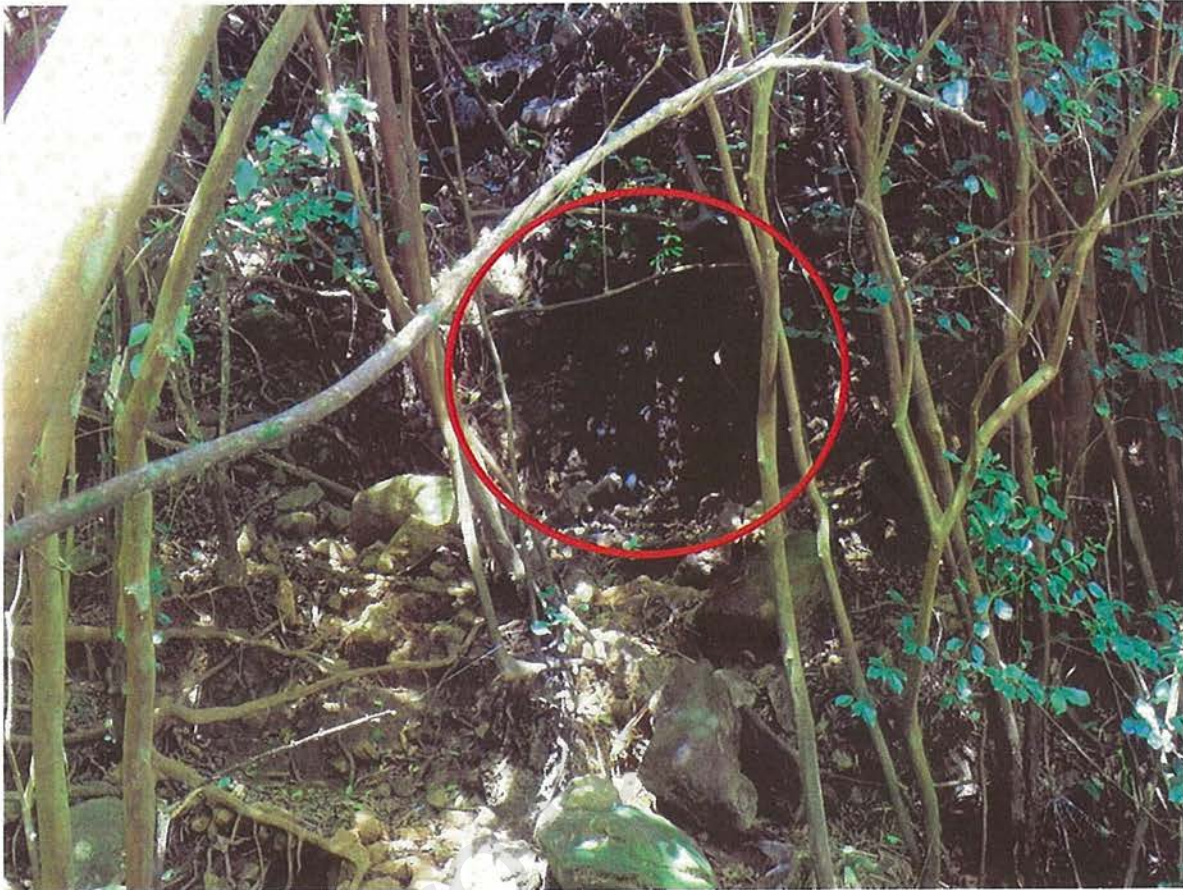
Photograph 12

- 8) At multiple locations between where I entered Kaohaoha Gulch at the "airstrip" and where I ultimately exited Kaohaoha Gulch at a location near the calf pens, I observed evidence of locations where wastewater used to fertilize the Dairy's fields entered into Kaohaoha Gulch. The locations showed clear signs of erosion and dried sludge-like solids (Photograph 12).

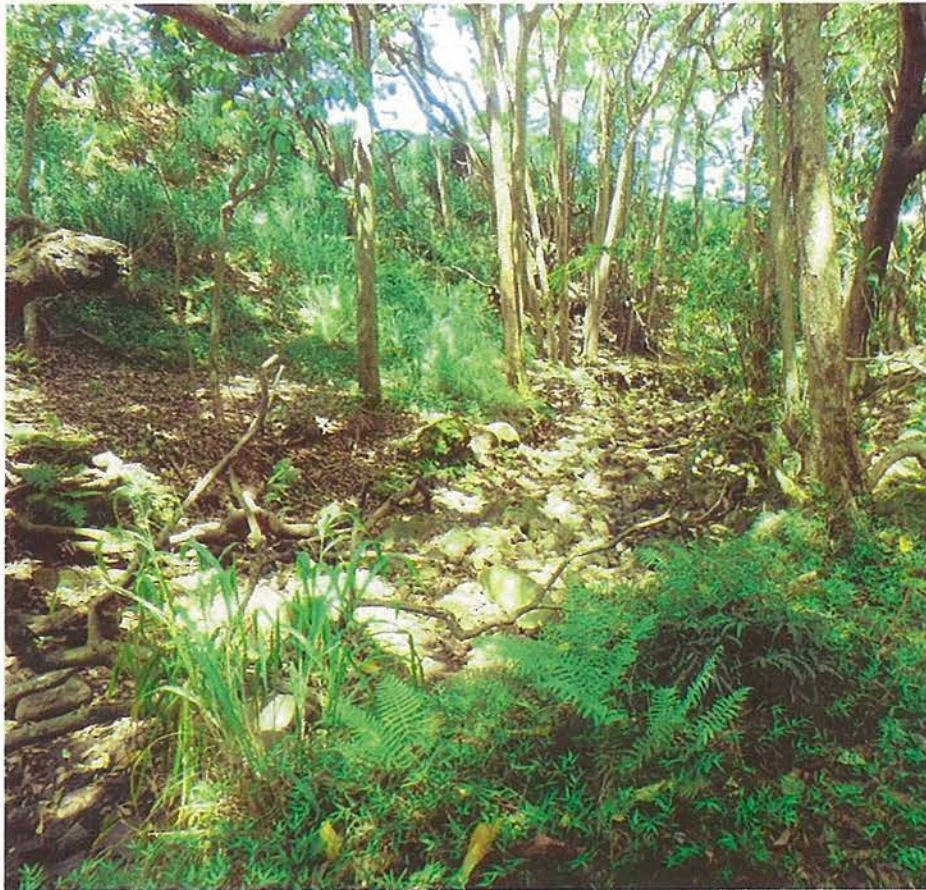
Photograph 14

- 10) Near the area where N. Mukai, B. Duff and I exited Kaohaoha Gulch at approximately 19°59'46.97"N, 155°16'58.50"W, Kaohaoha Gulch was dry (Photograph 14). B. Duff stated that Kaohaoha Gulch doesn't always flows at elevations above the Dairy but will always flow in lower areas due to overflow water from the Dairy's well (Photograph 15). Based on the lack of flow in Kaohaoha Gulch near the location I exited the gulch, the flow observed lower in Kaohaoha Gulch was due to discharges from the Dairy.

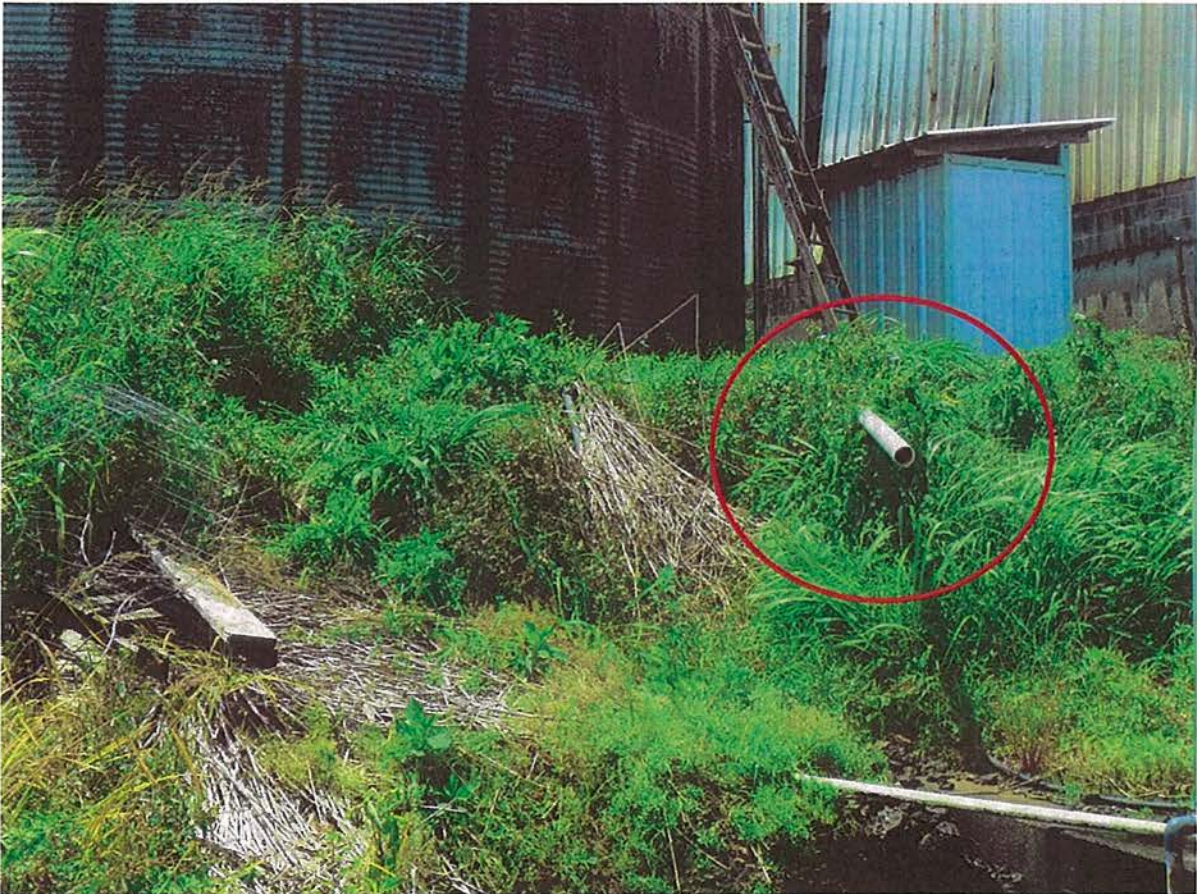
Photograph 15

- 11) After exiting Kaohaoha Gulch, N. Mukai, B. Duff and I walked to the location where the Dairy's well overflow pipe (Photograph 15) is located. B. Duff stated that discharge from the overflow pipe was variable depending on the amount of water used in the Dairy operation. B. Duff stated that during the day, the Dairy consumes more water for Dairy operations and as such, less water discharges into Kaohaoha Gulch.

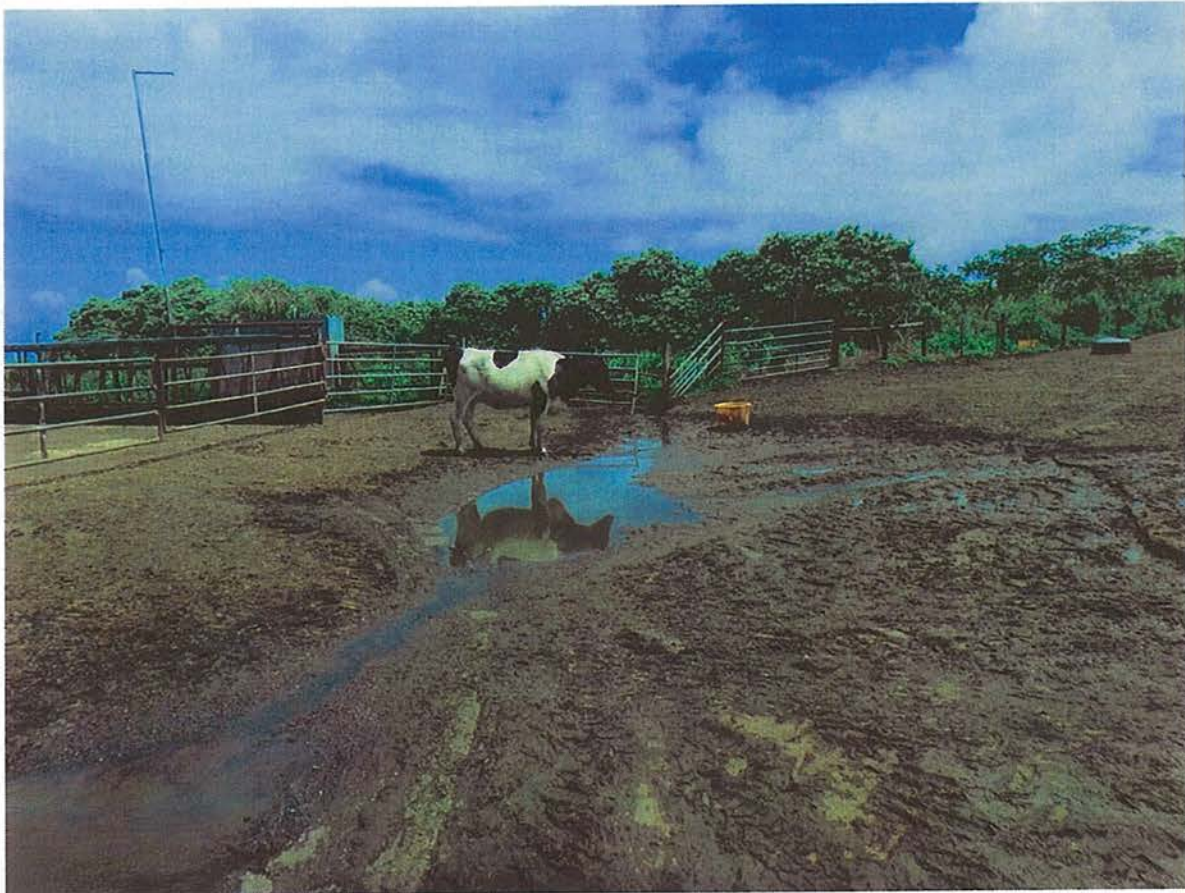
Photograph 16

- 12) Between the Dairy's well overflow pipe and Kaohaoha Gulch, I observed that the Dairy's overflow water flows through an area where cows were confined (Photograph 16). The confined area had a layer of cow waste and the waste was discharging into Kaohaoha Gulch at the time of inspection. Though the volume of discharge was relatively low at the time of inspection, during the times of day when less water is consumed by Dairy operations, discharges from this area would likely be greater.
