**Hawaii Department of Health
 Clean Water Branch
 Enforcement Oversight Inspection Report**

Inspection Date: May 17, 2018

Inspection Report Number: HA0296

Site Name: Big Island Dairy

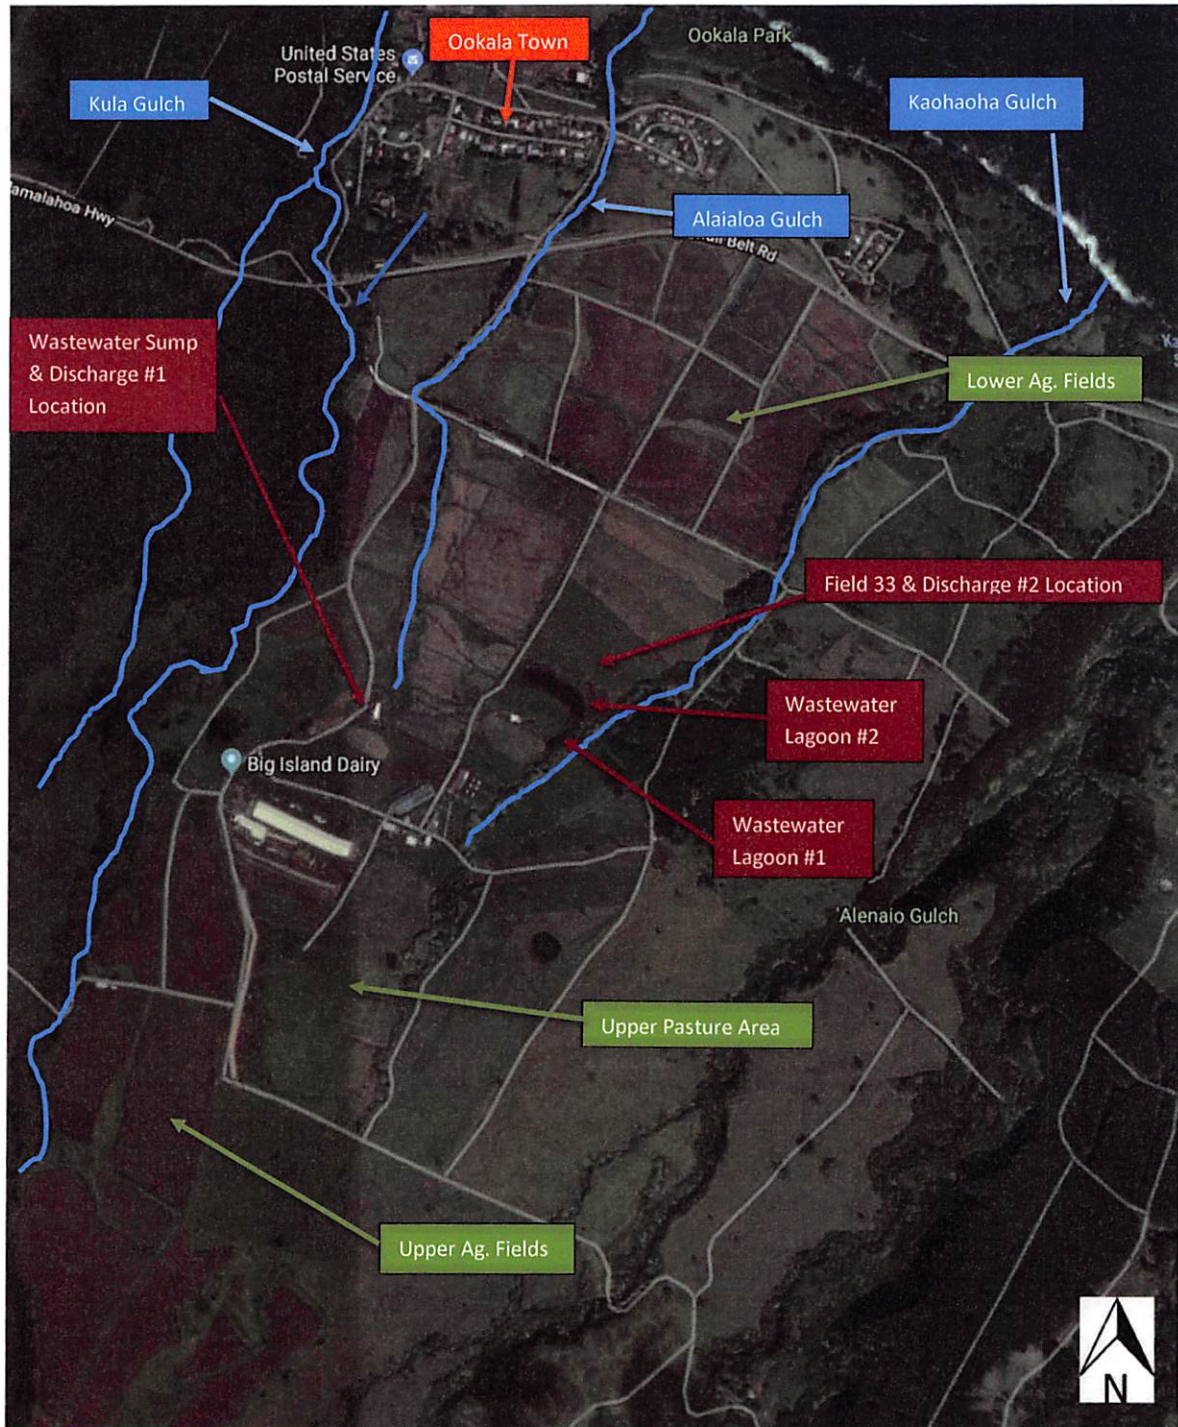
Image 2: Aerial view, from Google Earth, of Big Island Dairy and call outs for field areas, gulch locations, process areas, wastewater release location and Ookala Town.

- a. M. Kurano asked the Site Representatives to describe Discharge #1 that occurred on May 6, 2018 from the Wastewater Sump Pit (refer to, Image 2).
 - b. J. Mecham stated that the Dairy's Composter Operator discovered the discharge. J. Mecham stated that the Composter Operator showed up for his shift on May 6, 2018 at approximately 2:00 PM but did not notice whether there was a spill occurring as he drove passed the spill location towards the main office prior to beginning his shift.

3. M. Kurano then asked the Site Representatives to describe Discharge #2 that took place between May 7, 2018 and May 9, 2018 of wastewater from Wastewater Lagoon #2 (refer to, Image 2).

8. It was confirmed the first of the two wastewater discharges occurred on Sunday, May 6, 2018. The Dairy experienced a pipe failure at their wastewater sump (refer to, Image 2) causing a discharge of raw wastewater to Alaiialoa Gulch. Initial reports from Site Representatives to DOH-CWB on May 7, 2018 indicated the volume was at least 10,000 gallons. The discharge was stopped on May 6, 2018, at approximately 2:30 PM. Due to the nature of the area where the discharge occurred, the Dairy could only recover a small amount of the spilled wastewater. Following the discharge, at approximately 5:00 PM the Dairy started to receive heavy rains washing the unrecovered wastewater down Alaiialoa Gulch through the town of Ookala.
